Spring 2024

Historic Structure Report

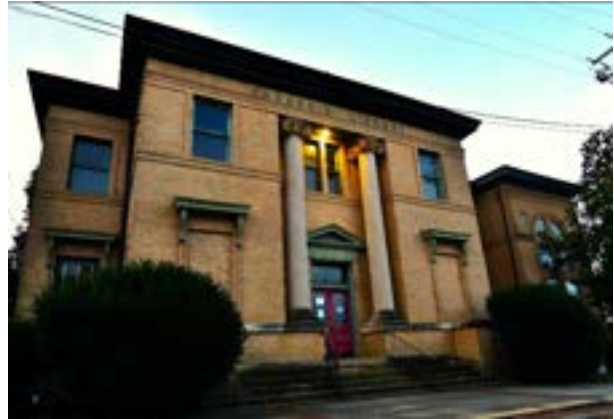
The Pelham Carnegie Library, 200 Hand Avenue West, Pelham, Mitchell County, Georgia.

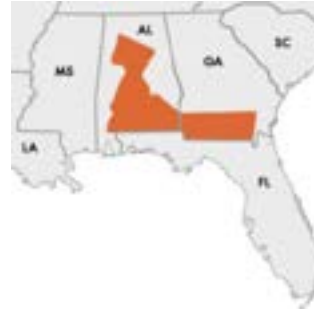
Figure 1.3. Land ceded by Treaty of Fort Jackson, 1814 included future Mitchell County. Image Wiki public domain.

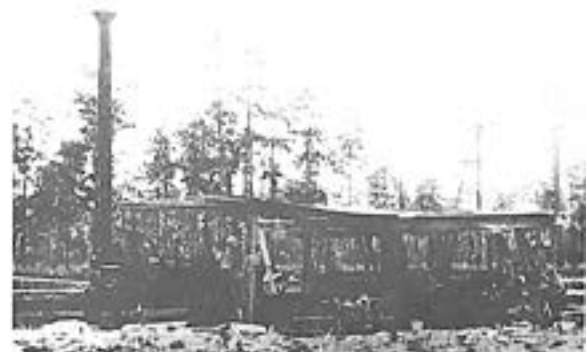
Figure 1.7. The little engine that ran the sawmill for J.L. Hand, 1873. Courtesy of *The Building of a Town*, 14.

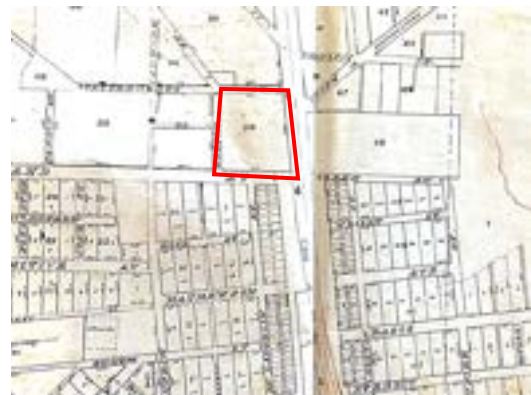
Figure 1.10. Enlargement - Pelham, GA Plat map "drawn for J.L. Hand May 1893". Site of J.L. Hand's residence, "Highland Villa" noted in red. Courtesy of Hargrett Rare Book and Manuscript Library/ University of Georgia Libraries.

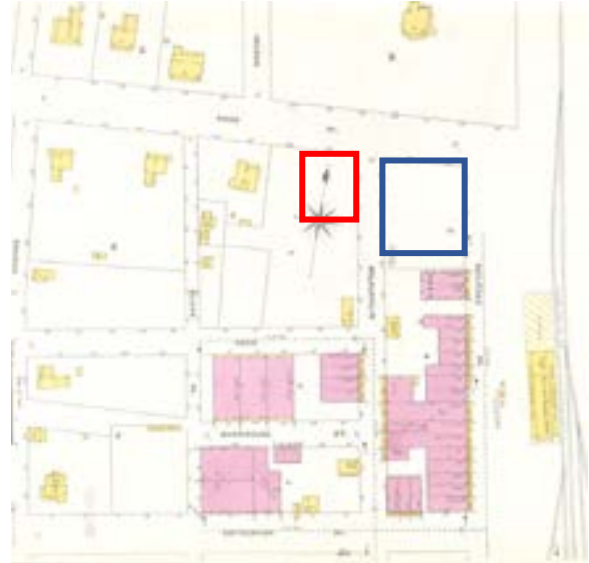
Figure 1.12. Enlargement of Pelham, Mitchell Co., GA, August 1906 Sanborn Map, plate 3. Courtesy Digital Library of Georgia.

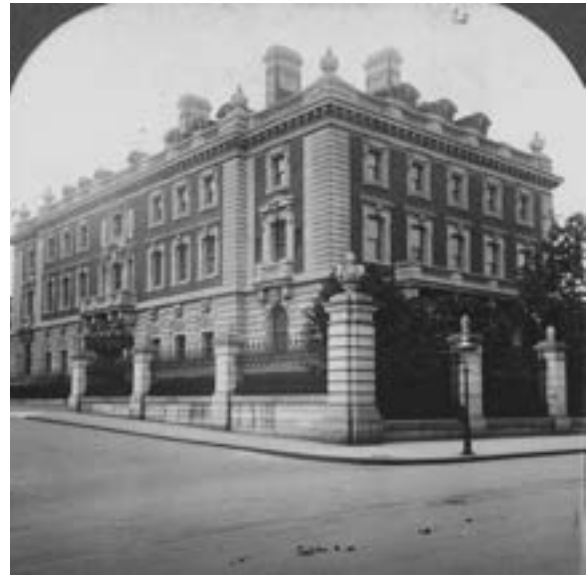
Figure 1.14. The building J.L. Hand arrived unannounced. The Andrew Carnegie Mansion, East 91st St., New York, NY. Courtesy of The Library of Congress.

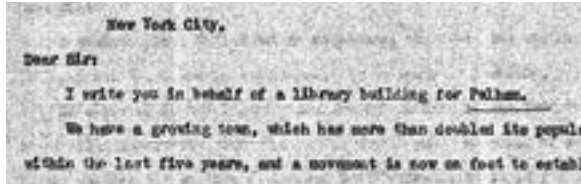
Figure 1.15. Excerpt of a Letter from J.L Hand to Andrew Carnegie, July 30, 1906, introducing the town of Pelham. Courtesy of the Carnegie Corporation of New York Records. Rare Book and Manuscript Library. Columbia University.

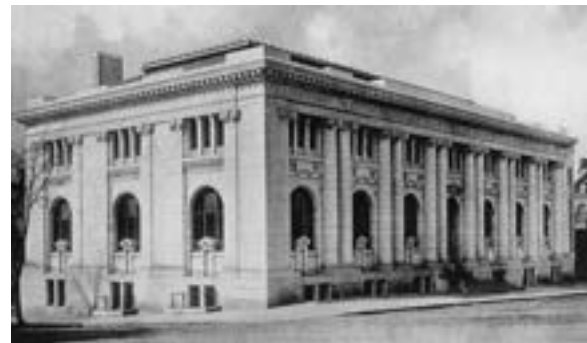
Figure 1.18. Carnegie Library, Atlanta Main Branch 1908. Courtesy Kenan Research Ctr., Atlanta History Center.

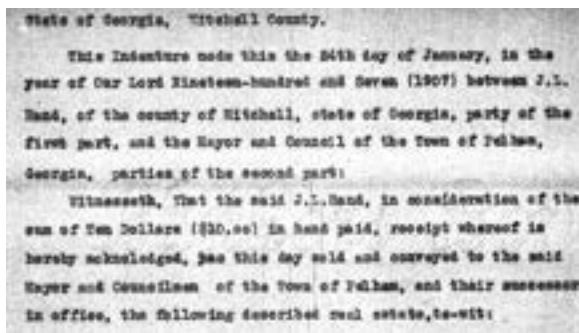
Figure 1.22. Deed for sale of library plot from J.L Hand to Town of Pelham for \$10, January 24, 1907. Courtesy of Carnegie Corporation of New York Records. Rare Book and Manuscript Library. Columbia University.

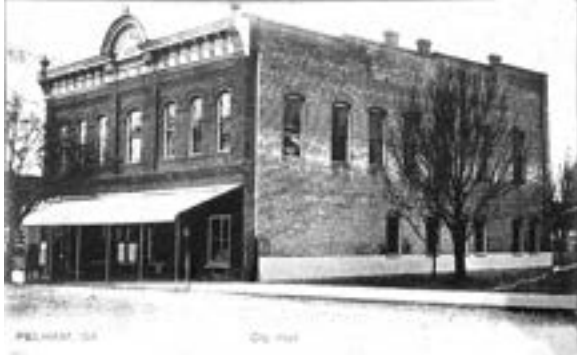
Fig. 1.29. The Pelham City Hall, erected in 1900, had a second-floor auditorium “where all amusements were held.” From *The Building of a Town*, 169.

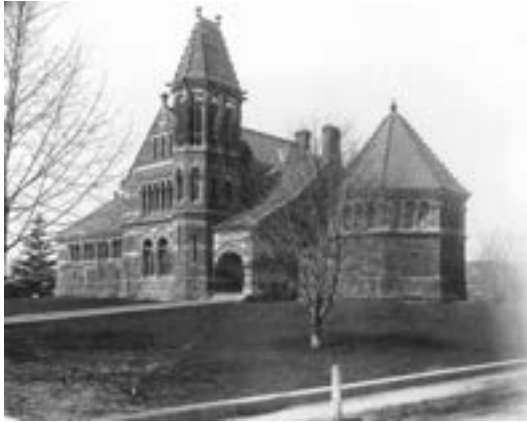
Figure 1.30. The Romanesque Woburn Public Library designed by Henry Hobson Richardson, 1881. Courtesy of The Woburn Public Library.

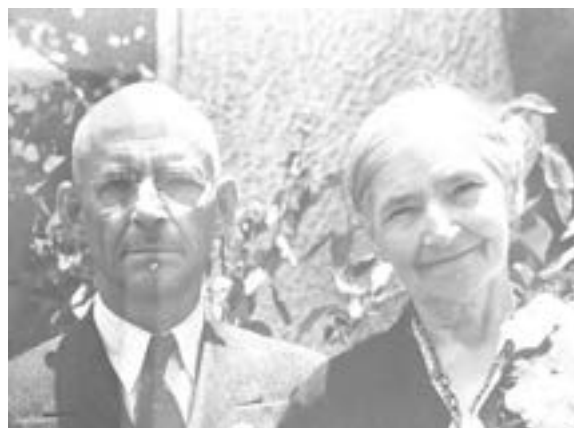
Figure 1.34. Long-time librarian Alice Barrow and her son. Date unknown. Courtesy of Hargrett Rare Book and Manuscript Library/University of Georgia Libraries.

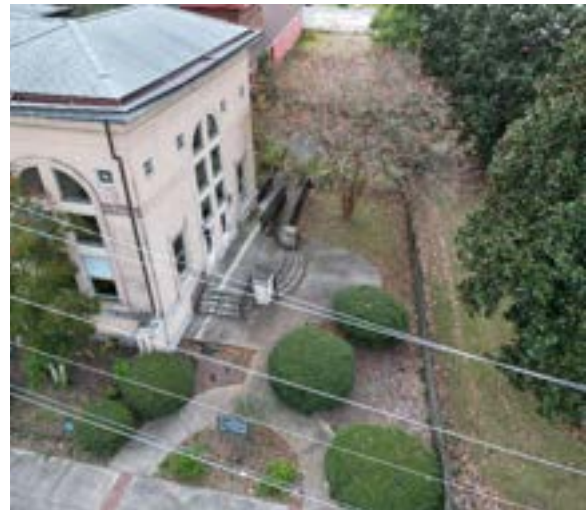
Figure 1.48. Western border of property with landscaping. Photo by author.

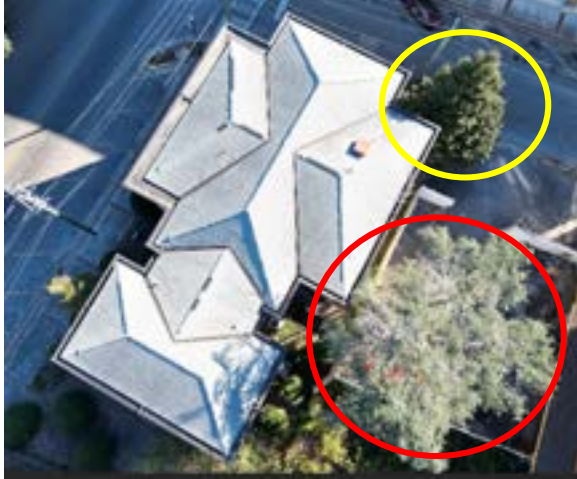
Figure 1.49. High canopy trees along southern elevation. Magnolia (yellow) and a probable loblolly pine (red) are contacting the building and being used by squirrels. Photo by author.

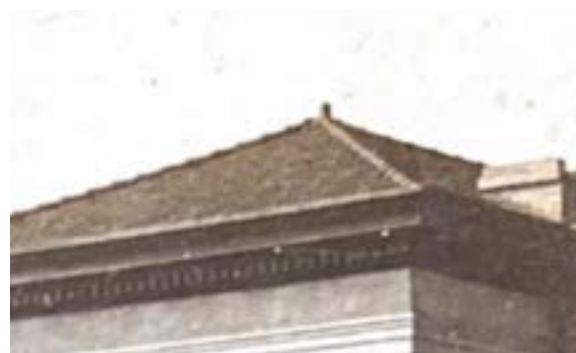
Figure 1.50. Enlargement – Undated early photo shows tile roofing, likely terra cotta or slate. Courtesy of Hargrett Rare Book and Manuscript Library/University of Georgia Libraries.

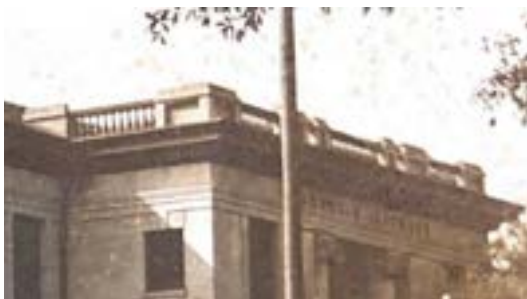
Figure 1.52. Enlargement – Undated early photo shows balustrade atop north elevation. Courtesy of Hargrett Rare Book and Manuscript Library/University of Georgia Libraries.

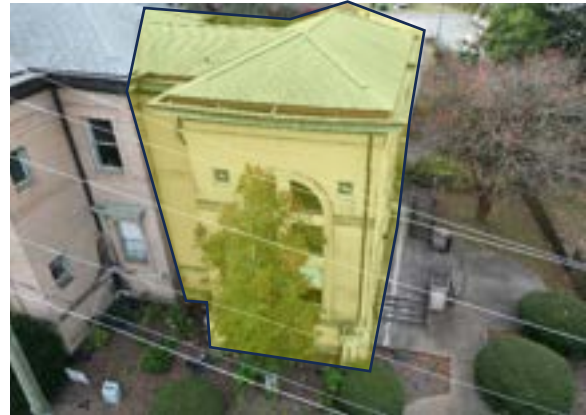
Figure 1.53. The 1990s addition (highlighted in yellow) expanded the western side of the historic building. Photo by author.

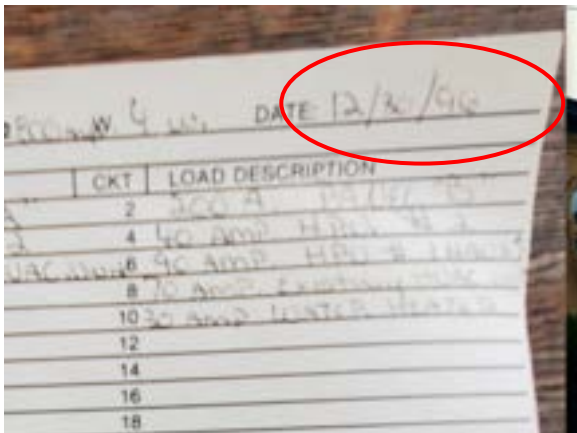
Figure 1.55 Electrician's circuit card in "B" subpanel on second floor dated December 30, 1996. Photo by author.

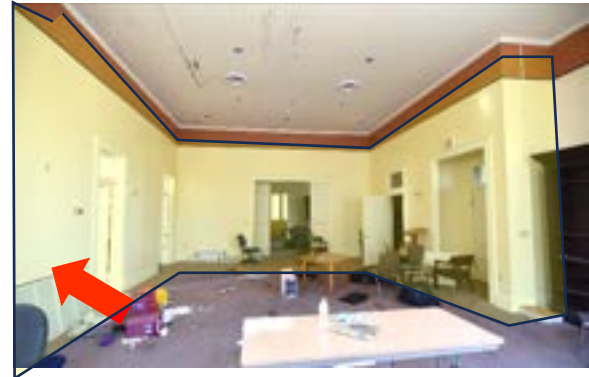
Figure 1.56. Second floor walls and closet (highlighted) likely added during 1990s expansion/renovation. Photo by author.

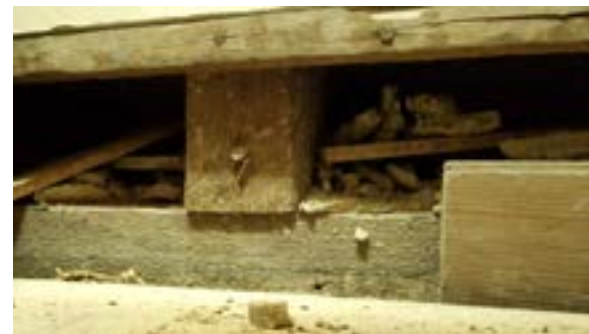
Figure 1.57. Historic 2" x 6" framing, plaster, and lath inside and/or behind the non-historic wall on second floor. Photo by author.

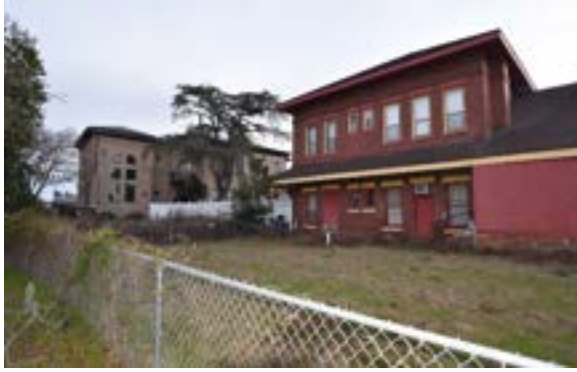
Figure 1.66. View to northeast of historic Flint River & Northeast Railroad depot. Photo by author.

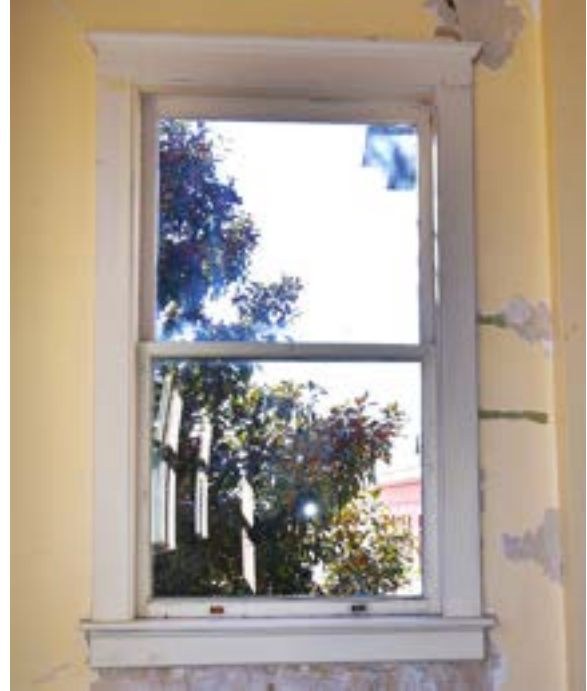
Figure 1.67. The building retains 32 of the original double sash historic wood windows. Photo by author.

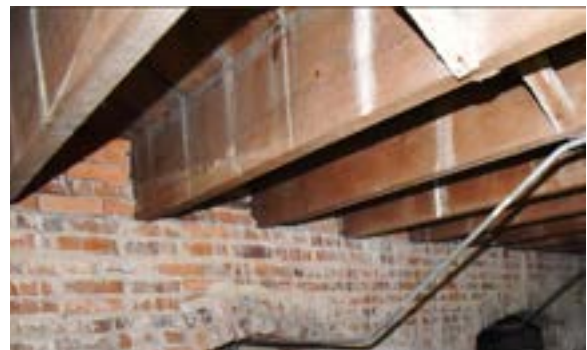
Figure 1.68. The floor system is comprised of 2"x12" (actual) southern yellow pine joists, some measuring 21' in length. Photo by author.

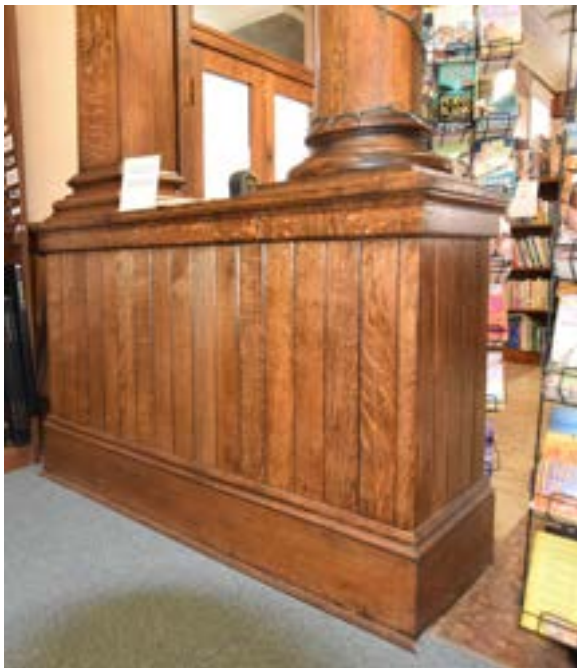
Figure 1.70. Interior oak detailing includes wainscoting, trim, columns, and doors. Photo by author.

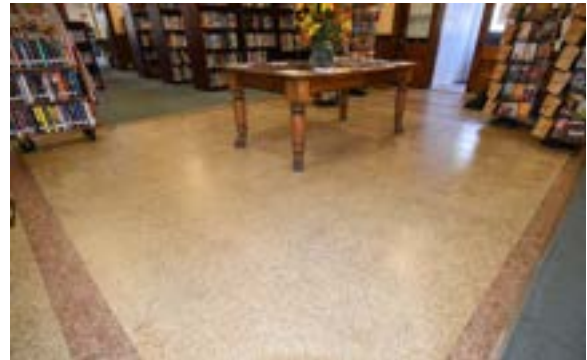
Figure 1.71. The central terrazzo flooring preserves a rich finish and technique common in early 20th c. public buildings. Photo by author.

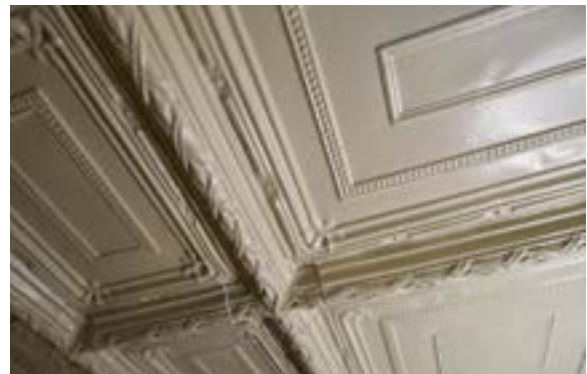
Figure 1.72. The pressed metal first floor ceiling is in excellent condition and captures a popular and economic alternative to more elaborate and costly plaster finishes. Photo by author.

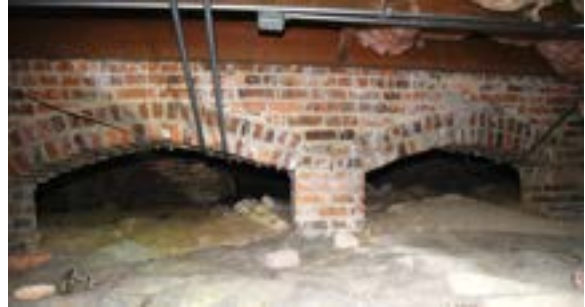
Figure 1.74. Out of sight in the crawlspace a series of beautifully constructed masonry arches line the building's northern interior wall. Photo by author.

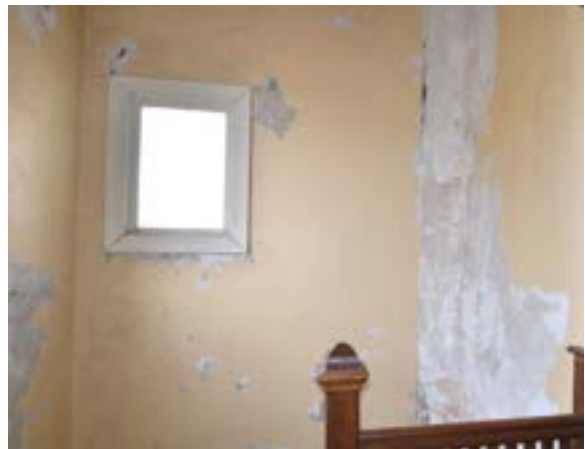
Figure 1.75. Plaster on brick finish is found throughout the building's first and second floors. Although areas are damaged, over 75% of these historic plaster walls are intact needing only cleaning. Photo by author.

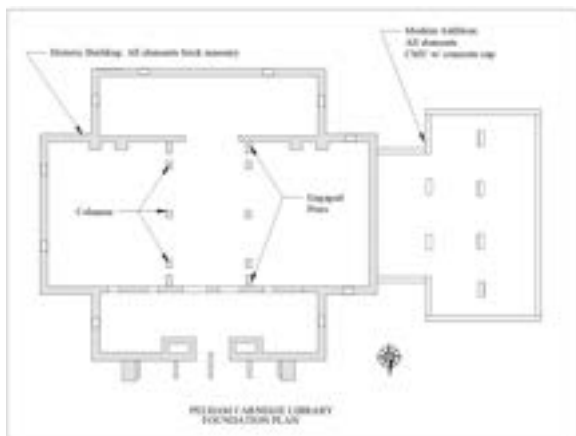
Figure 2.1. As built foundation plan for historic building and addition.

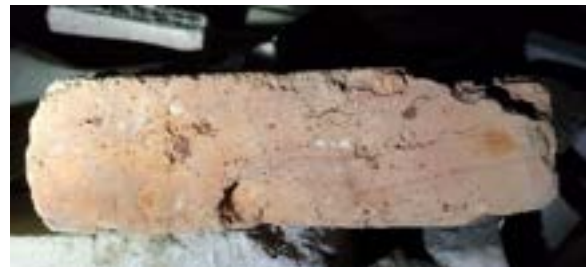
Figure 2.2. Historic common red brick used throughout the building. Note smooth surfaces and imperfections. Photo by author.

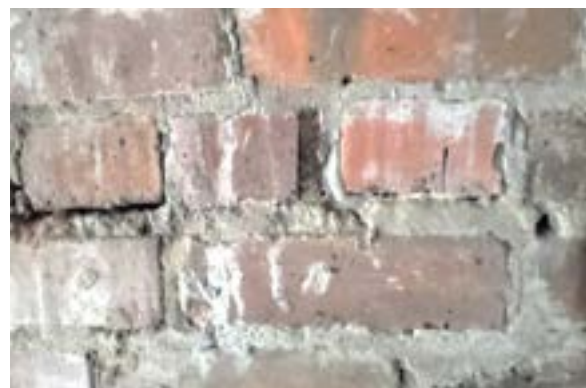
Figure 2.3. An acidity test of mortar used in foundation indicates a high lime content. Photo by author.

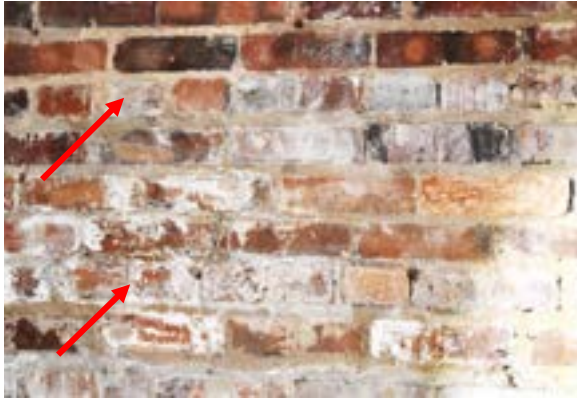
Figure 2.4. Running bond pattern with interlocking header bricks (indicated in red) every fourth course. Photo by author.

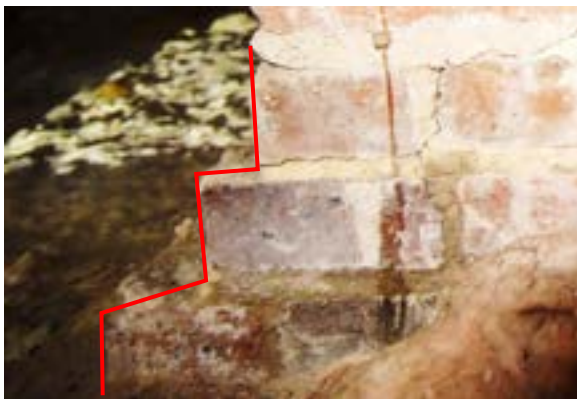
Figure 2.5. Exposed corbelled spread footer (outlined in red) below engaged piers. Photo by author.

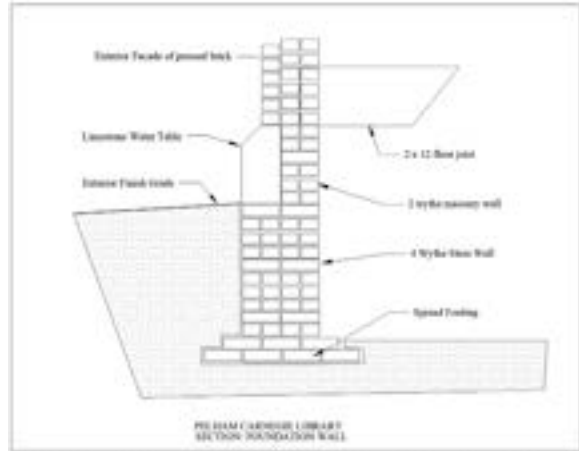
Figure 2.6. Sectional view of historic building foundation wall.

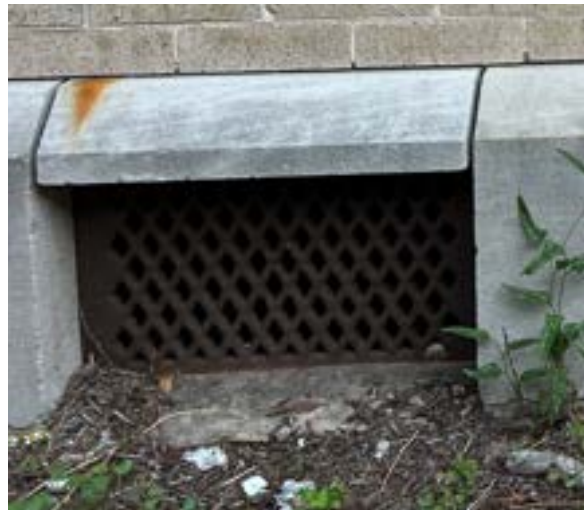
Figure 2.7. Historic building foundation windows. Photo by author.

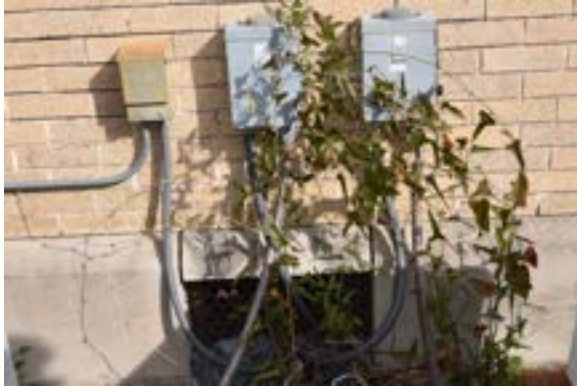
Figure 2.8. Three foundation openings are used for utility/mechanical lines. Photo by author.

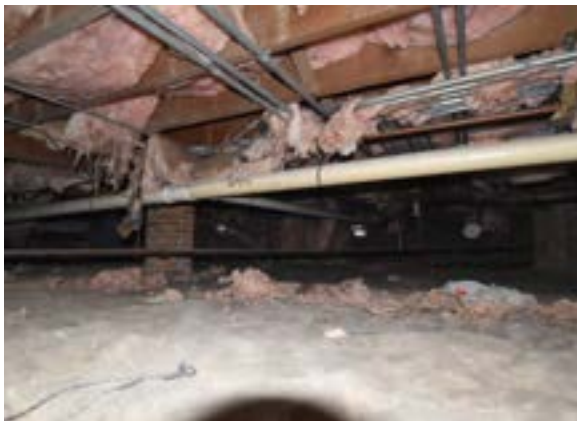
Figure 2.9. Good clearance in crawlspace (42") but access is limited by small foundation windows. Photo by author.

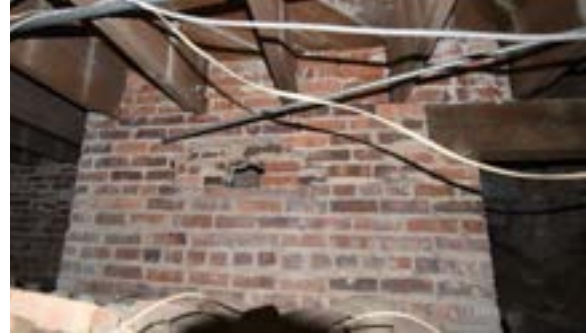
Figure 2.10. Large hollow box piers supporting the building's front entry. Photo by author.

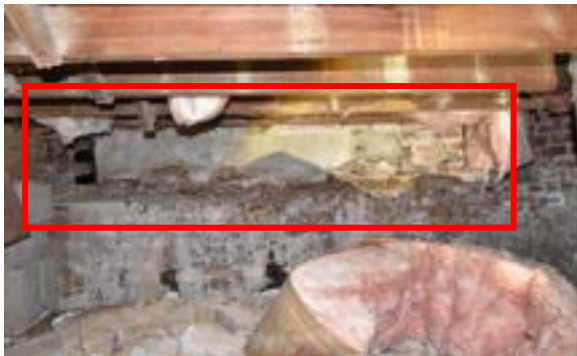
Figure 2.13. Demolished section of perimeter wall in northeast corner measures 8' x 16". Photo by author.

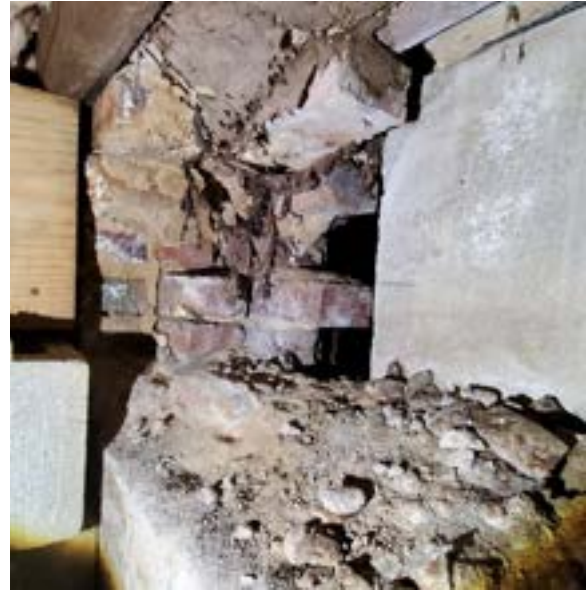
Figure 2.14. Junction of interior three wythe wall with perimeter foundation. Rear of limestone water table clearly visible on right. Photo by author.

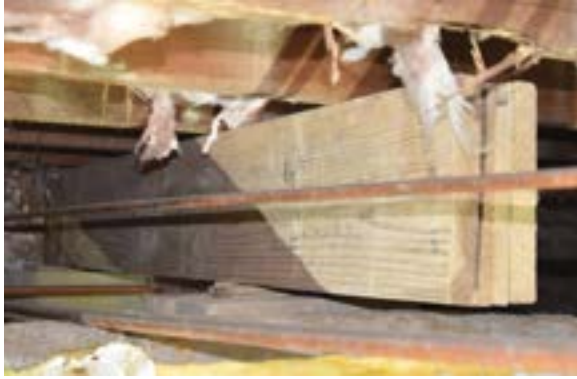
Figure 2.15. Evidence of repairs. A multiply wood beam captures weight of floor but not exterior wall. Photo by author.

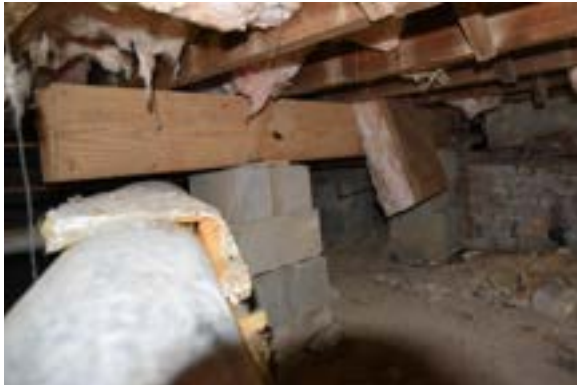
Figure 2.16. The repair beam is supported by non-mortar CMU piers. Photo by author.

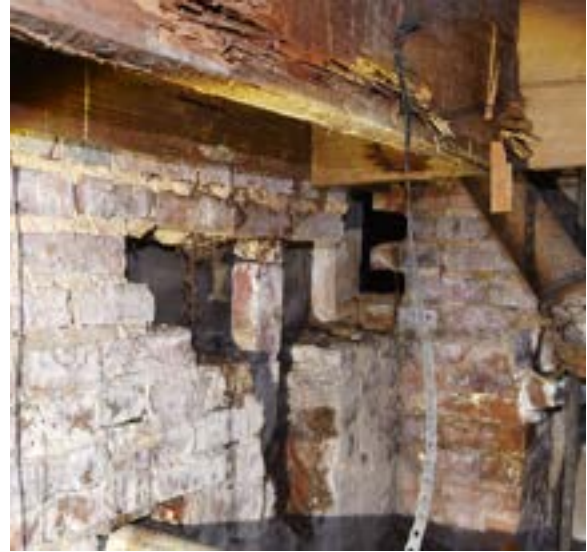
Figure 2.17. Extensive material failure to eastern stairway wall at junction with interior masonry wall. Note vertical bricks providing support. Photo by author.

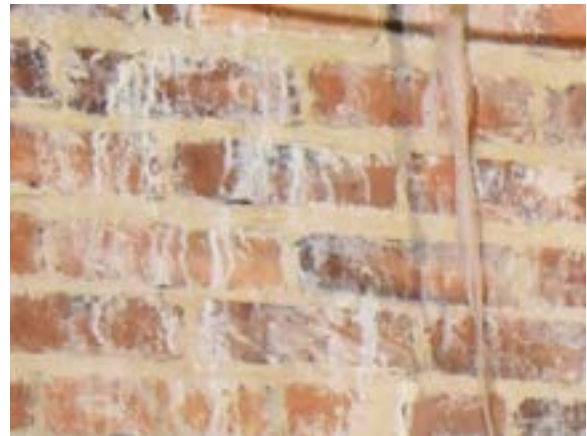
Figure 2.18. Evidence of efflorescence at various locations on perimeter wall. Photo by author.

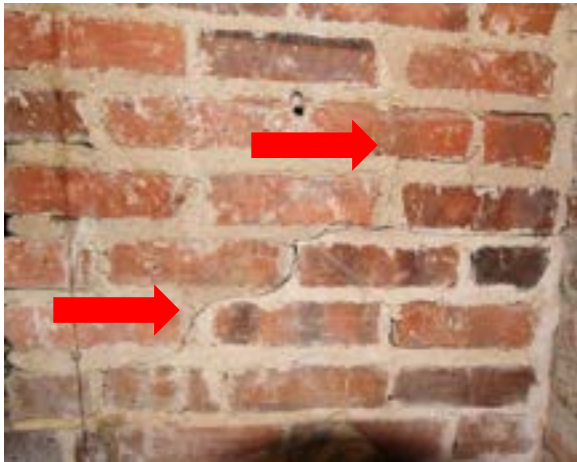
Figure 2.19. Step crack observed in western engaged pier beneath center of building. Photo by author.

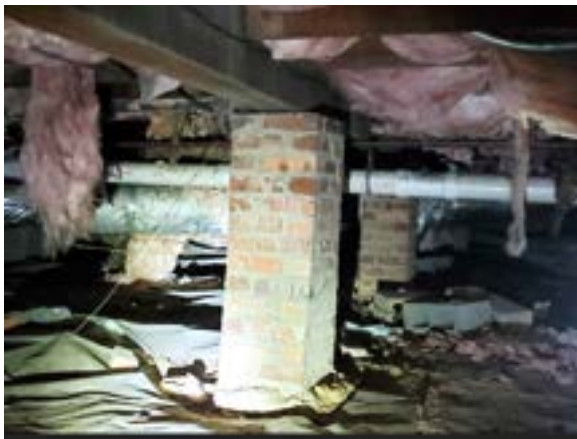
Figure 2.20. Free standing masonry columns are out of plumb, leaning to east. Photo by author.

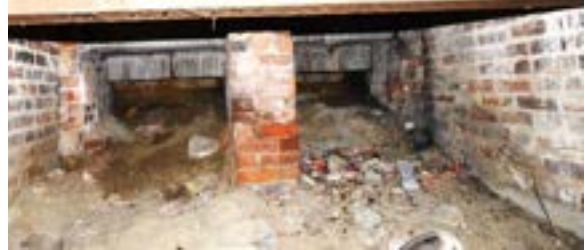
Figure 2.21. Cracks to terrazzo flooring above this section indicate possibility of foundational settling with free standing pier (center) or flanking masonry walls. Photo by author.

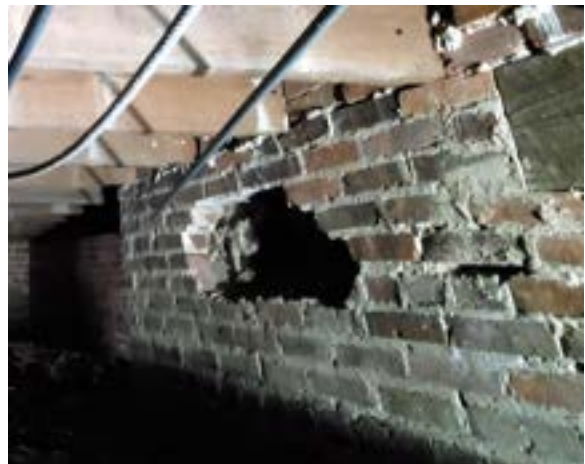
Figure 2.22. Unexplained punctures to hollow box foundations beneath main entry. Photo by author.

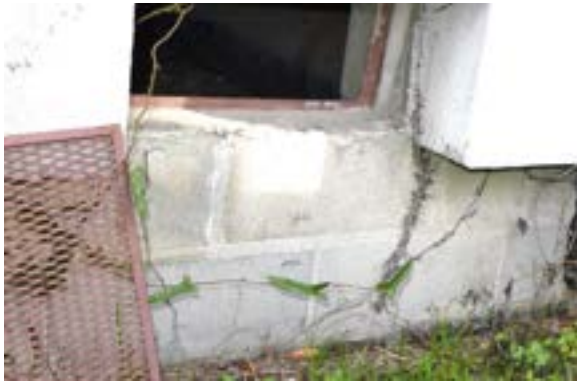
Figure 2.23. Running bond pattern of CMU on the addition foundation. Photo by author.

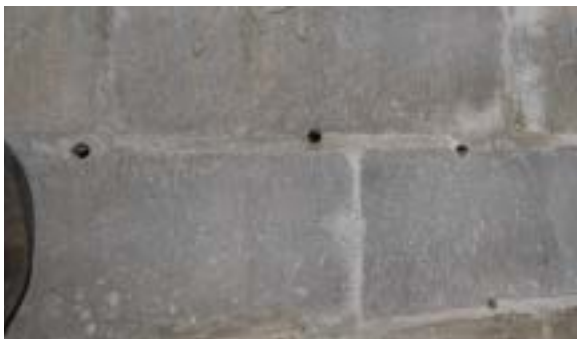
Figure 2.24. Weeps holes in mortar joint on inside of the addition foundation walls. Photo by author.

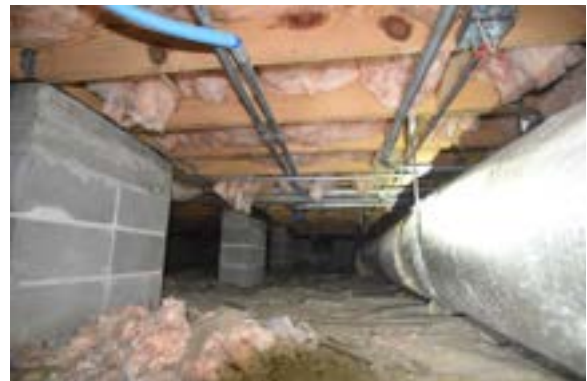
Figure 2.26. Tight access (approx. 32") below the modern addition. Photo by author.

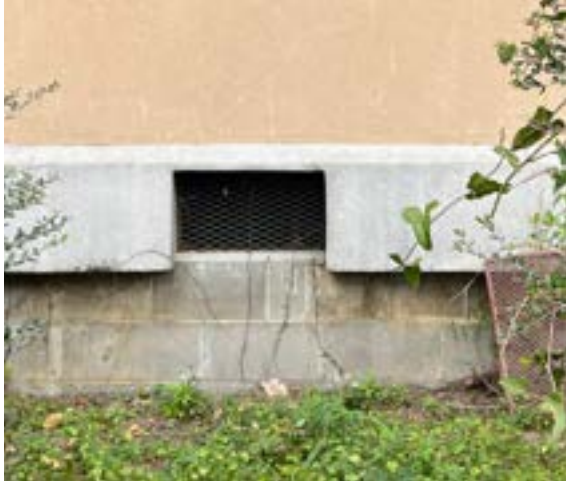
Figure 2.27. Six foundation windows below modern addition. Photo by author.

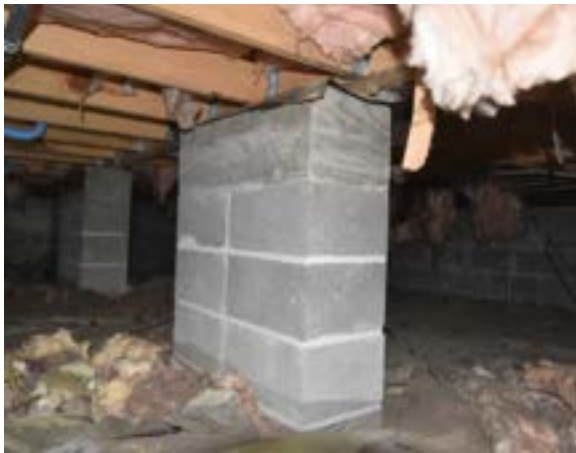
Figure 2.28. CMU piers supporting flooring system of addition. Photo by author.

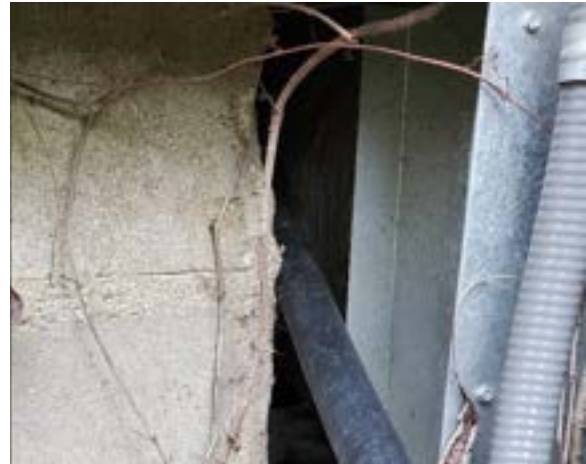
Figure 2.29. The addition's foundation wall was altered (southside) after construction for mechanical pass-through. Structural integrity may be compromised in this section. Photo by author.

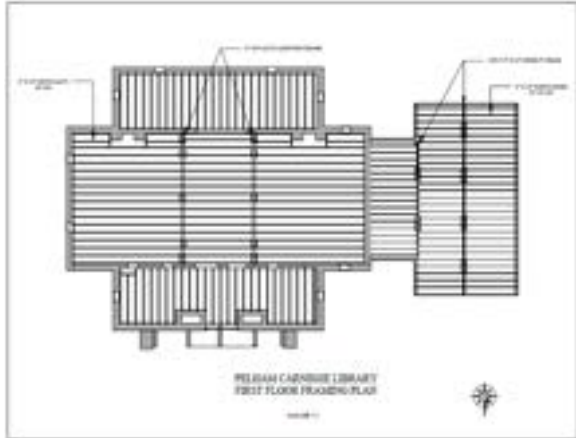
Figure 2.30. First floor framing plan.

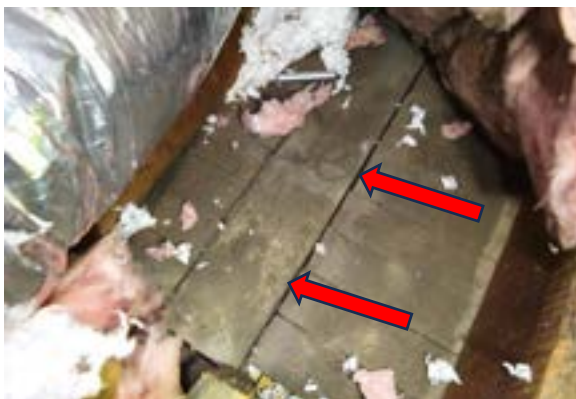
Figure 2.31. Original 2" x 6" top plate of kitchen demising wall in attic. Photo by author.

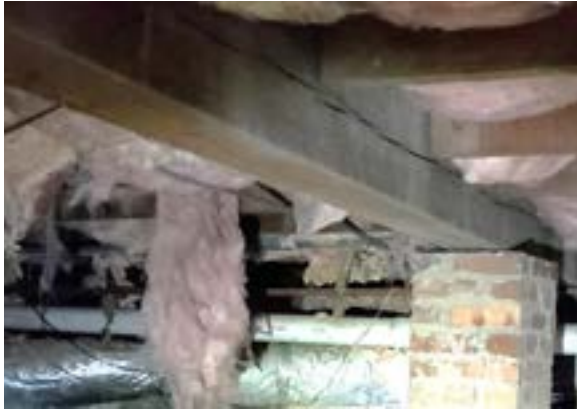
Figure 2.34. One of a pair of 6" x 8" girders in crawlspace. No lap or scarf joints observed in these 26' timbers. Photo by author.

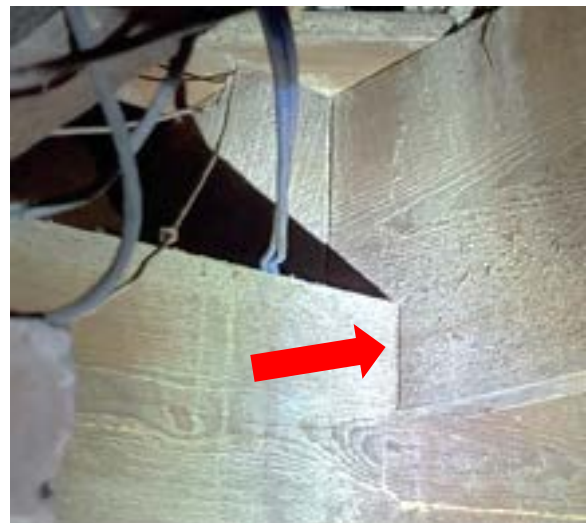
Figure 2.36. Floor joists notched on carrying beam. No evidence observed of checking (cracking) at notch which is common. Photo by author.

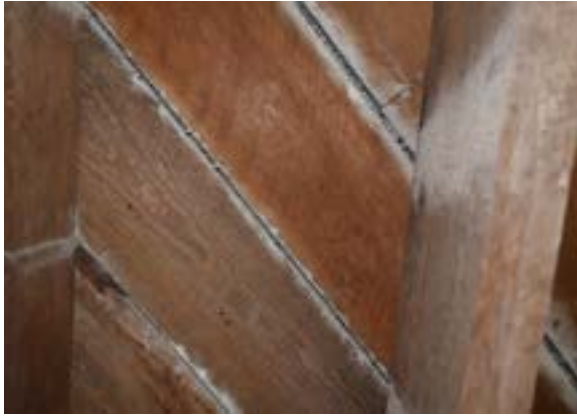
Figure 2.37. The subfloor is 1" x 8" (nominal) laid diagonally. Photo by author.

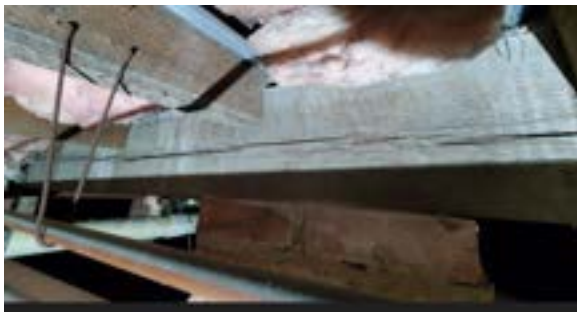
Figure 2.38. Some checking observed in long carrying beams. Photo by author.

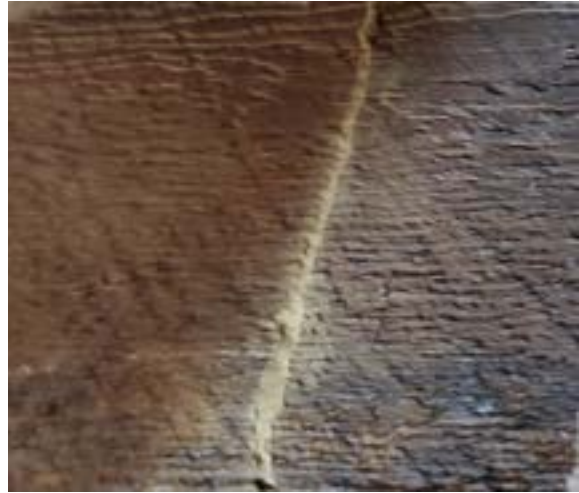
Figure 2.39. Termite trail on floor joist in crawlspace. Photo by author.

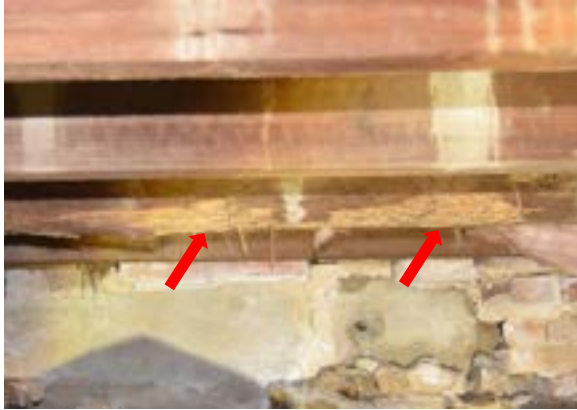
Figure 2.40. Insect damage to joists in northeast corner. Photo by author.

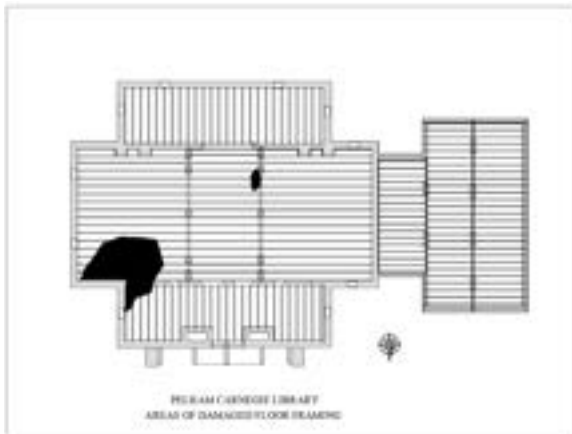
Figure 2.41 Areas of damage and decay to first floor framing system.

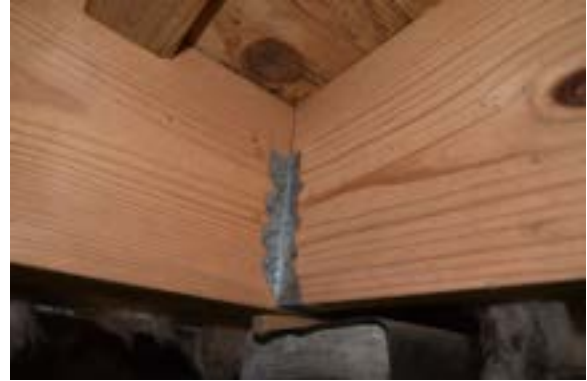
Figure 2.42. Joists attached to carrying beam with Simpson type hangers. Photo by author.

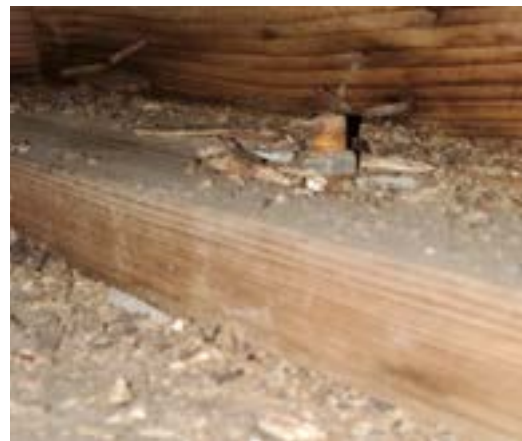
Figure 2.43. Joists fastened to 2"x 8" sill which is secured with anchor bolt in concrete cap. Photo by author.

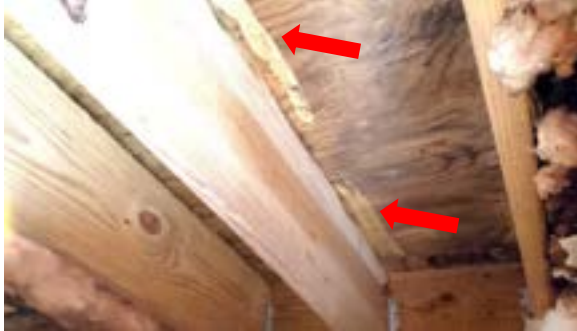
Figure 2.44. Subfloor in addition is plywood. Evidence of glue used during installation was observed (red arrows). Photo by author.

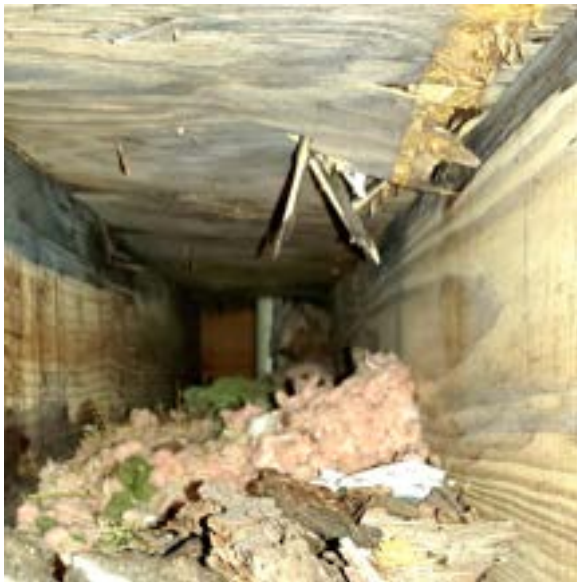
Figure 2.45. Failing floor and organic growth beneath first floor restroom (south). Photo by author.

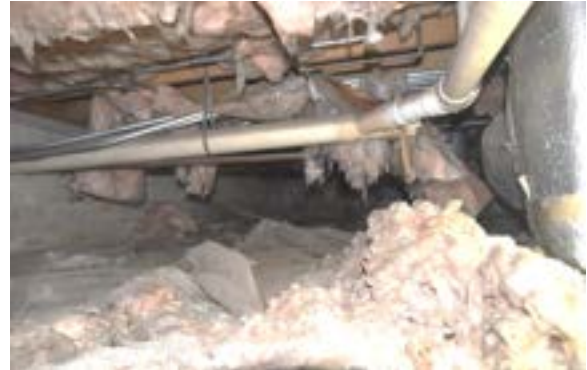
Figure 2.46. Insulation staples have rusted away causing fiberglass to fall onto crawlspace floor. Photo by author.

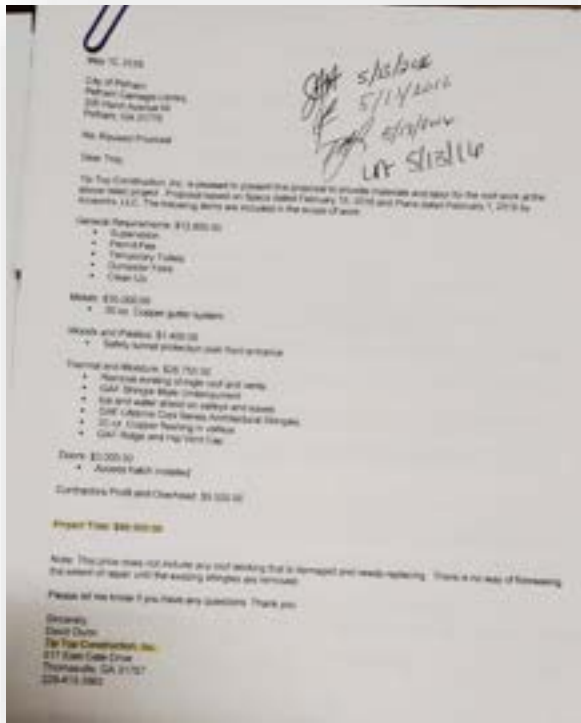
Figure 2.47. Signed contract for roof repairs with Tip-Top Construction, May 2016. On file at Pelham City Hall.

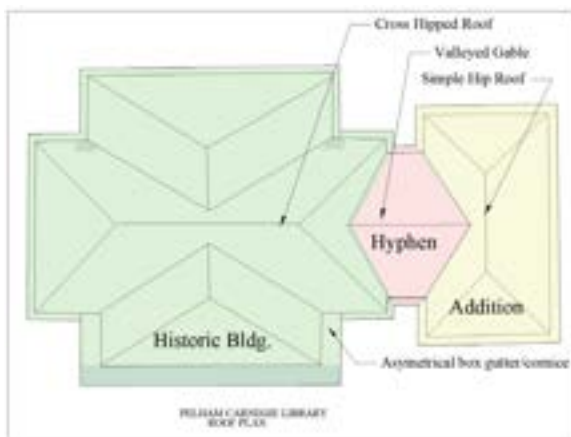
Figure 2.48. Roof plan for historic building and modern addition.

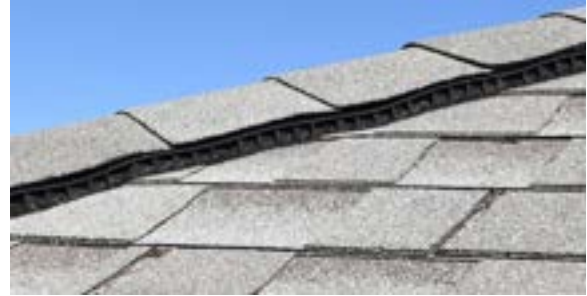
Figure 2.53. Ridge vents line the crest of asphalt roof. Note that missing ridge vents will be identified in a later section of this report. Photo by author.

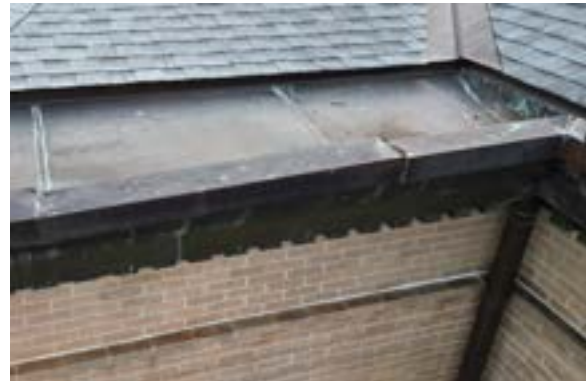
Figure 2.54. Box gutter assembly on historic building (northwest corner). Photo by author.

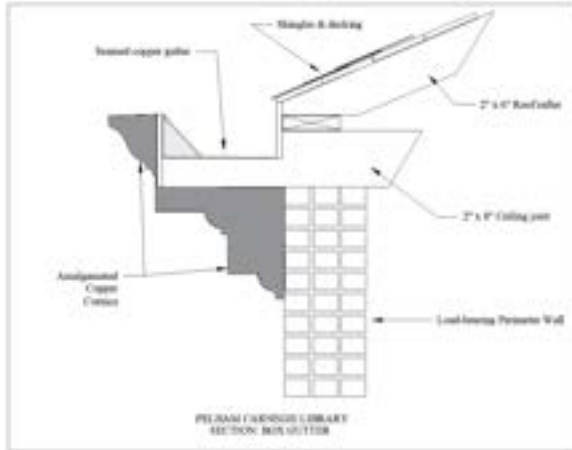
Figure 2.55. Section view of box gutter assembly on historic library building.

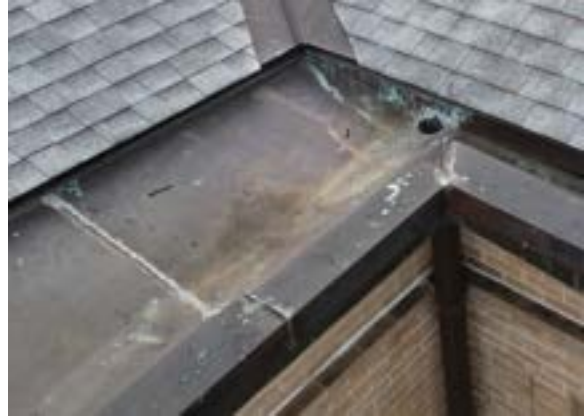
Figure 2.57. Welded seam copper lining in the box gutter troughs. Photo by author.

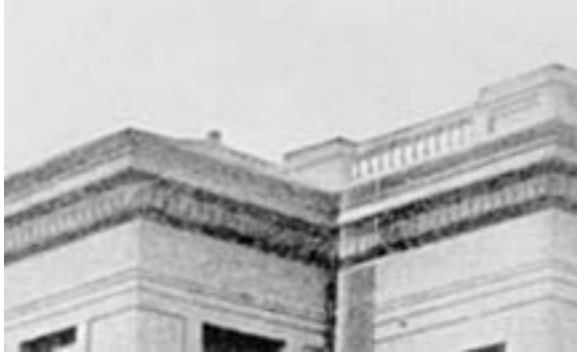
Figure 2.59 Early undated photograph shows original cornice design.

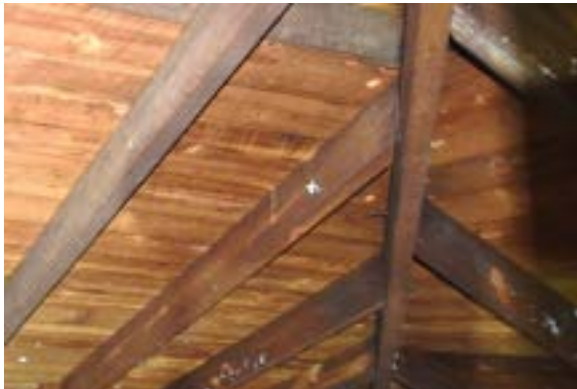
Figure 2.60. Roof framing is sound, and decking is well seated on rafters. Photo by author.

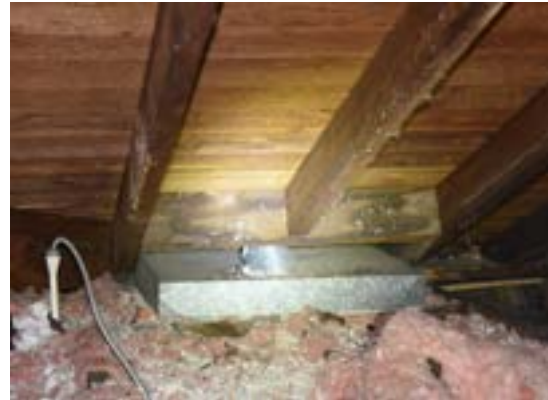
Figure 2.61. Sheet metal cap on western chimney top in attic. Photo by author.

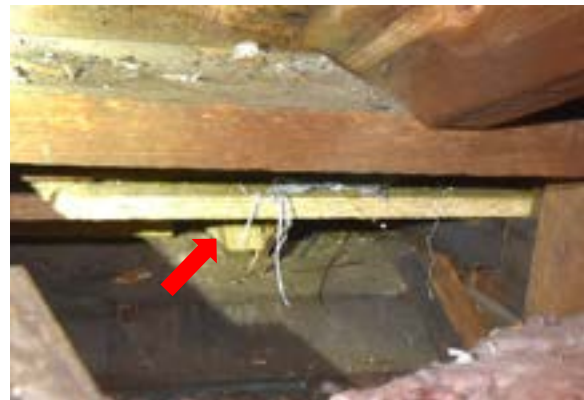
Figure 2.62. Evidence of repairs to box gutter in northeast corner. Note the pressure treated lumber visible (highlighted with red arrow). Photo by author.

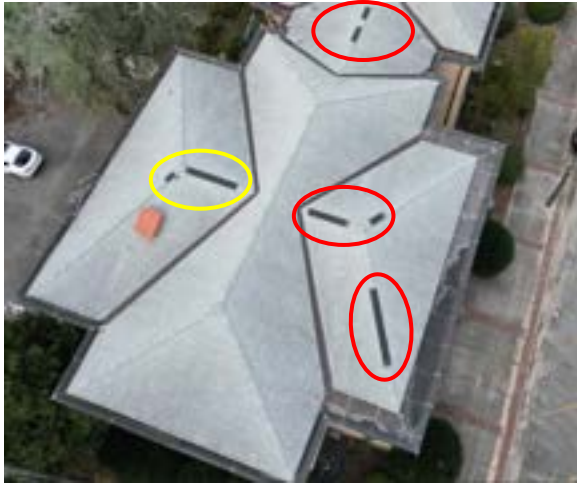
Figure 2.63. Circled areas indicate missing sections of ridge vent shingles. Photo by author.

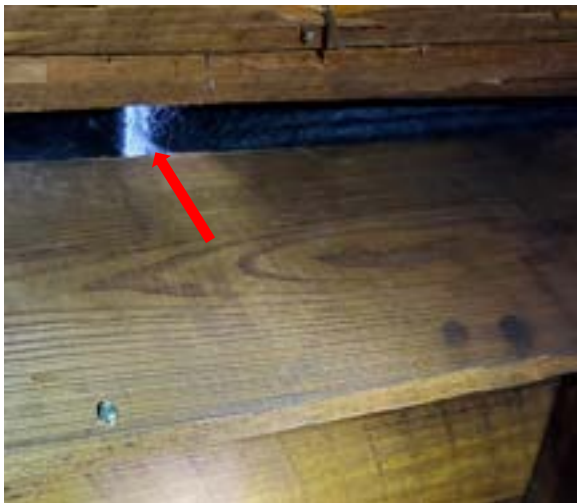
Figure 2.64. Open gap in roof system below southern end of north/south ridge line. Photo by author.

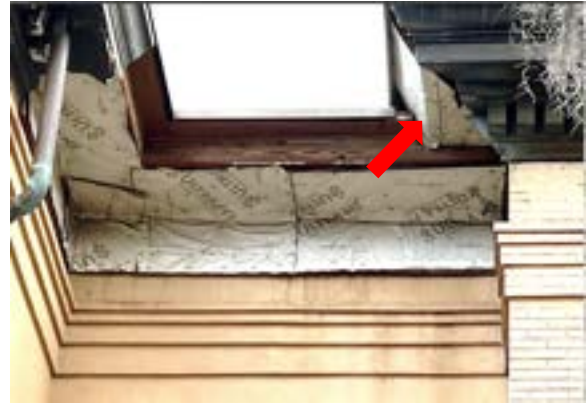
Figure 2.65. Missing section of hyphen roof cornice and southwest corner of historic building. Photo by author.

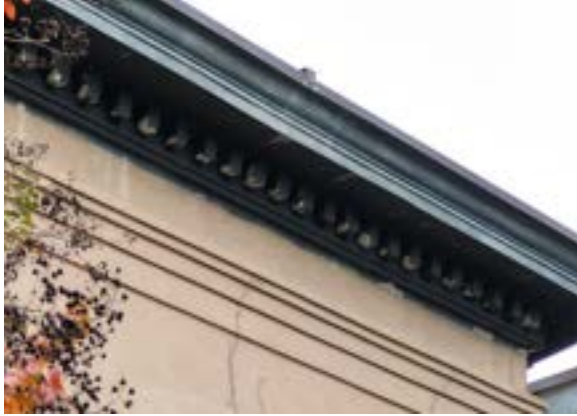
Figure 2.66. The gutter/cornice on the addition is a combination of copper lined gutters and polyurethane molding. Photo by author.

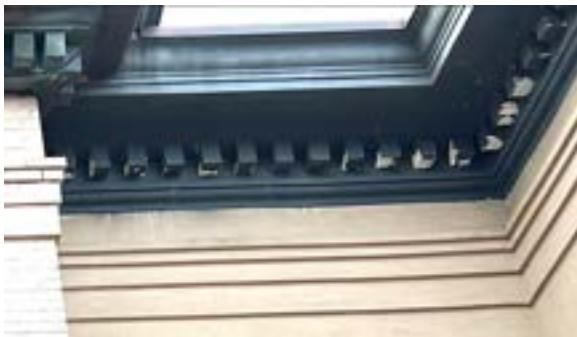
Figure 2.67. Dentil molding shows material decay and damage. Photo by author.

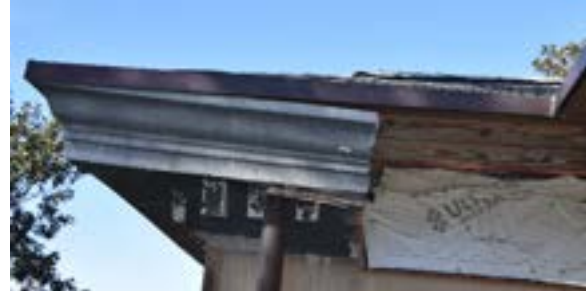
Figure 2.68. Missing section of cornice on southside of addition. Photo by author.

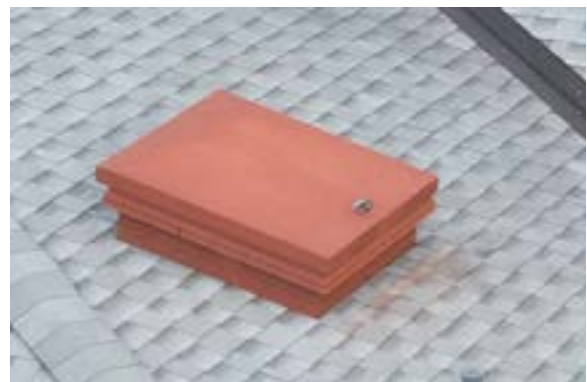
Figure 2.69. Access door on southeast facet of historic roof. Photo by author.
