Spring 2024

Historic Structure Report

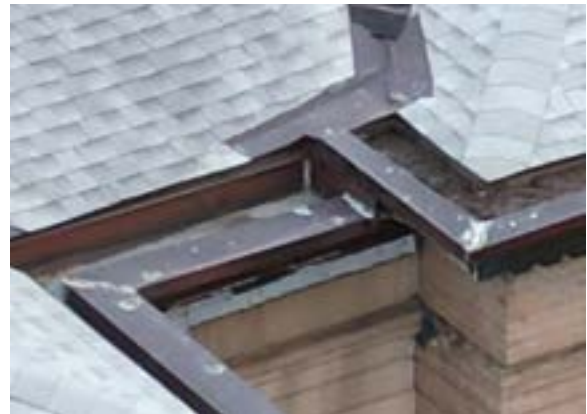
Figure 2.73. Note drop in elevation of modern addition gutter system and valley extension. Photo by author.

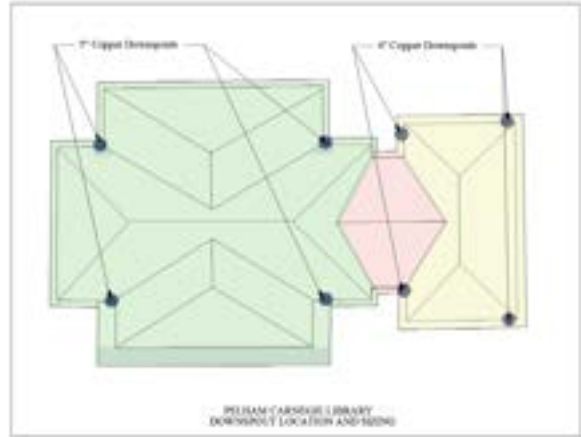
Figure 2.76. Downspout location and sizing.

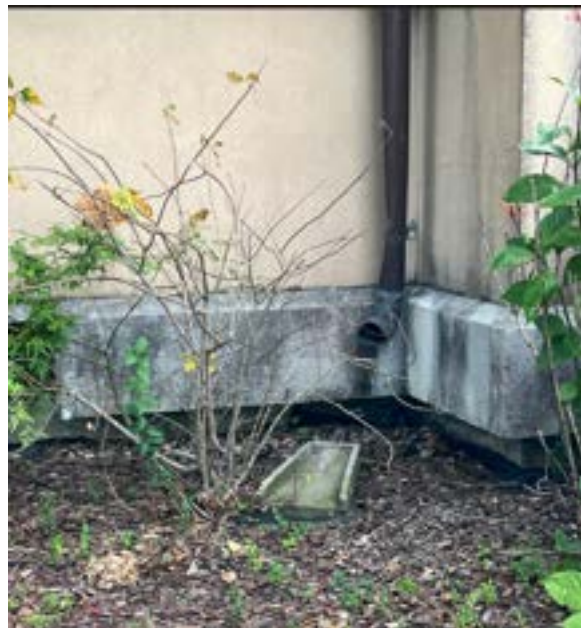
Figure 2.77. Downspouts are intended to terminate at an elbow drain near grade, but most are broken or disconnected. Photo by author.

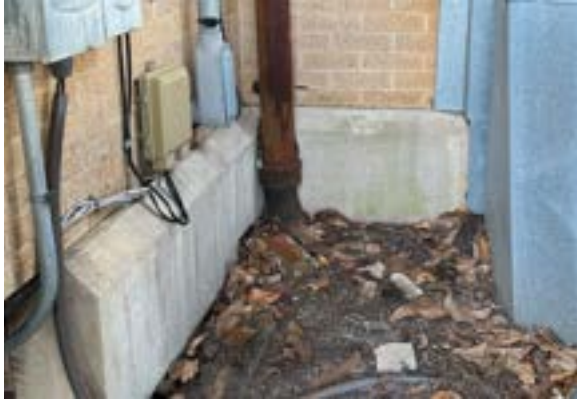
Figure 2.78. Southeast corner historic building downspout drains into cast iron city waste line. Photo by author.

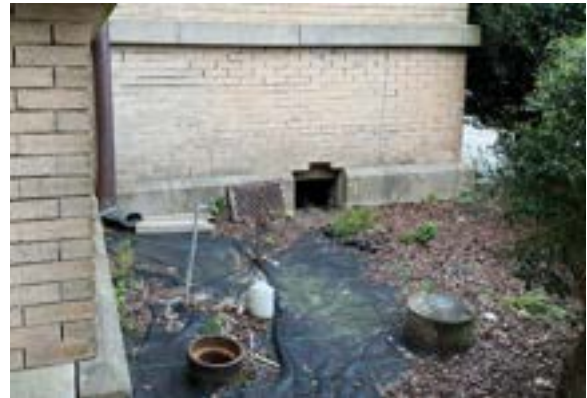
Figure 2.80. Northeast corner of building has a poor slope away from foundation causing water to pool and/or run back against foundation. Photo by author.

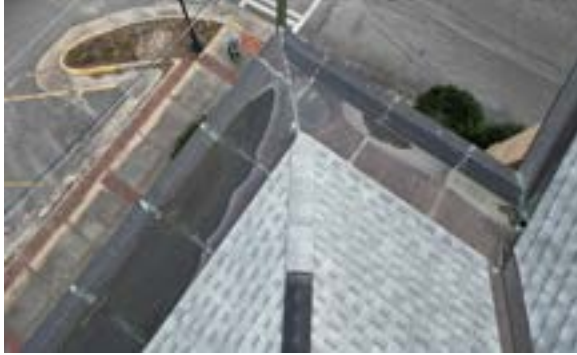
Figure 2.81. Northeast corner box gutter with some water pooling. Photo by author.

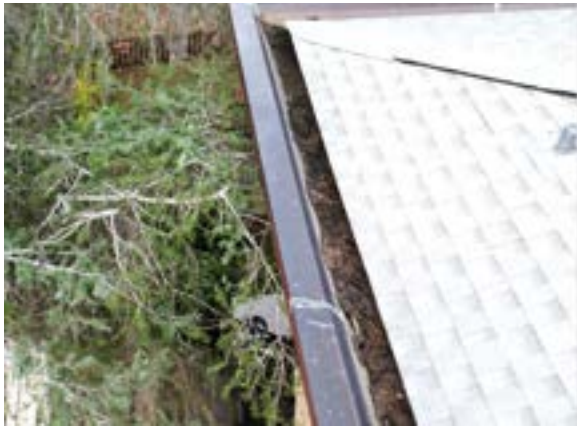
Figure 2.82. Southside historic building gutter heavily clogged with organic debris. Photo by author.

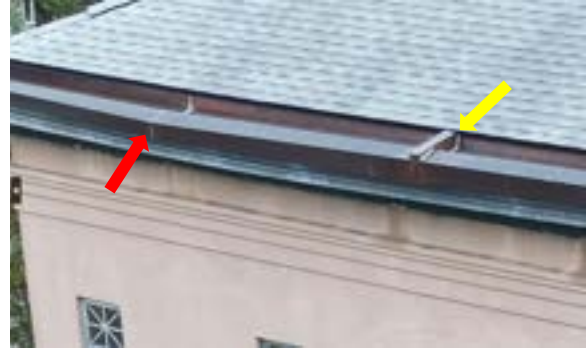
Figure 2.83. Box gutter on addition's western side. Note sag (red) and disengaged retention bracket (yellow). Photo by author.

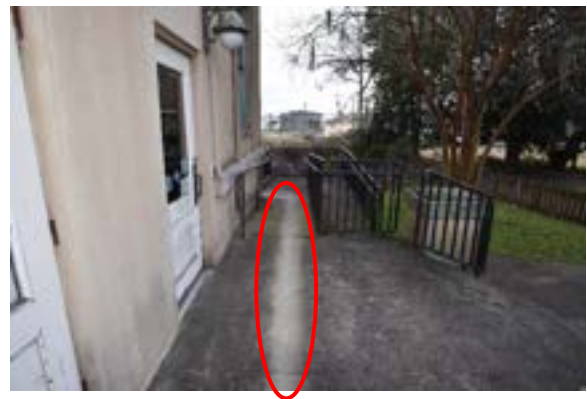
Figure 2.84. Evidence of chronic water draining onto west side concrete landing from poorly functioning box gutter above. Photo by author.

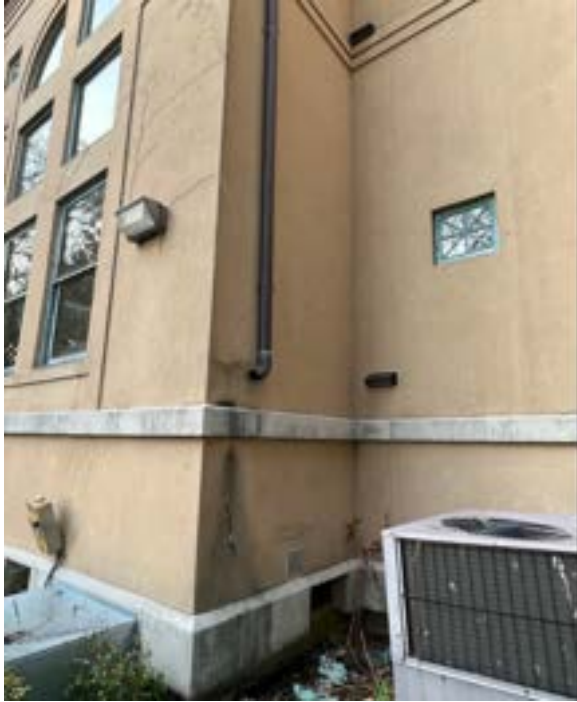
Figure 2.85. Shortened downspout on the addition's southside causing water to drain down wall. A similar situation exists with other downspouts. Photo by author.

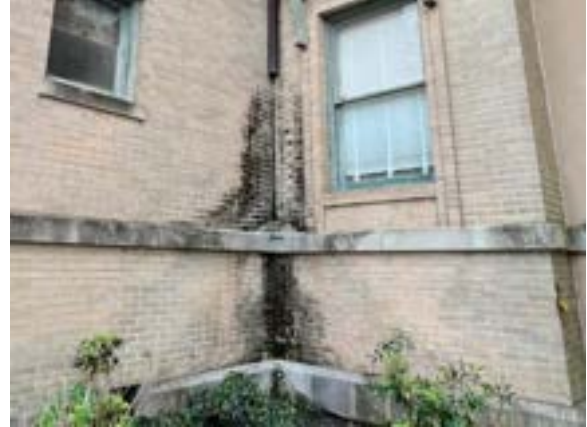
Figure 2.86. Broken downspout on historic building northwest corner resulting in significant organic growth on face brick and mortar. Photo by author.

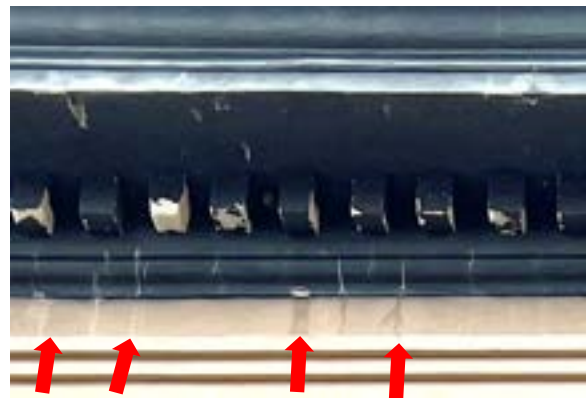
Figure 2.87. Addition's dentil molding showing heavy decay. Note water stain on EIFS wall (red). Photo by author.

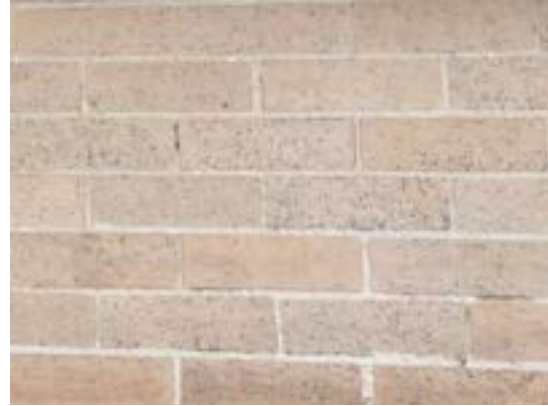
Figure 2.88. Face brick laid in a running bond pattern with ¼" to ⅜" mortar joints. Photo by author.

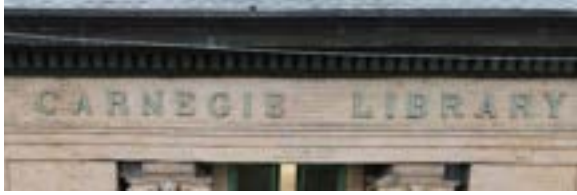
Figure 2.97. Wall culminates with dentil molding and cornice. Photo by author.

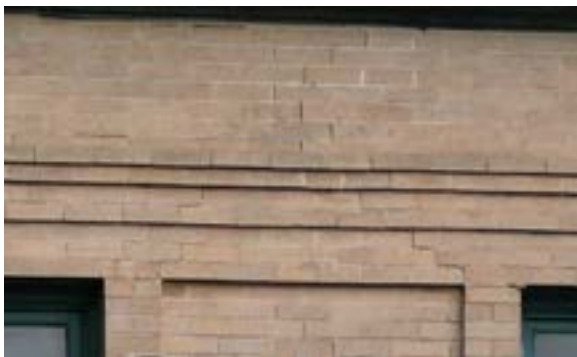
Figure 2.98. Step cracks visible in mortar on building south side. Photo by author.

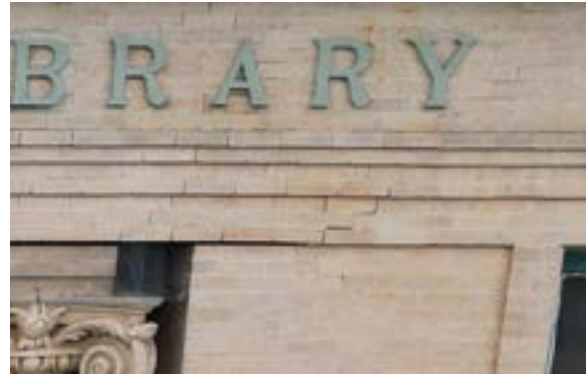
Figure 2.99. Step cracks on either side of building name north side. Photo by author.

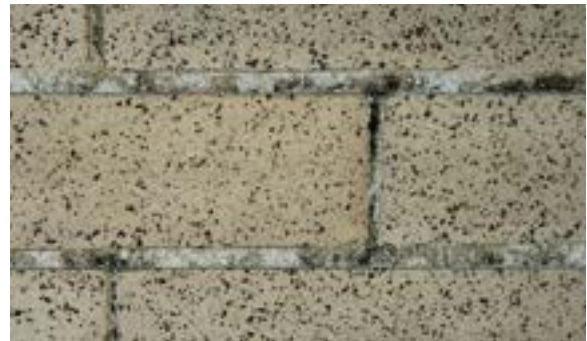
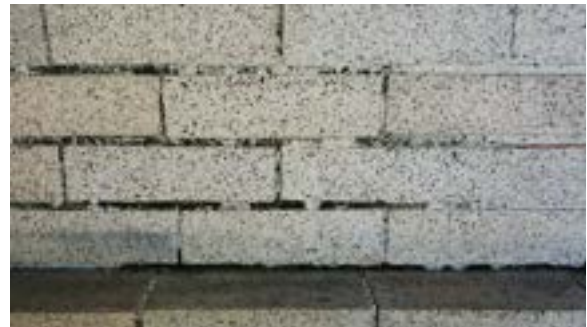
Figure 2.100. Organic growth on mortar widespread in low sunlight areas on all sides of the historic building. Photo by author.

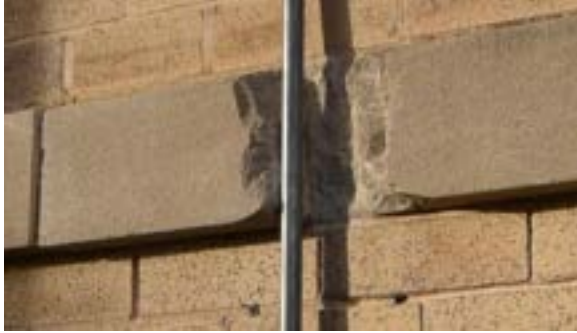
Figure 2.101. Damaged lower belt course on south side. Photo by author.

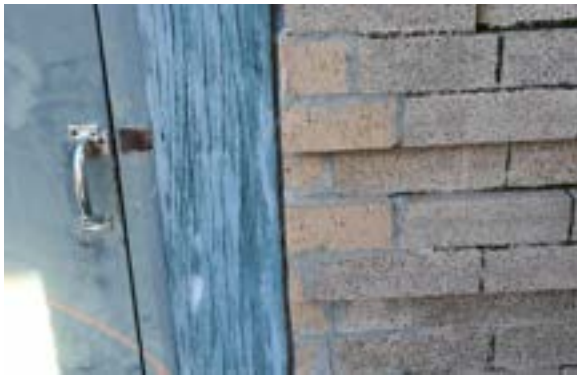
Figure 2.102. Repairs with non-matching bricks around 2nd floor fire escape door. Photo by author.

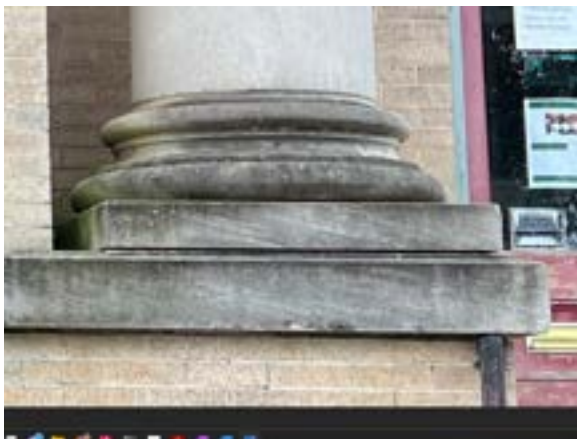
Figure 2.103. Column bases encrusted with grime. Photo by author.

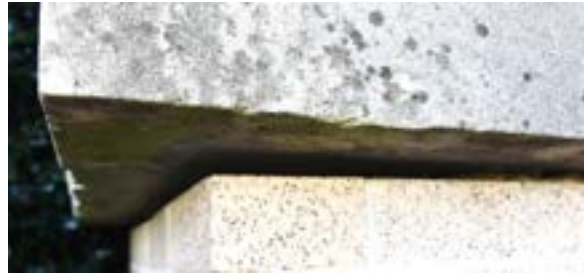
Figure 2.104. Significant mortar recession beneath entire length of limestone belt course on north side. Photo by author.

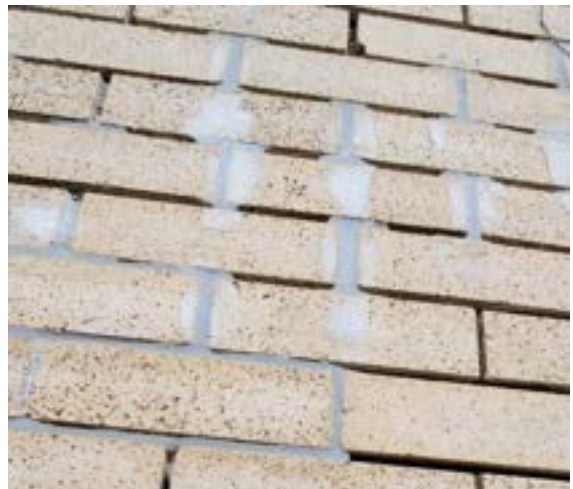
Figure 2.105. Incompatible silicone patching in building northeast corner. Photo by author.

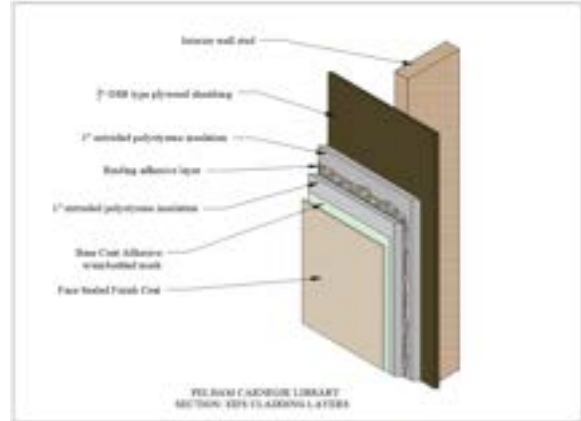
Figure 2.106. Sectional view of EIFS cladding on the library modern addition.

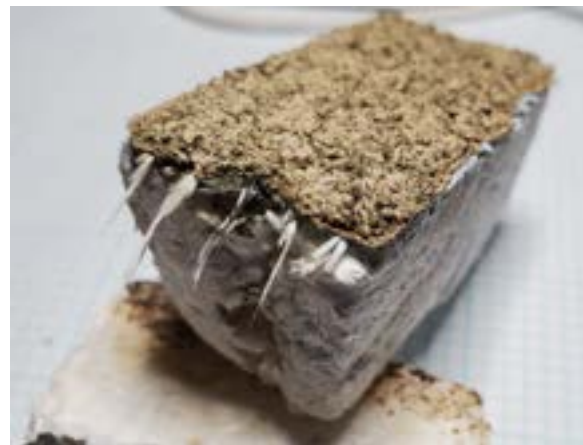
Figure 2.107. EIFS Sample from addition exterior wall. Photo by author.

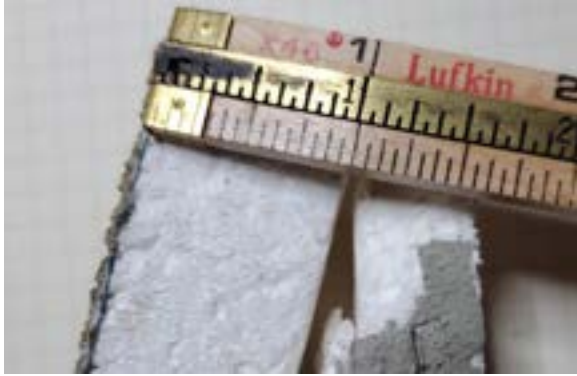
Figure 2.108. Two sheets of 1" EPS were installed. Photo by author.

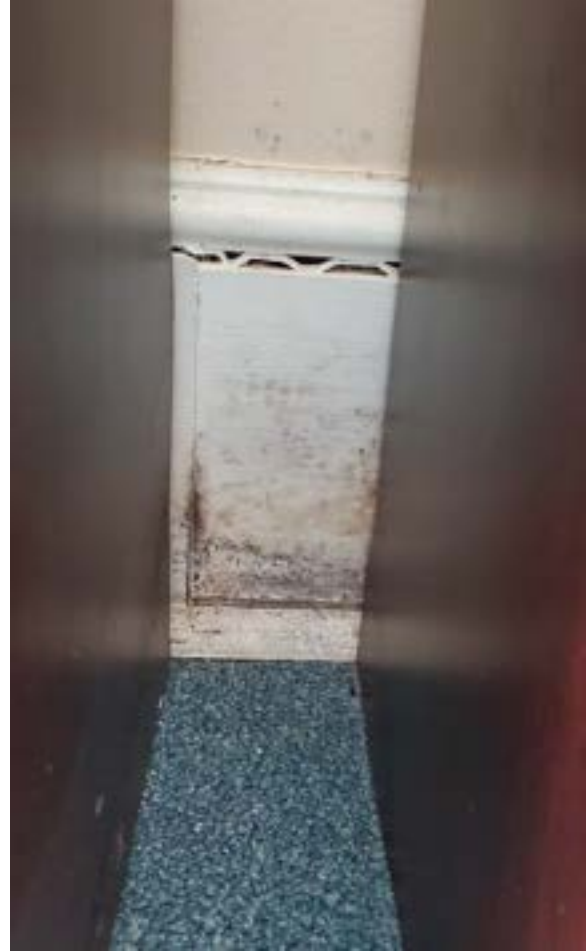
Figure 2.109. Evidence of water penetration and decay on interior baseboard in the addition's northwest corner (partially obscured by bookshelf). Photo by author.

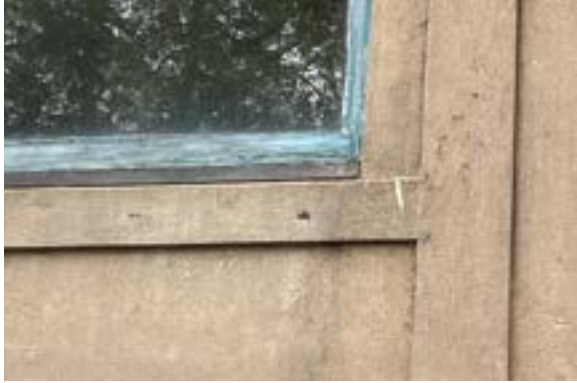
Figure 2.110. In addition to punctures to the veneer, window openings have also been noted to fail. Photo by author.

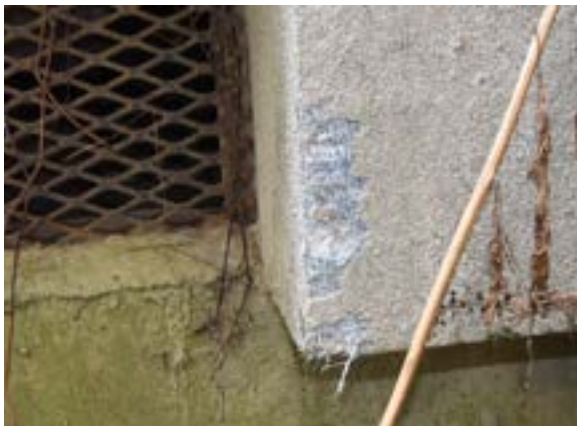
Figure 2.111. All the addition's exterior wall features, like the water table pictured above, are constructed with EIFS. Photo by author.

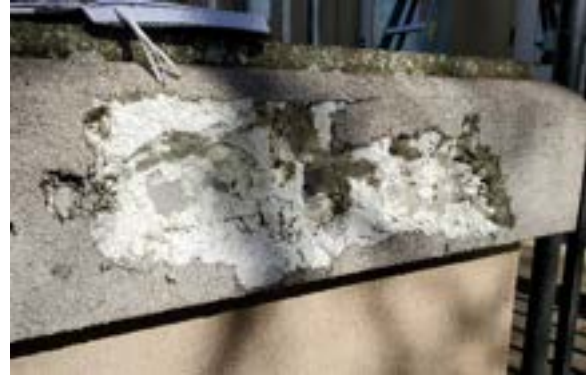
Figure 2.112. Damaged EIFS cladding on ADA ramp pier. Photo by author.

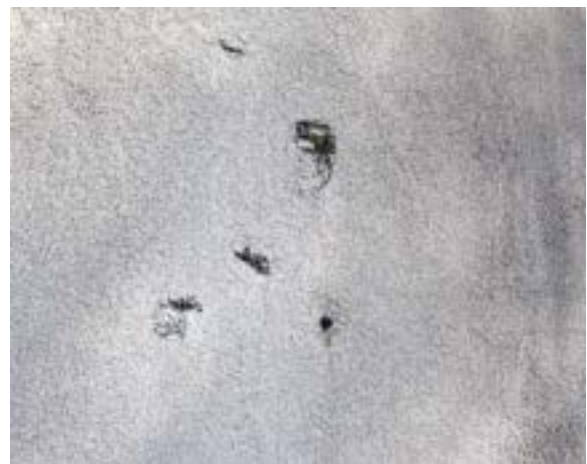
Figure 2.113. Indentations on southwest wall. Photo by author.

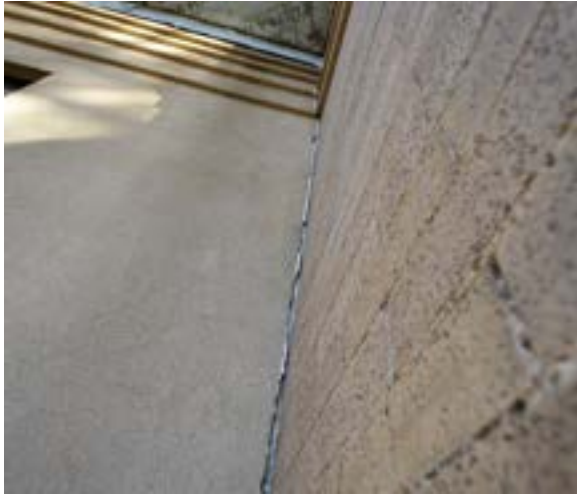
Figure 2.114. Poorly sealed vertical seam where addition joins historic building on south side. Photo by author.

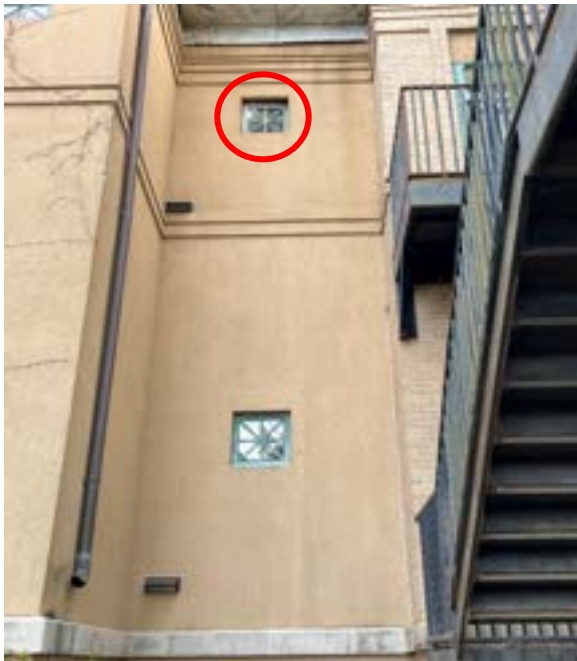
Figure 2.115. Complete weather seal failure on upper casement window on hyphen south side. Photo by author.

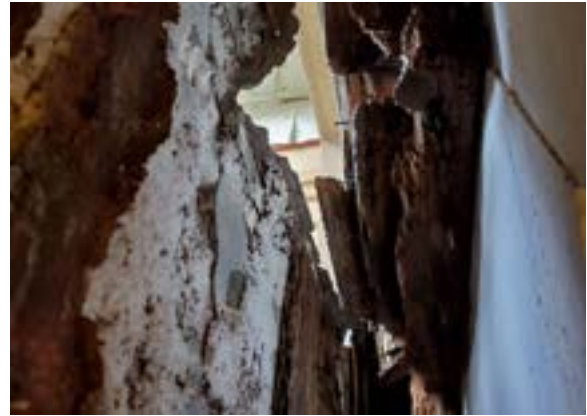
Figure 2.116. Full material failure inside the load bearing wall behind the casement window, hyphen south side. Photo by author.

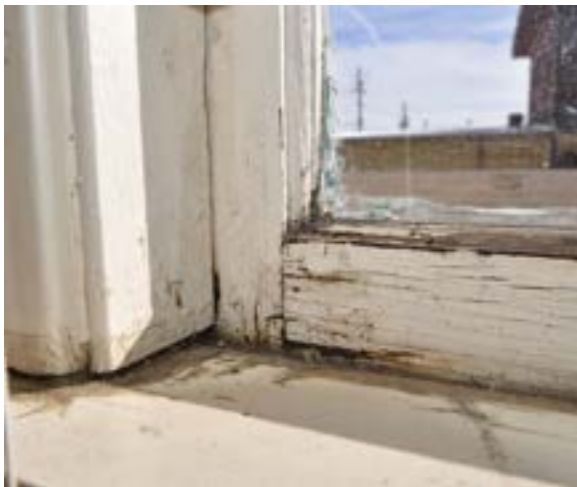
Figure 2.121. Sashes are traditional dimensions with milled ogee profile. Photo by author.

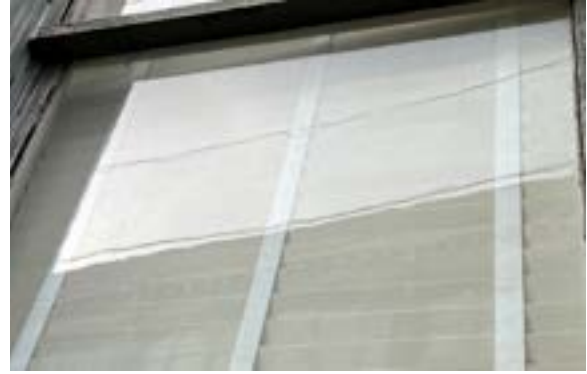
Figure 2.122. Some of the glass exhibits characteristics of antique rolled manufacturing. Photo by author.

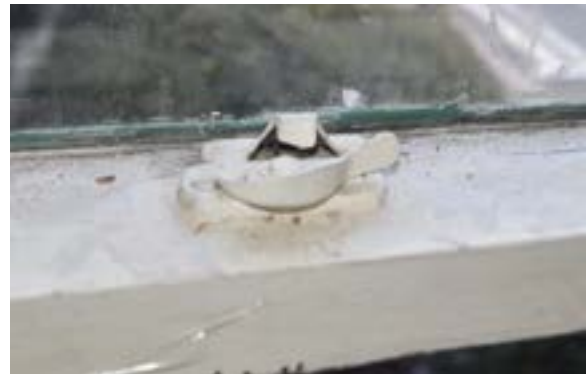
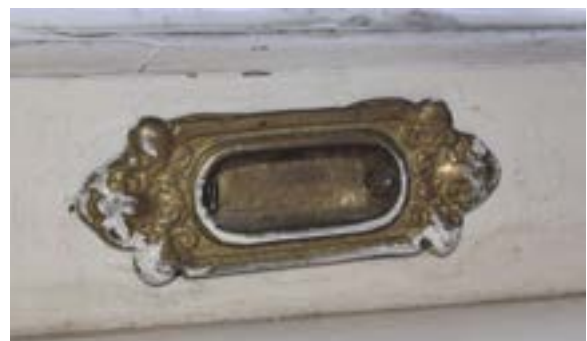
Figure 2.123. Hardware on historic windows. Photo by author.

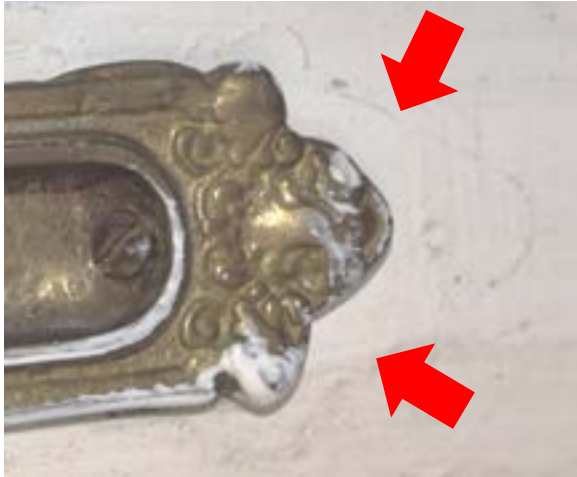
Figure 2.124. Evidence of prior hardware set observed on most lower sashes. Note ghosted outline highlighted by red arrows. Photo by author.

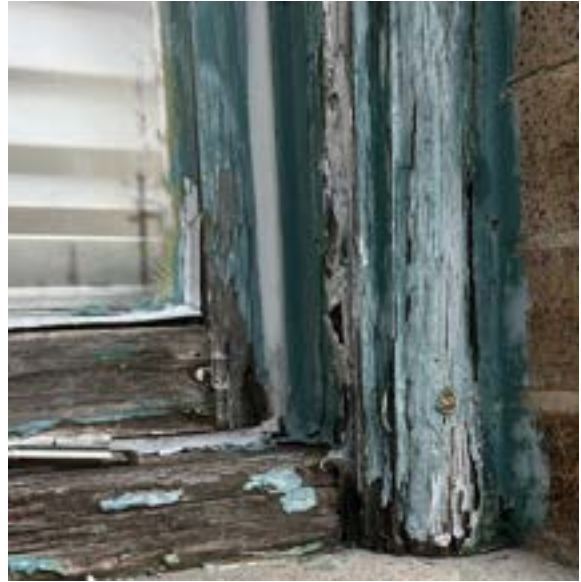
Figure 2.125. Exterior wood frames with molding. The condition of these frames and molding vary greatly around building. Photo by author.

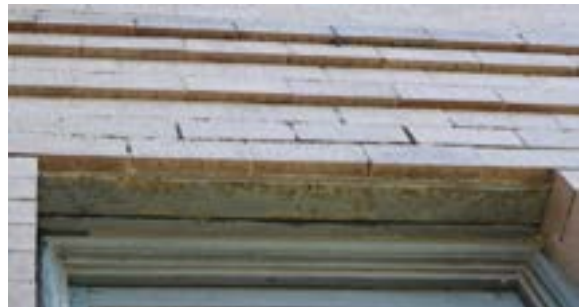
Figure 2.126. Steel lentiil above larger historic windows. Photo by author.

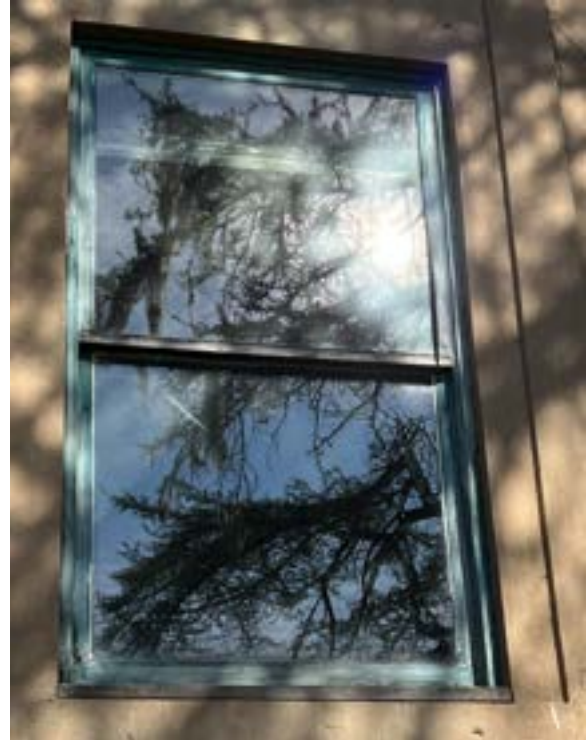
Figure 2.131. A double sash window in the modern addition. Photo by author.

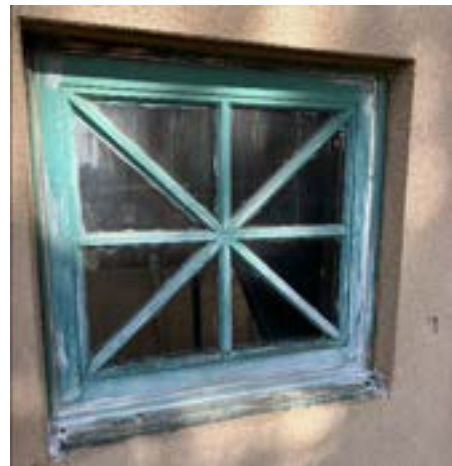
Figure 2.132. 2' x 2' starburst casements are located on all sides of the addition. Photo by author.

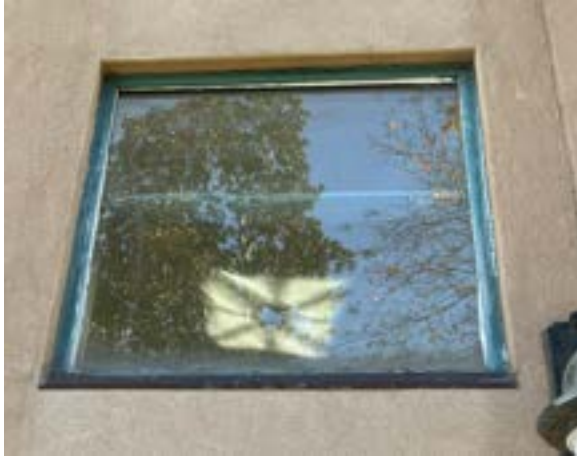
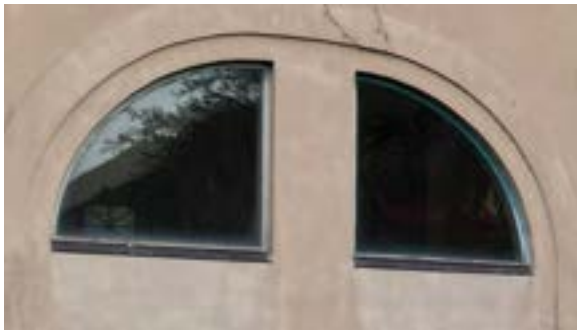
Figure 2.133. Upper casement window elements on modern addition: square and quarter round configurations. Photo by author.

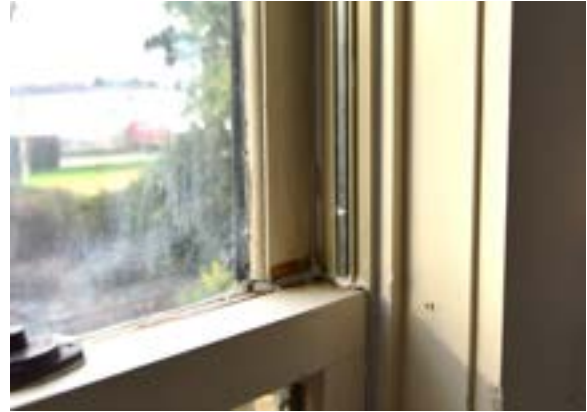
Figure 2.134. Vinyl jamb divider and spring mechanism on double-hung windows in Addition. Photo by author.

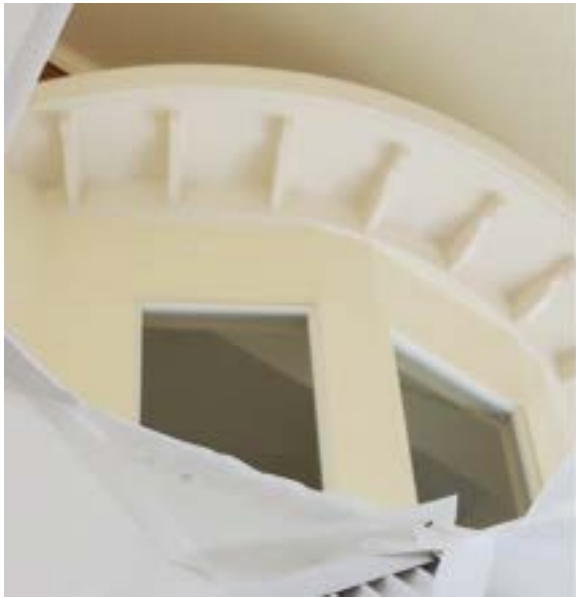
Figure 2.141. Easy to miss apron roof detail over interior balcony windows. Photo by author.

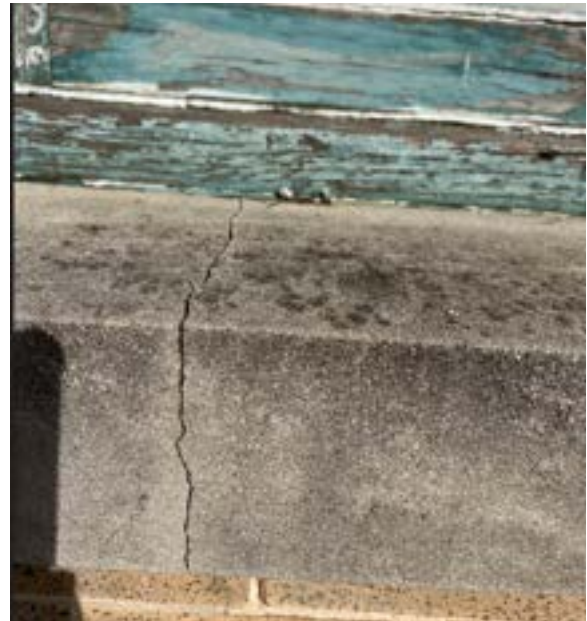
Figure 2.142. Window #112 has a broken belt course sill. Photo by author.

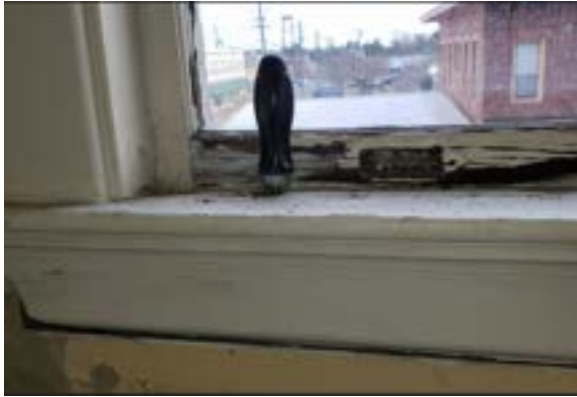
Figure 2.143. Window #206 has a heavily decayed stool. Note depth of probe. Photo by author.

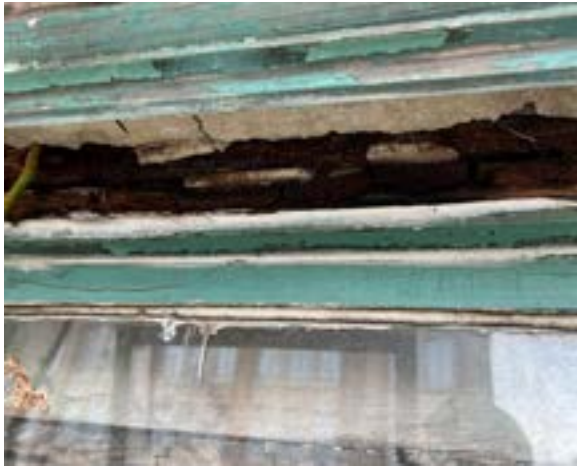
Figure 2.144. Decayed casement frame on second floor west stairway wall, historic building. Photo by author.

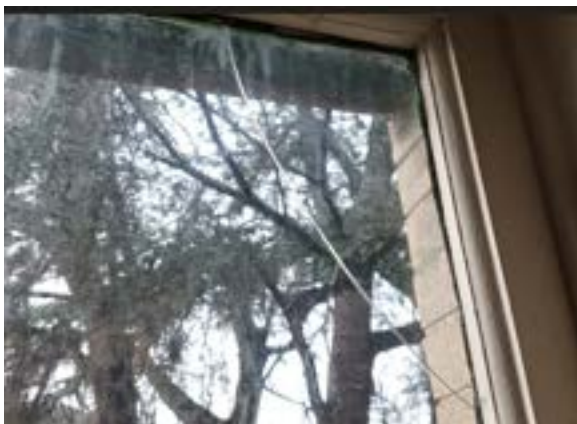
Figure 2.145. Window #204 has broken historic glass. Photo by author.

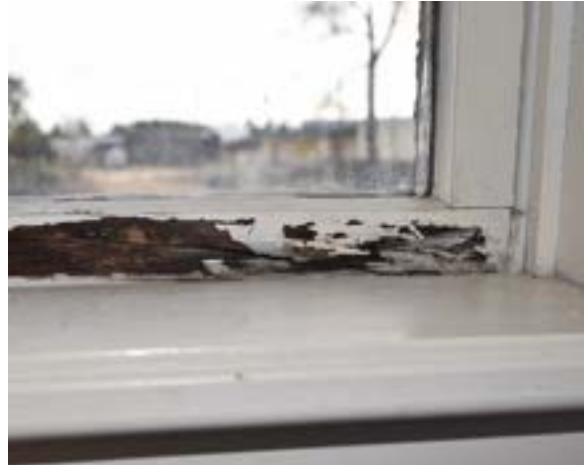
Figure 2.146. Window #119 has extensive material damage on modern window sash. Photo by author.

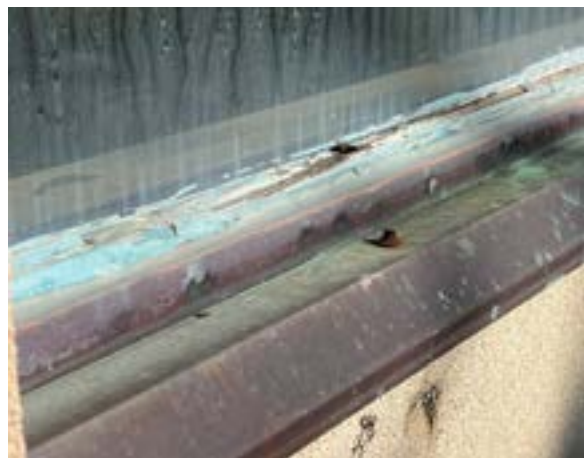
Figure 2.147. Clouded glass and decayed glazing noted on several windows in Addition. Photo by author.

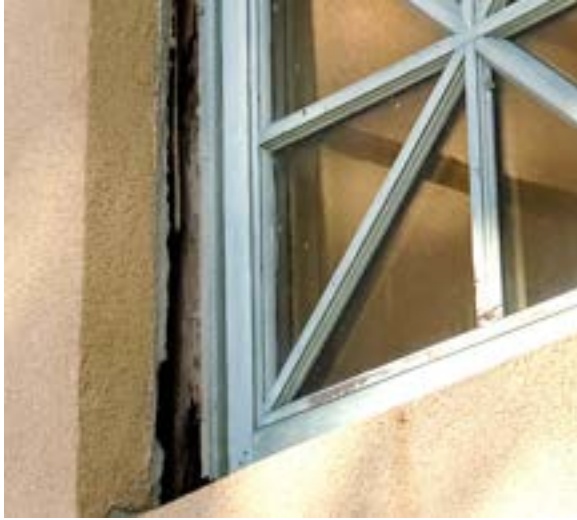
Figure 2.148. Complete EIFS separation at window frame. Photo by author.

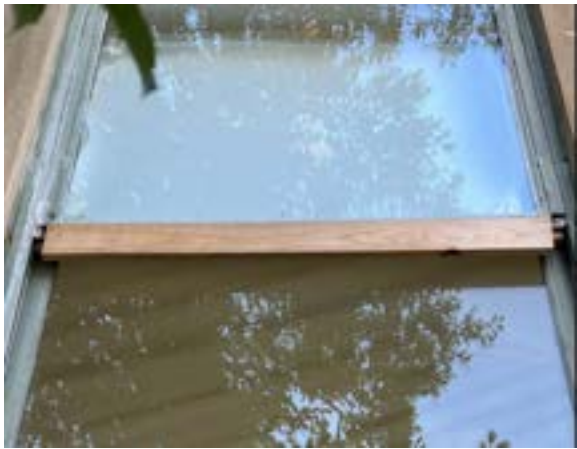
Figure 2.149. Evidence of prior repairs to hold glass in place. Photo by author.

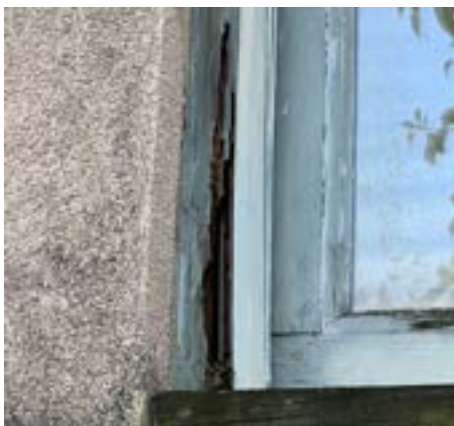
Figure 2.150. Fully decayed window frame. Photo by author.

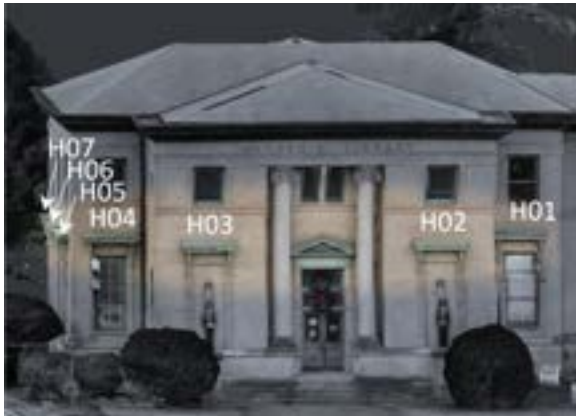
Figure 2.151. Hood identification west to east.

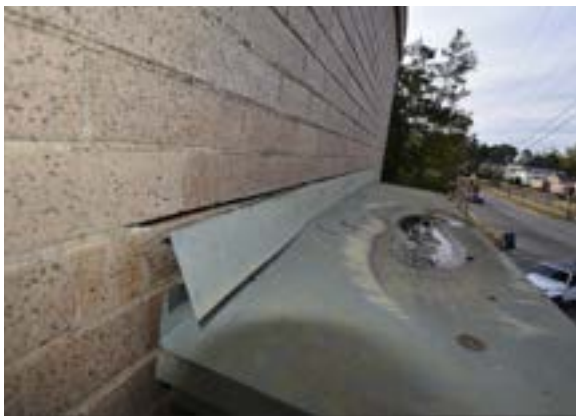
Figure 2.152. Hood H01, wall flashing separating from mortar. Photo by author.

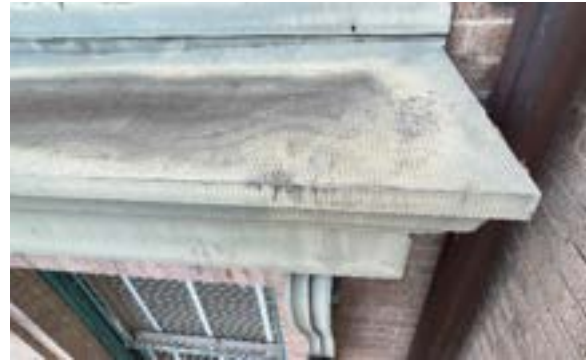
Figure 2.153. Hood H04 shows signs of chronic water pooling. Photo by author.

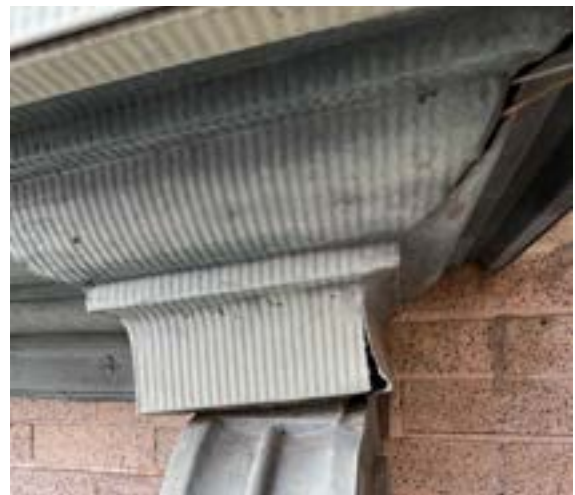
Figure 2.154. Hood H04, cornice corner and corbel have fractured. Photo by author.

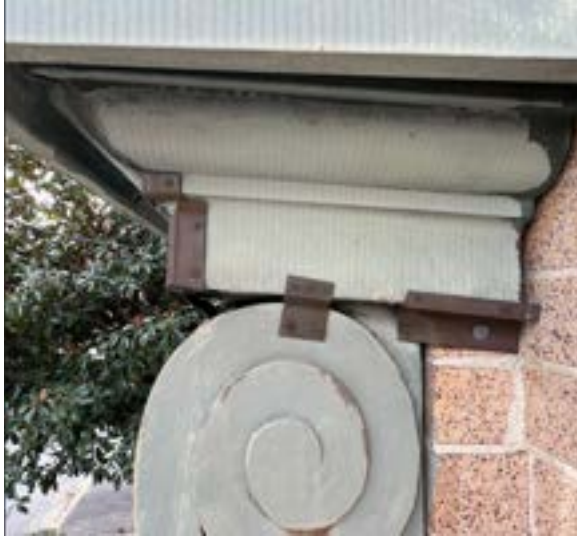
Figure 2.155. Excellent and stable repairs to HO5 & HO6.
Photo by author.

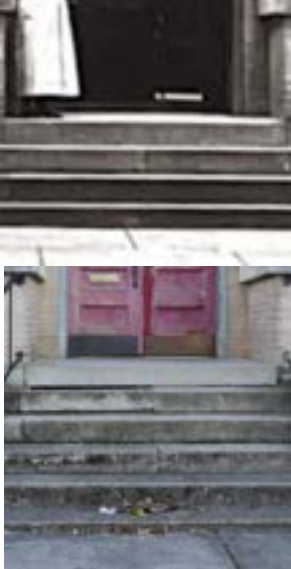
Figure 2.158 Two steps were added at bottom of main entrance stairway, notice difference from historic configuration pictured above.

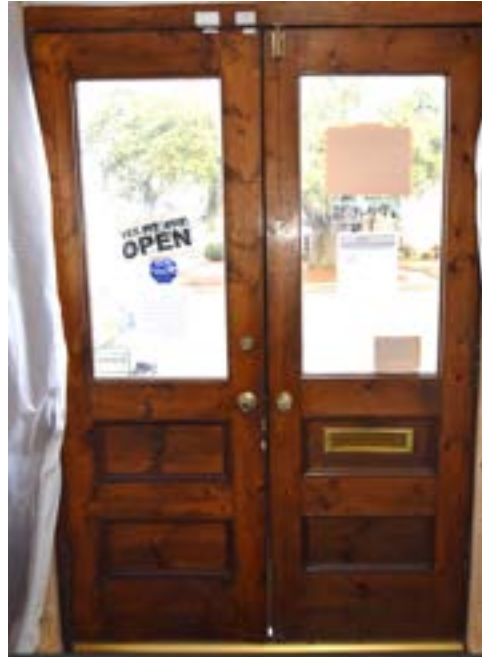
Figure 2.160. Interior view main entrance doors. Photo by author.

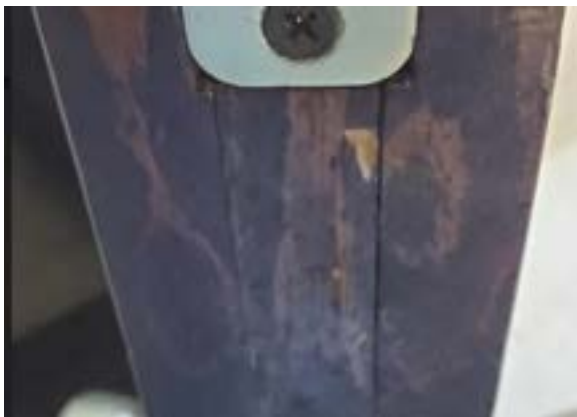
Figure 2.162. The main entrance doors may be older than 50 years, but construction is different from other historic doors in the building. Note presence of three sandwiched boards vs. one solid piece noted elsewhere in the building. Photo by author.

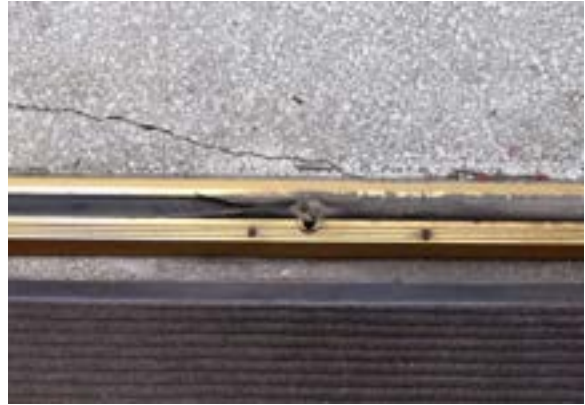
Figure 2.163. Non-historic aluminum threshold. Photo by author.

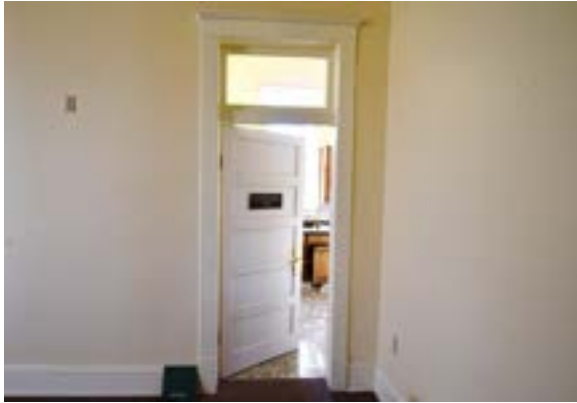
Figure 2.174. A historic doorway within a modern wall suggests an original configuration. Photo by author.

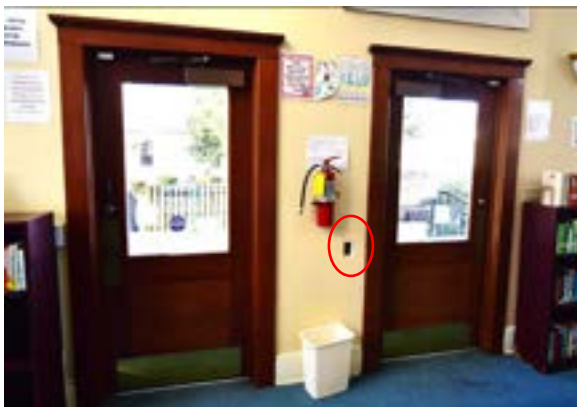
Figure 2.179. Exterior access doors on western side of addition. Note low mounted disused switch receptacle. Photo by author.

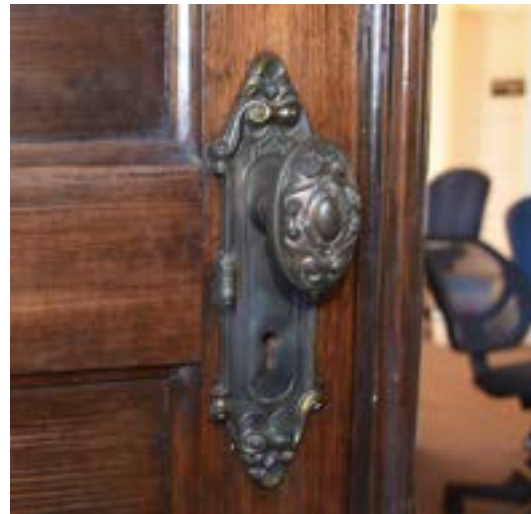
Figure 2.180. Original hardware intact and operational on many of the historic doors. Photo by author.

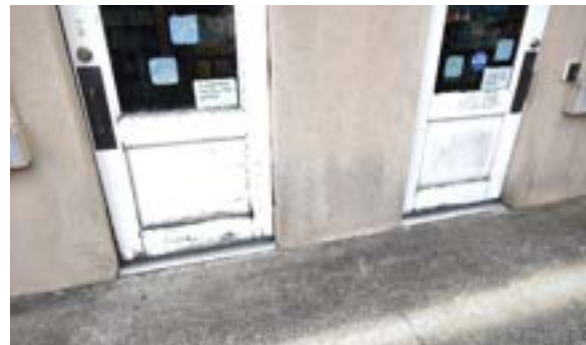
Figure 2.181. Degraded paint finishes on the addition's exterior doors. Photo by author.

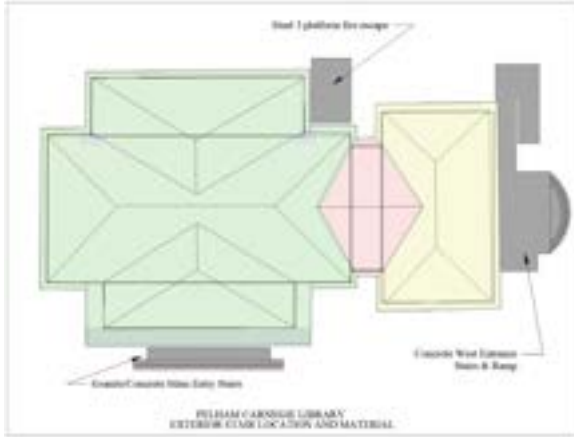
Figure 2.182. Exterior Stairs and materials.

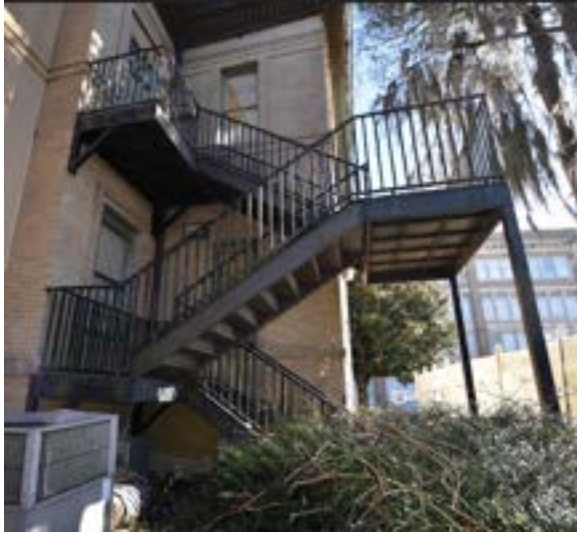
Figure 2.186 Fire escape on south side of building. Photo by author.

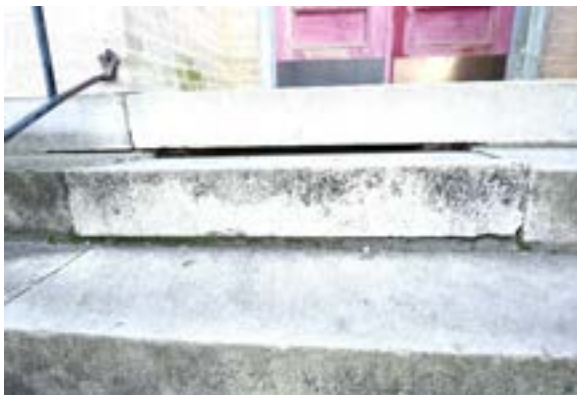
Figure 2.187. Settling evident to granite block on upper tread. Photo by author.

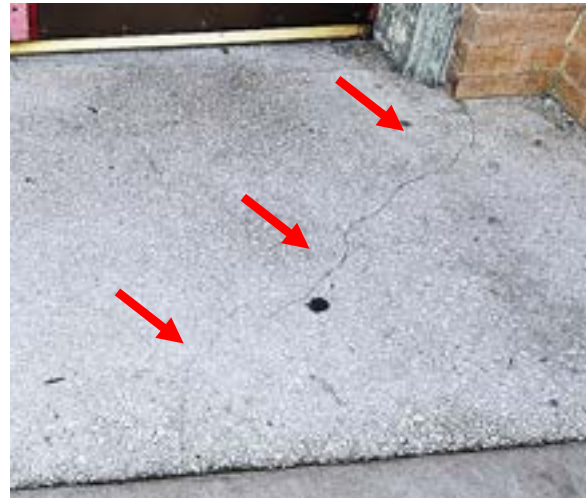
Figure 2.188. Crack in terrazzo apron outside front door. Photo by author.

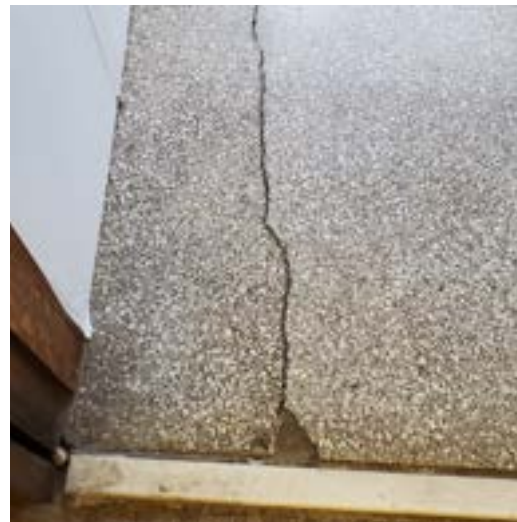
Figure 2.189. Significant crack in main entry terrazzo floor. Photo by author.

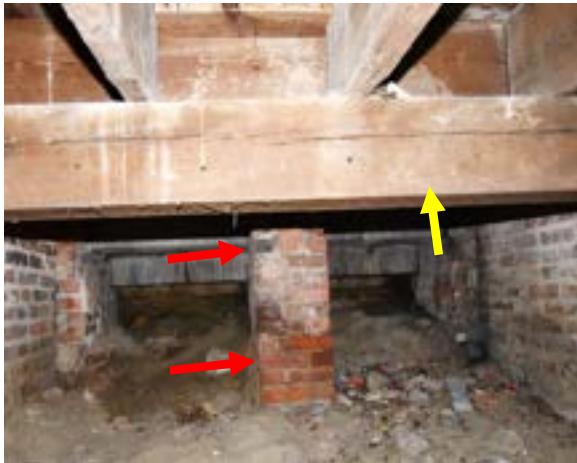
Figure 2.190. The settling of the masonry pier and the supporting wood timber (yellow arrow) may have contributed to cracks in the floor above. Photo by author.

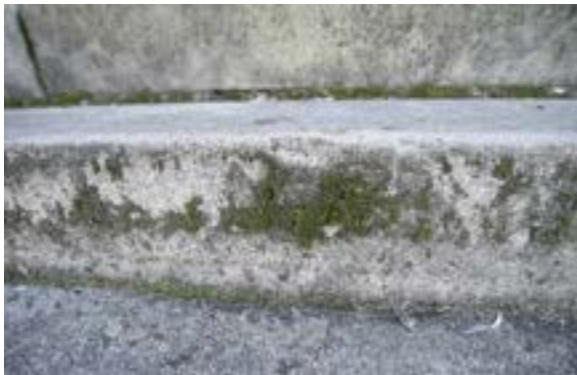
Figure 2.191. Significant organic growth on main entry stairs. Photo by author.

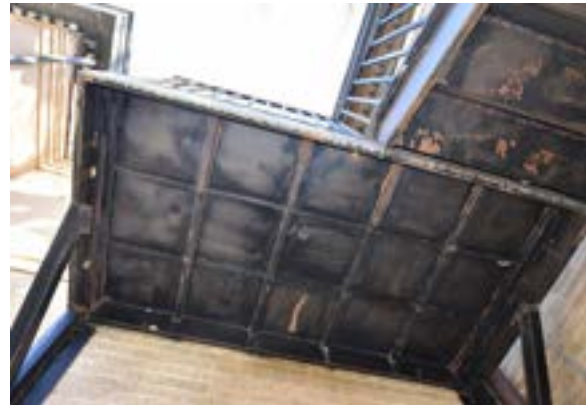
Figure 2.192. Rust evident on various fire escape surfaces. Photo by author.

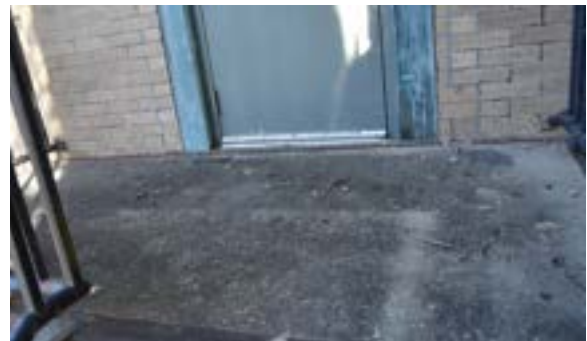
Figure 2.193. The upper fire escape platform may have been a source of water intrusion into the building in the past but tested dry during inspection. Photo by author.

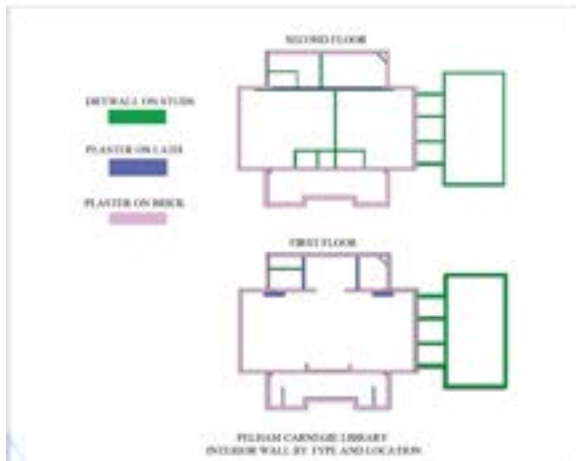
Figure 2.194. Interior wall by type of finish.

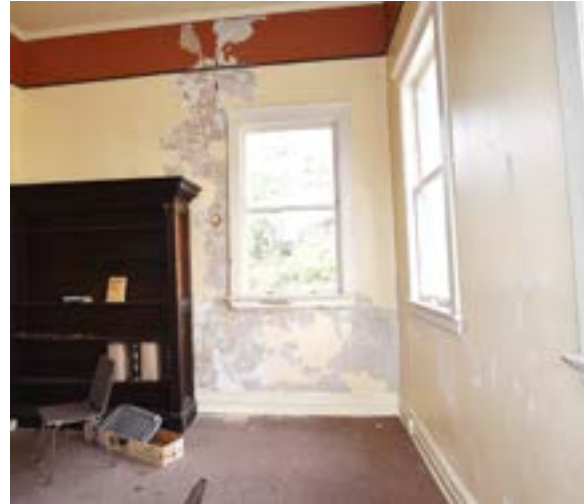
Figure 2.195. Plaster finish is historic, but several sections will require repair and restoration. Photo by author.

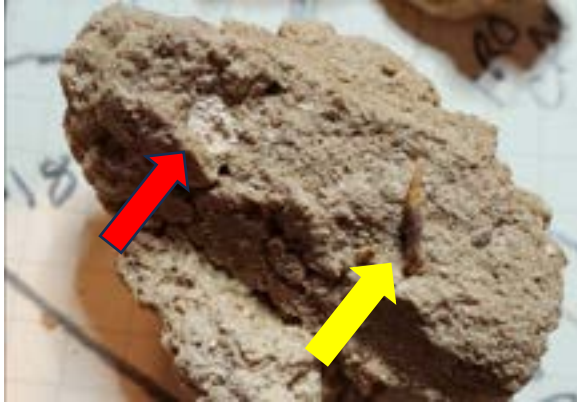
Figure 2.196. A sample of the plaster base coat. Note large lime deposit (red) and fibrous twig or straw (yellow). Photo by author.

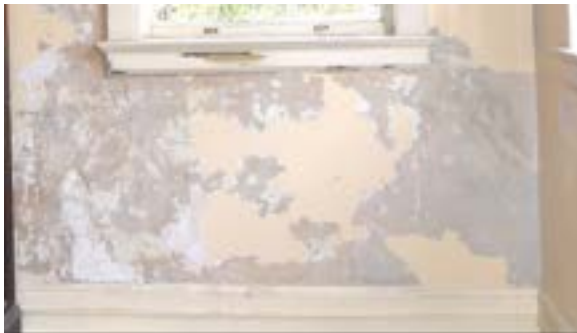
Figure 2.197. Base coat integrity is good in damaged areas. Photo by author.
