Spring 2024

Historic Structure Report

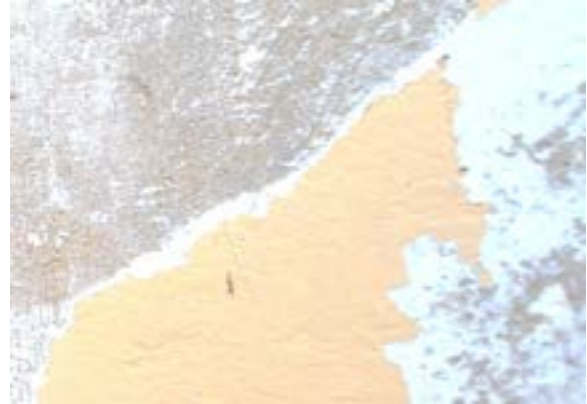
Figure 2. 198. Gypsum topcoat, smooth and hard but vulnerable to water damage. Photo by author.

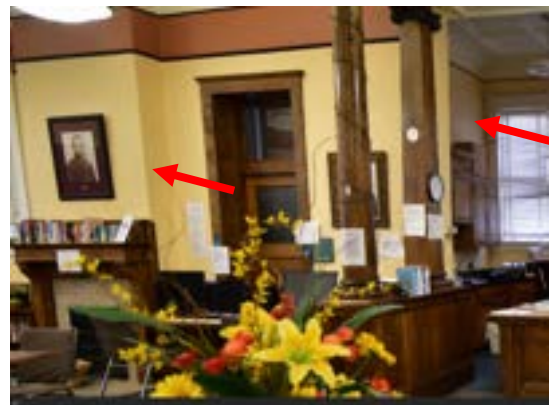
Figure 2.199. Several of the interior walls are plaster on lath. Photo by author.

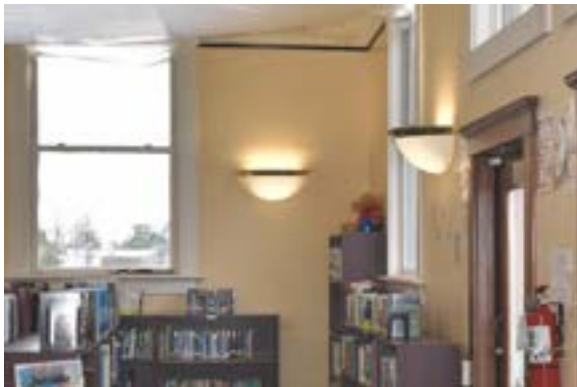
Figure 2.201. Approximately 50% of the interior walls are drywall with taped and sanded seams. Photo by author.

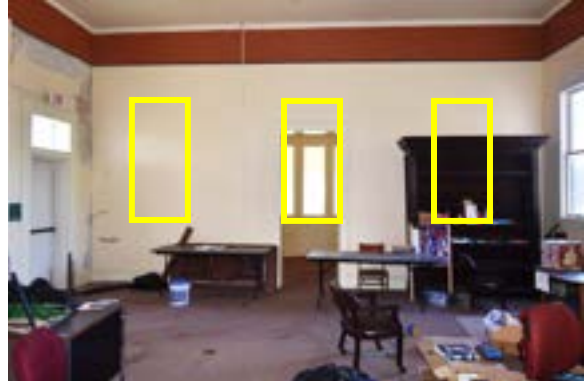
Figure 2.202. The walls on the western side of the building have drywall covering on top of the historic plaster. This is likely to cover the old window openings whose approximate locations are shown in yellow. Photo by author.

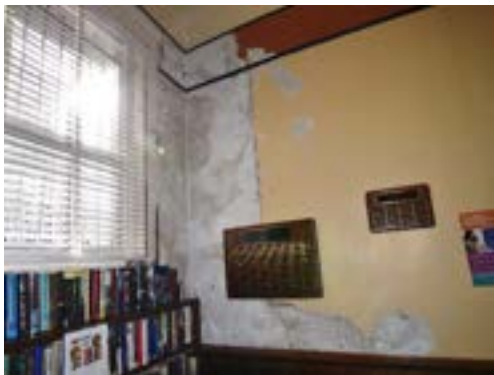
Figure 2.204. Topcoat plaster is damaged in the southwest corner of the first floor. Photo by author.

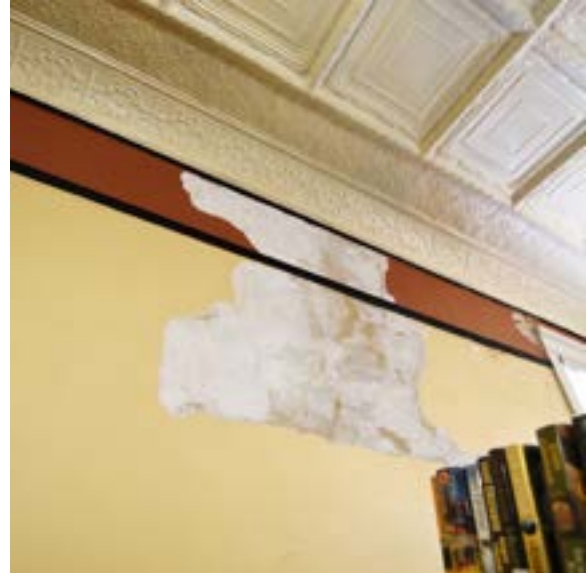
Figure 2.205. Damage along the side of first floor interior wall. Photo by author.

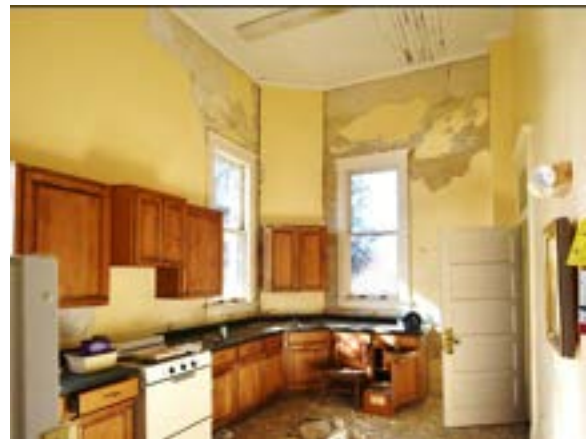
Figure 2.206. Extensive water damage in kitchen on 2nd floor. Photo by author.

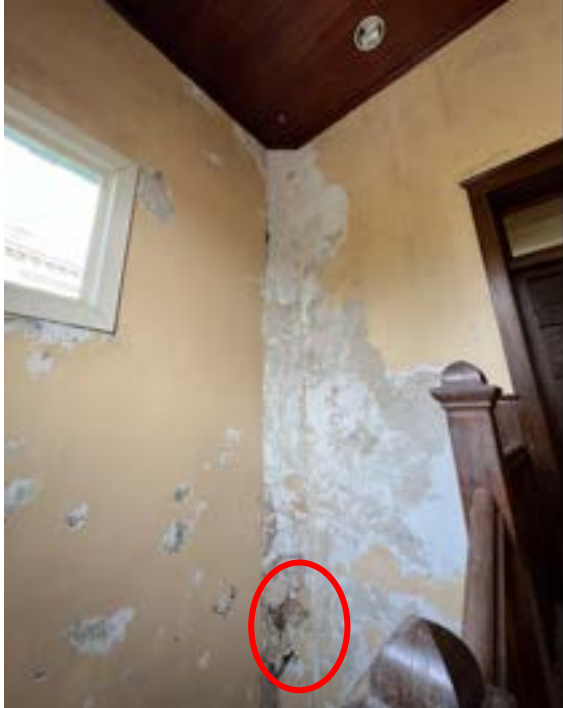
Figure 2.207. Extensive damage in eastern stairwell. Photo by author.

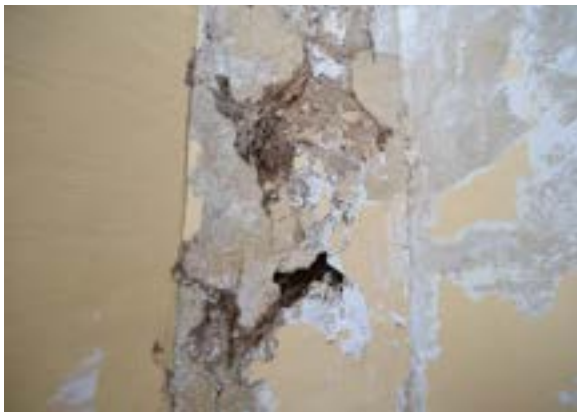
Figure 2.208. Large organic growth in eastern stairwell. Photo by author.

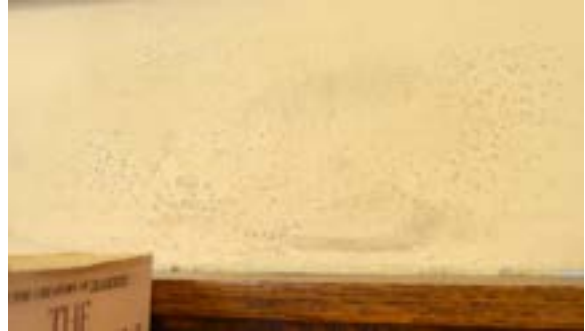
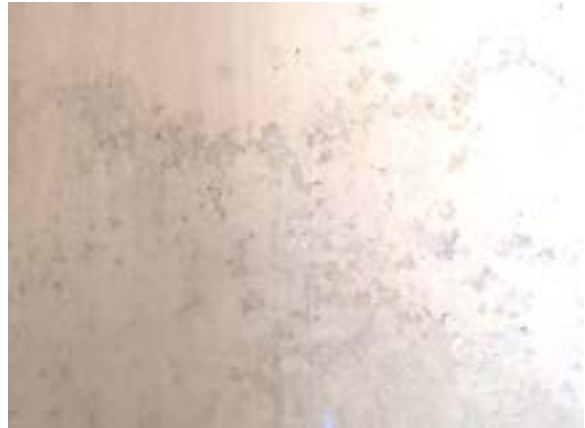
Figure 2.209. Mold growth on walls visible throughout building. Photo by author.

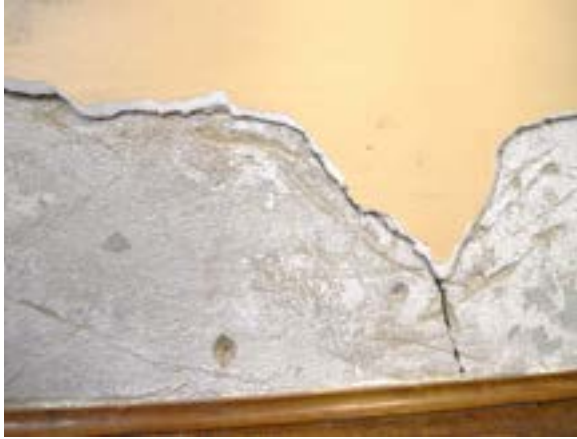
Figure 2.210. Damage to the base coat observed in places. Photo by author.

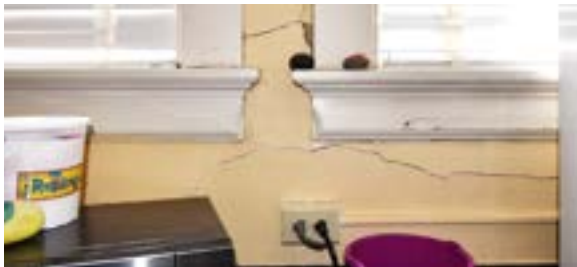
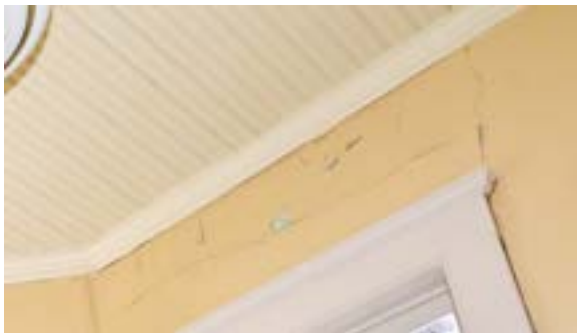
Figure 2.211. Two instances of plaster damage due to load shifting or settling. Photo by author.

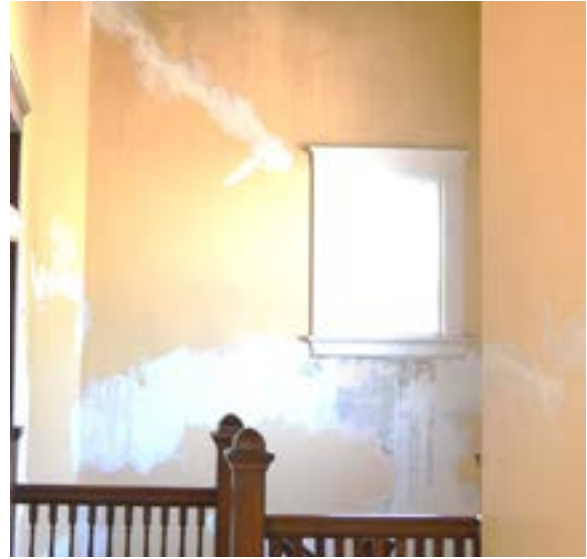
Figure 2.212. Evidence of prior repairs in western stairwell. Photo by author.

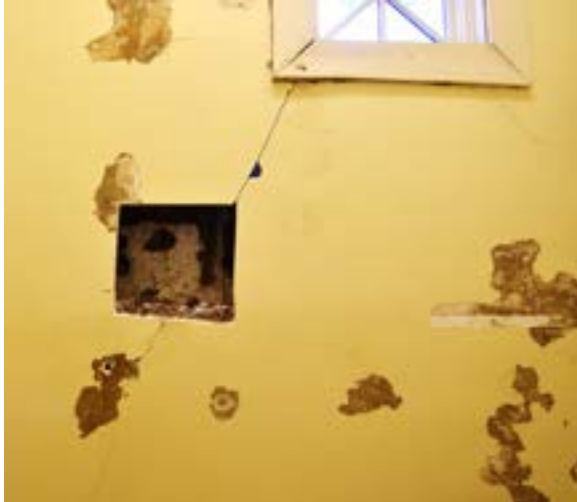
Figure 2.213. The damaged wall finish in 2nd floor southside restroom. Photo by author.

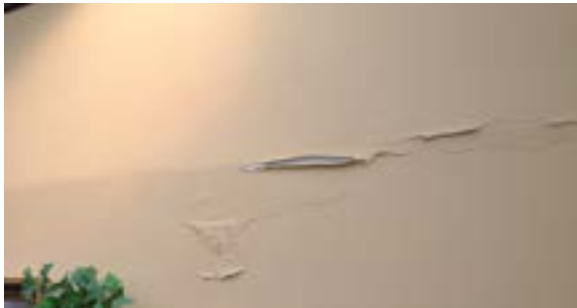
Figure 2.214. Drywall damage on east wall of modern addition. Photo by author.

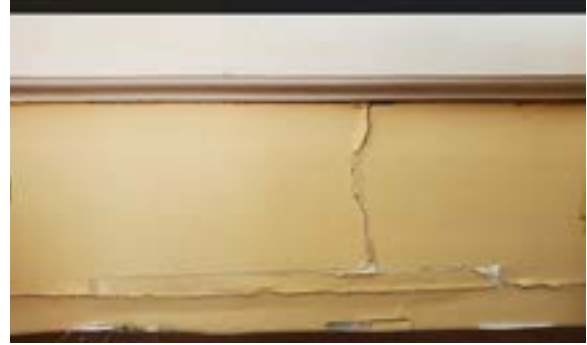
Figure 2.215. Possible water damage on southwest wall in modern addition. Photo by author.

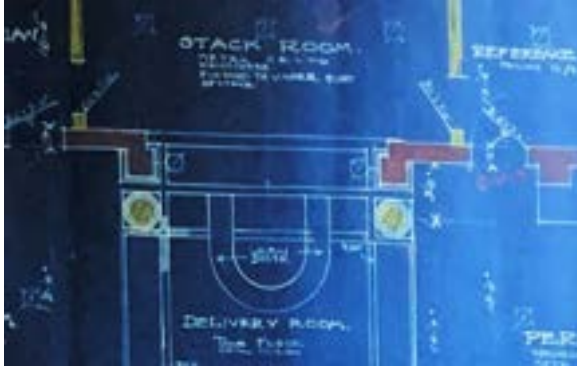
Figure 2.221. Detail from original blueprints. Courtesy City of Pelham.

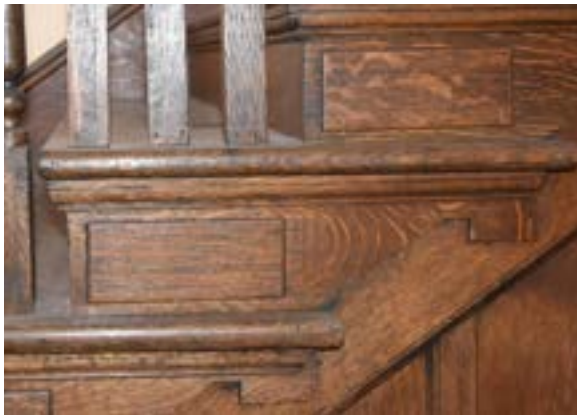
Figure 2.222. Outside stringer trim detail on foyer staircases. Photo by author.

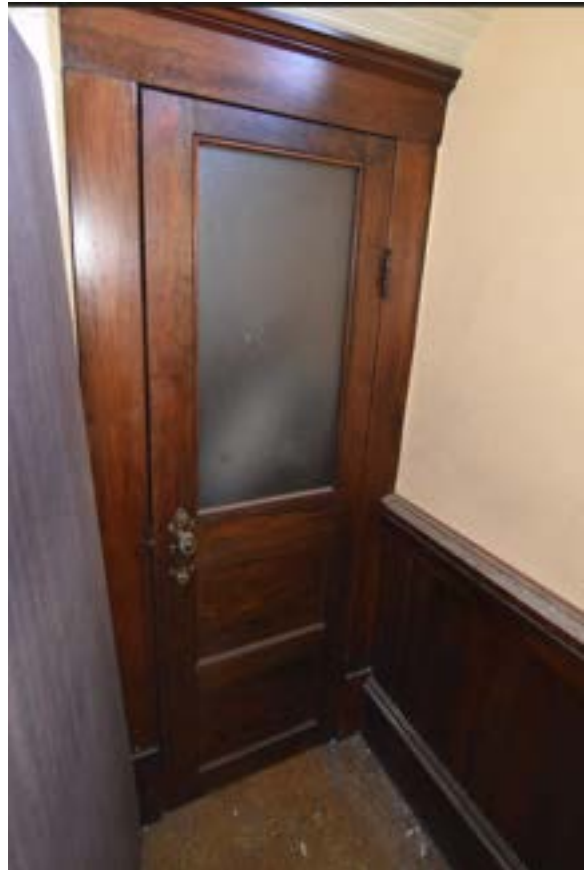
Figure 2.223. The hidden bathroom door below western foyer stairs. Photo by author.

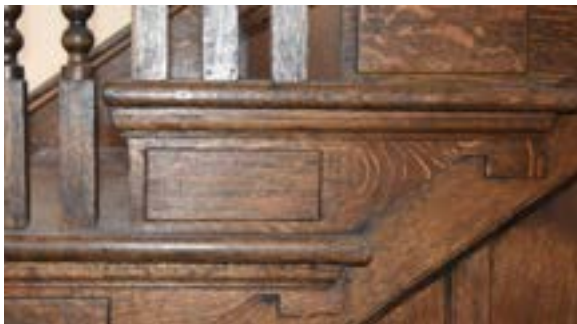
Figure 2.228. Outer stringer detailing. Photo by author.

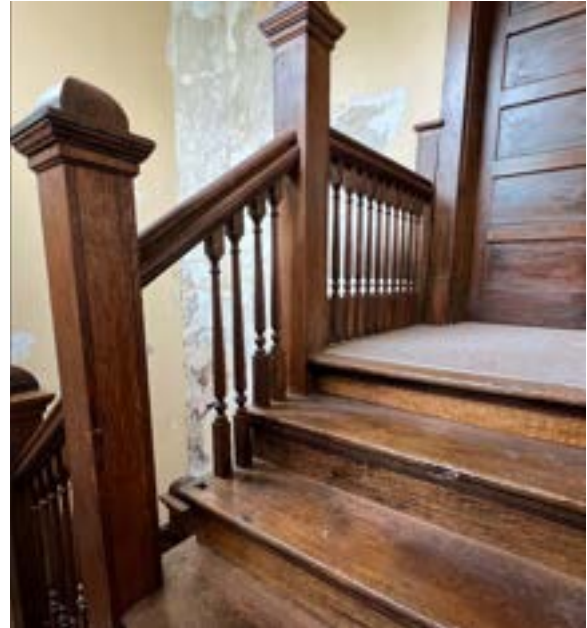
Figure 2.229. Missing baluster on upper section of eastern stair. Photo by author.

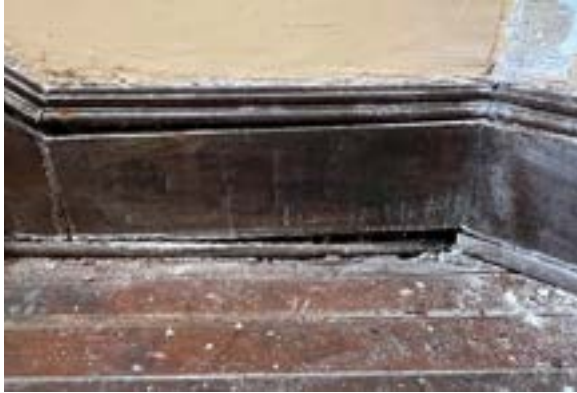
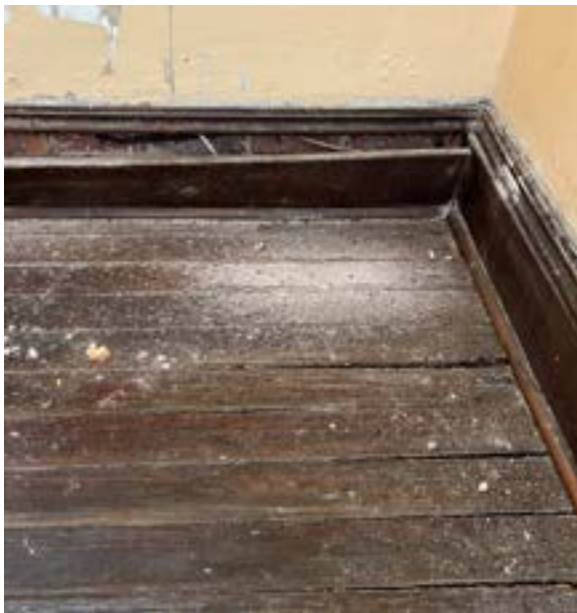
Figure 2.230. Some material failure is evident on the 2nd and 3rd platforms of the eastern stairway. Photo by author.

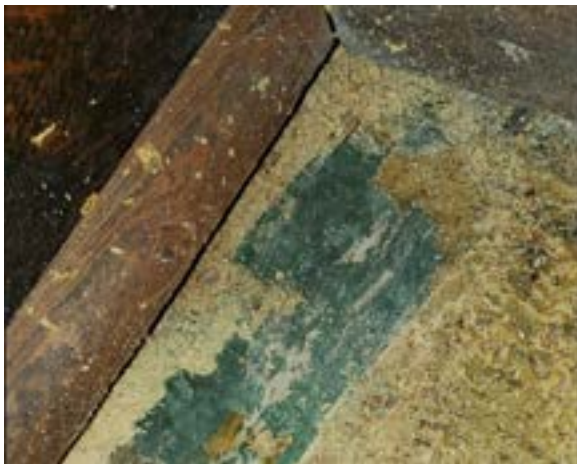
Figure 2.234. Hard density tile flooring located behind circulation desk is likely an asbestos product and should be approached and handled according to local and state abatement requirements. Photo by author.

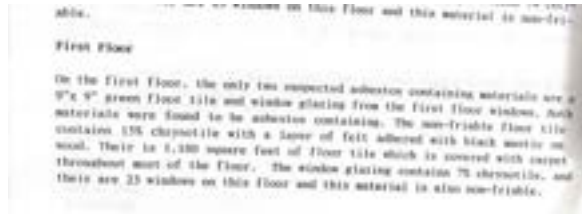
Figure 2.235. Excerpt of hazardous materials report in Library files.

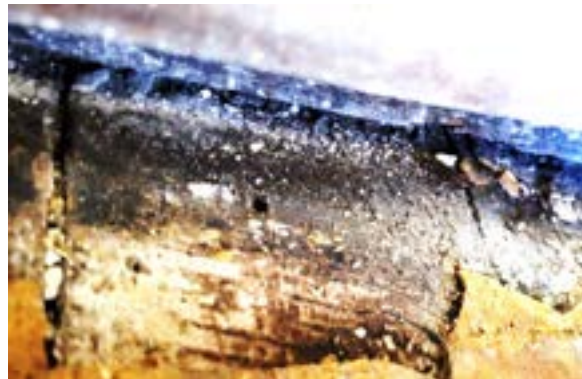
Figure 2.236. Wood flooring below first floor carpet. Photo by author.

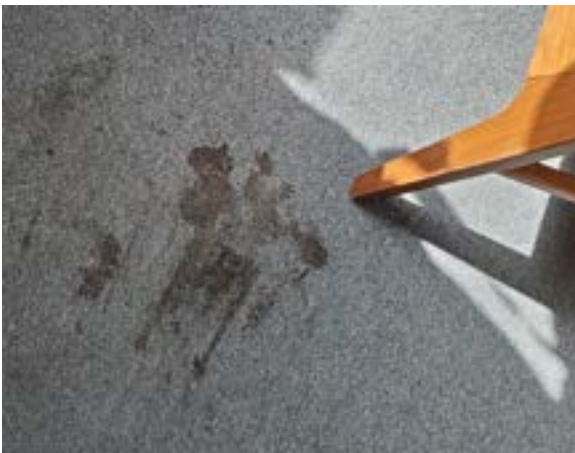
Figure 2.247. Carpet floors are showing their age. Photo by author.

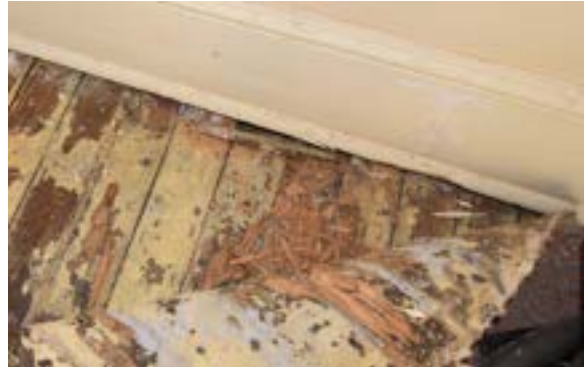
Figure 2.248. Significant material damage to 2nd floor decking in southwest corner of historic building. Photo by author.

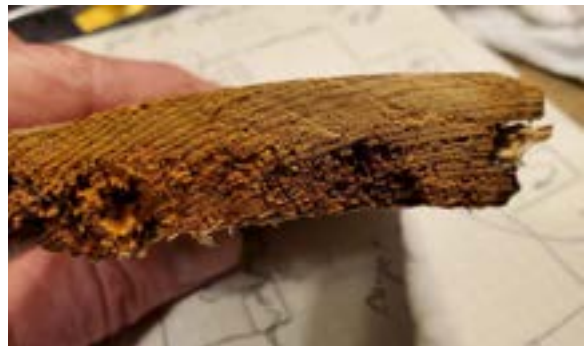
Figure 2.249. Decayed sections of 2nd floor decking. Photo by author.

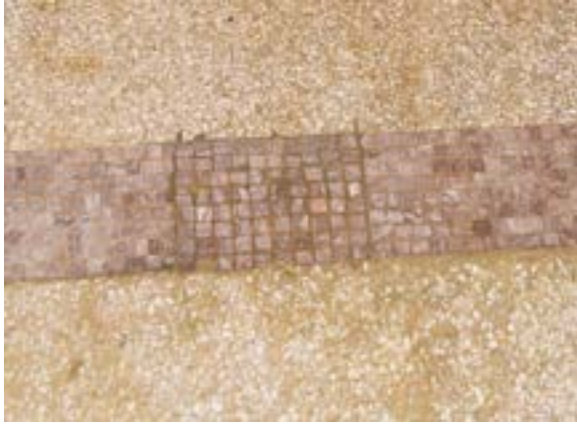
Figure 2.250. Previously repaired section of terrazzo in main room. Photo by author.

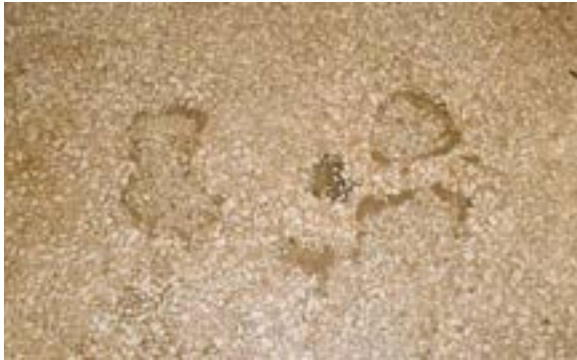
Figure 2.251. Additional patched areas in terrazzo flooring. Photo by author.

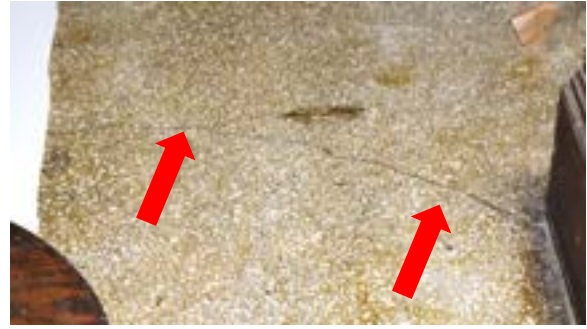
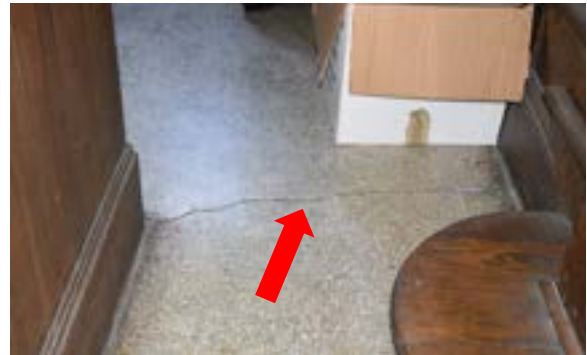
Figure 2.252. Cracks in terrazzo flooring on corresponding areas of the foyer near beginning of stairs. Photo by author.

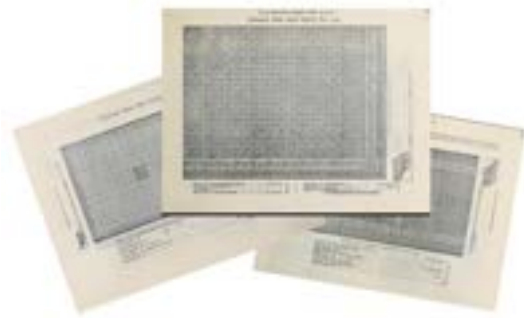
Figure 2.255. Sample metal ceiling designs from W.H. Mullins catalog (1894).

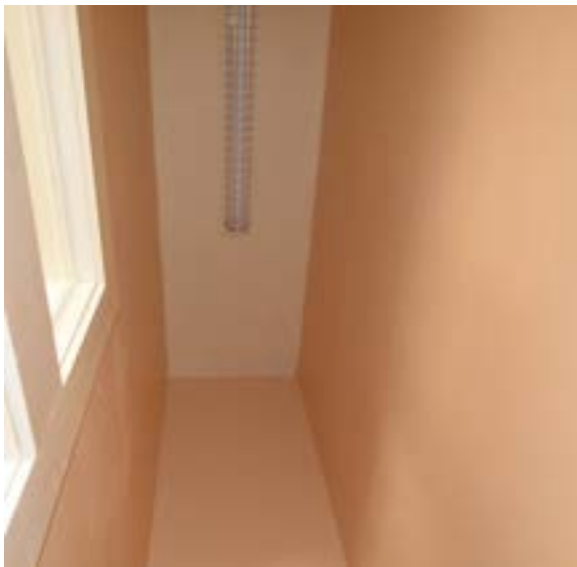
Figure 2.267. Drywall ceilings can be found throughout the historic building in areas altered by 1990s renovations. Photo by author.

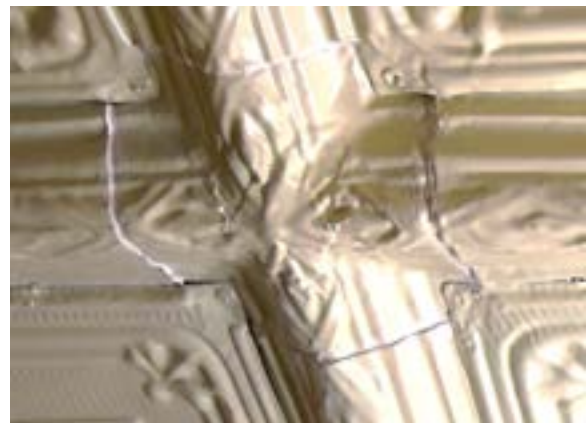
Figure 2.268. All molding seams on metal ceiling have been caulked. Photo by author.

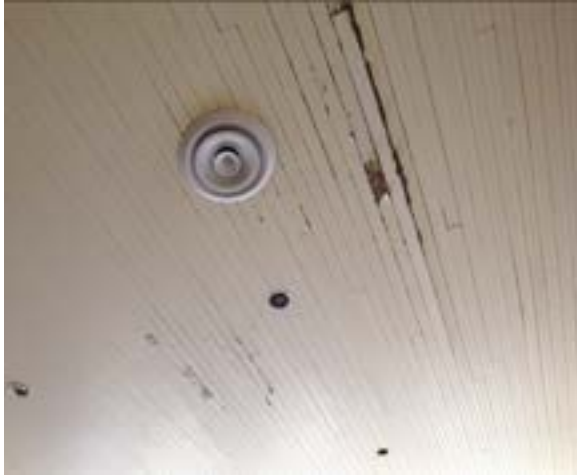
Figure 2.269. Damaged beadboard in 2nd floor main room (east). Photo by author.

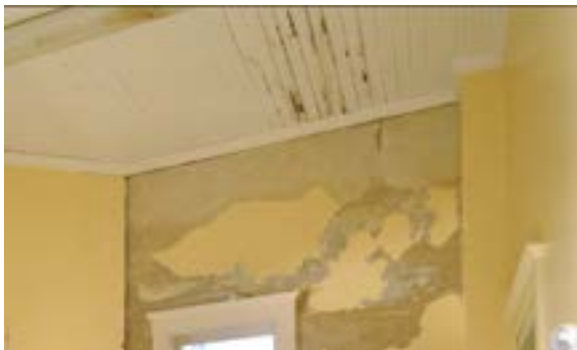
Figure 2.270. Damaged ceiling in kitchen area (west). Photo by author.

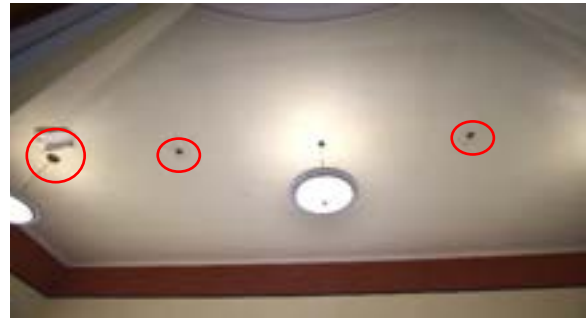
Figure 2.271. Ceiling in modern addition shows evidence of water damage in several places. Photo by author.

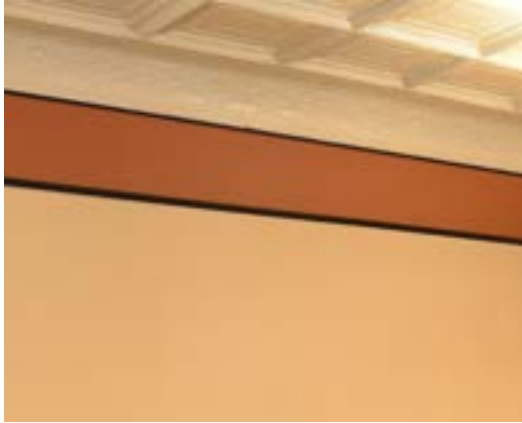
Figure 2.272. First floor wall color and trim. Photo by author.

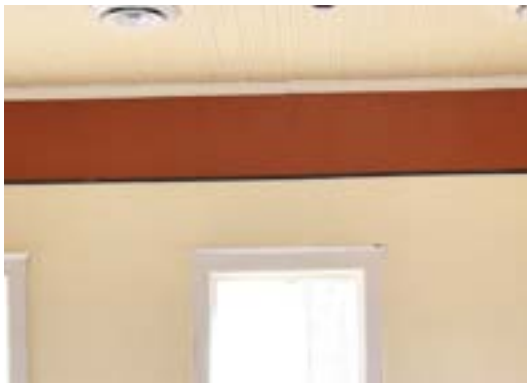
Figure 2.273. Second floor wall color slightly lighter, trim color appears to be the same as first floor. Photo by author.

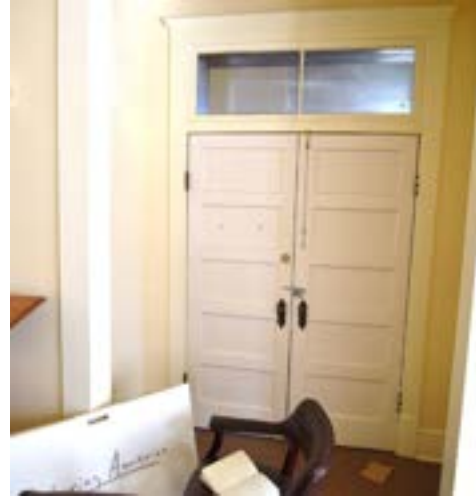
Figure 2.274. The doors and trim are painted semi-gloss white on the interior of the second floor main rooms. Photo by author.

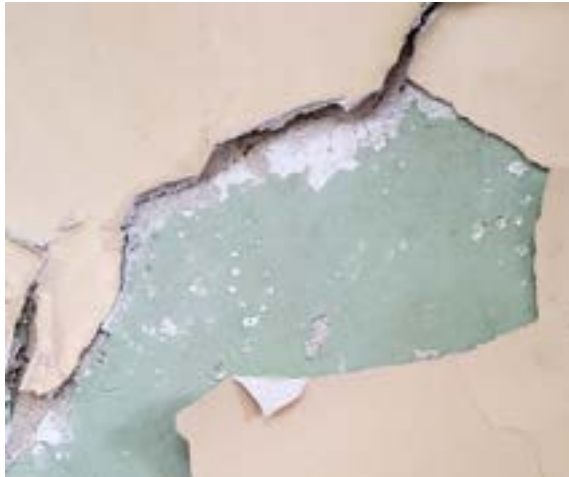
Figure 2.275. Damaged wall section showing possible paint chronology. Photo by author.

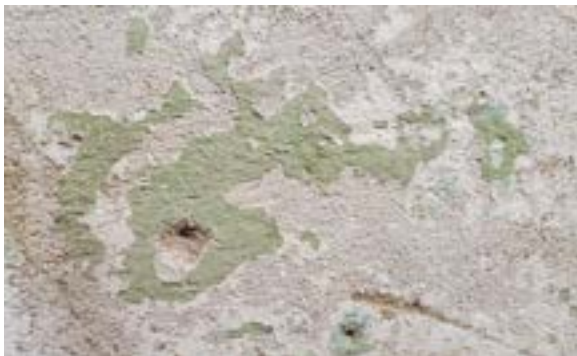
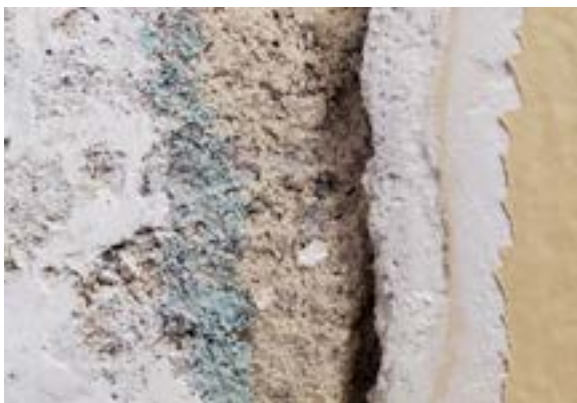
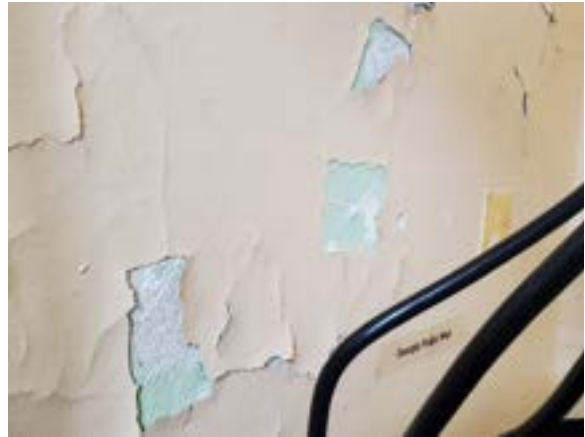
Fig. 2. 276. Multiple examples of the green on the plaster base coat with a whitewash below. Photo by author.

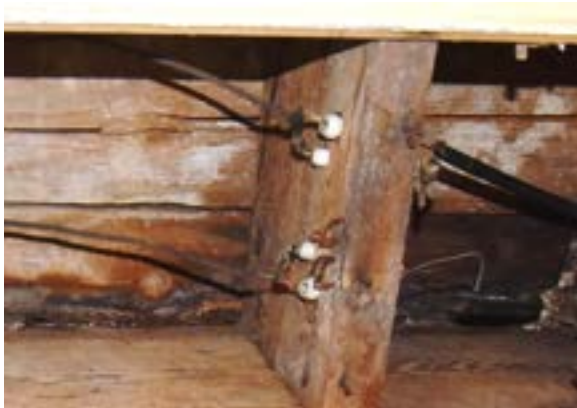
Figure 2.282. Original wiring visible in ceiling of east side foyer, beneath stairs. Photo by author.

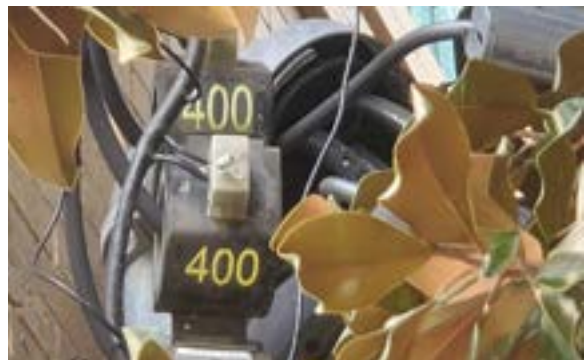
Figure 2.293. Modern service drop on southeast corner of the building. Photo by author.

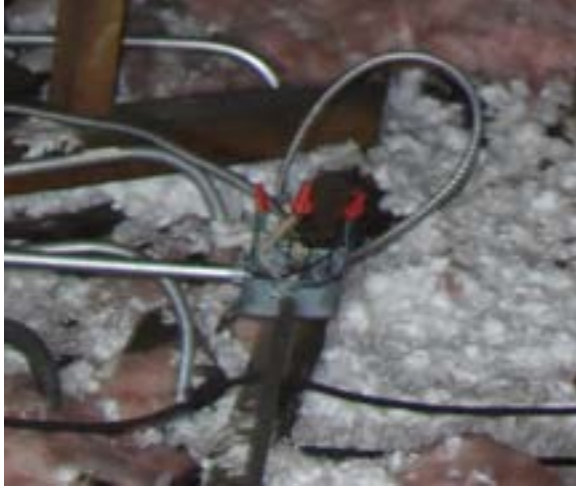
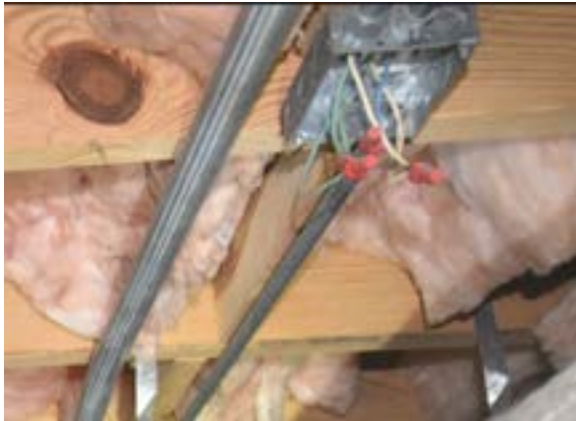
Figure 2.294. Numerous uncovered junction boxes were found throughout the building. Photo by author.

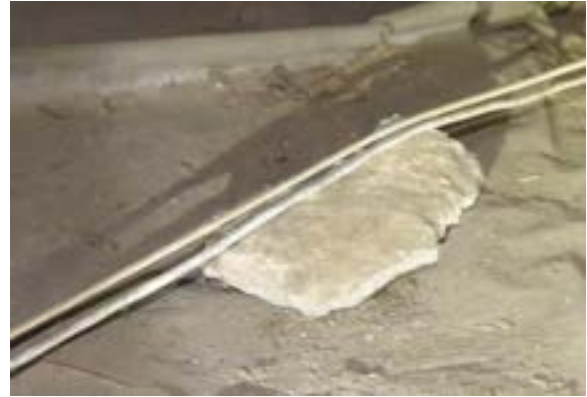
Figure 2.295. Non-code wiring in crawlspace of modern addition. Photo by author.

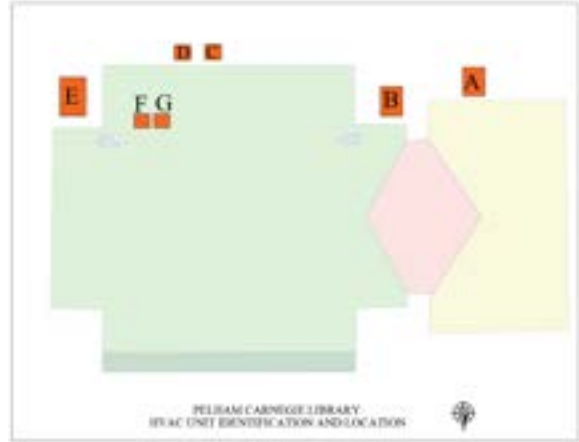
Figure 2.298. Location and naming key for HVAC Units.

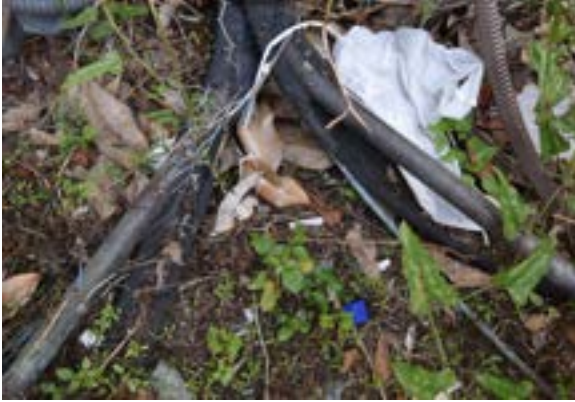
Figure 2.299. Units C & D have deteriorated insulation on coolant lines. Photo by author.

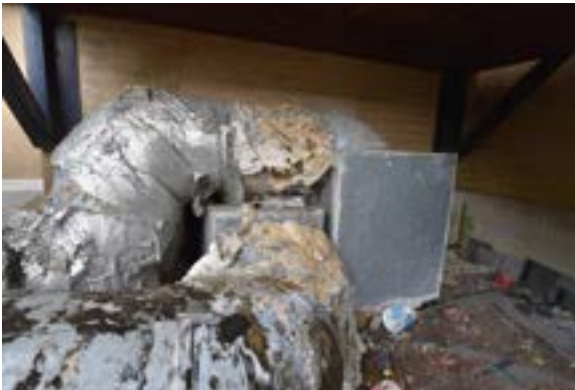
Figure 2.300. Unit B duct insulation heavily degraded. Photo by author.

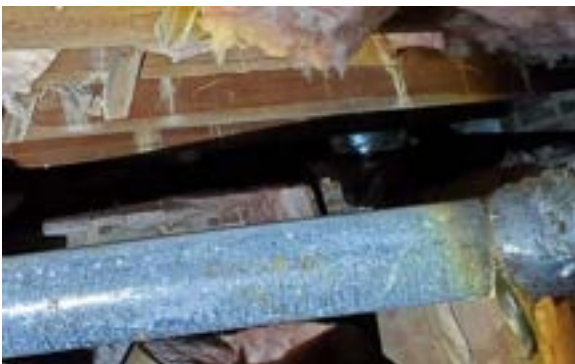
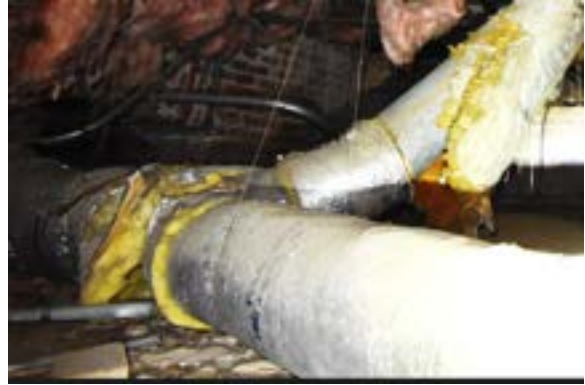
Figure 2.301. Deteriorated duct insulation and failing hangers in historic building crawlspace. Photo by author.

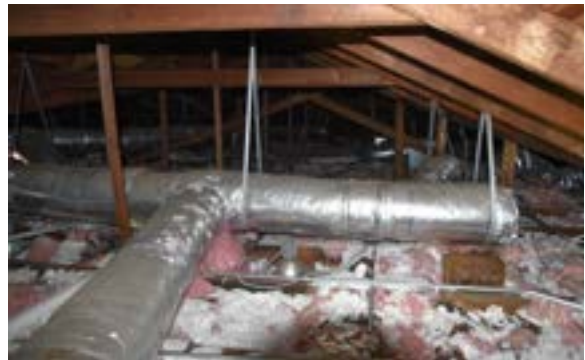
Figure 2.302. Ducting and insulation in attic in good condition. Photo by author.

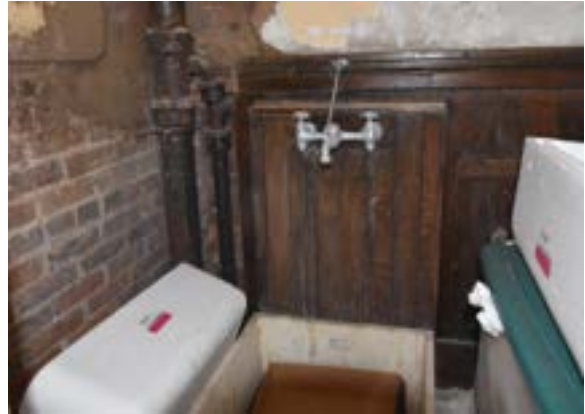
Figure 2.305. Surviving water faucet and basin below eastern stairway. Photo by author.

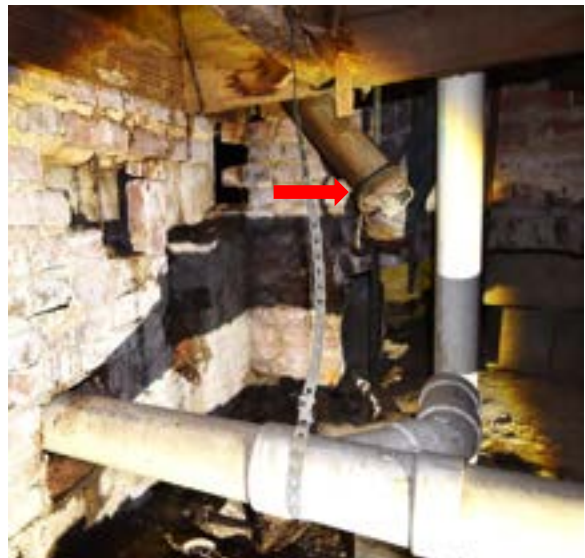
Figure 2.306. Cast iron waste lines (red arrow) replaced with PVC. Photo by author.

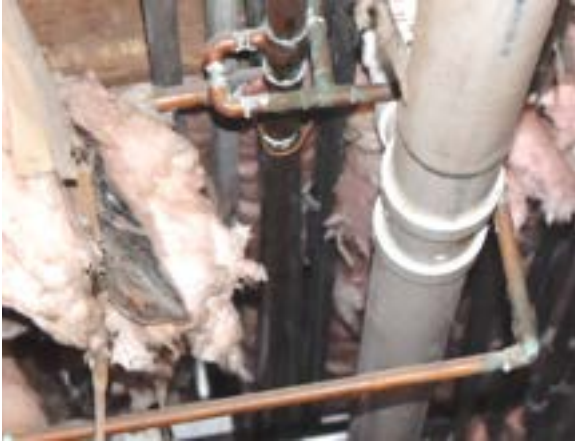
Figure 2.307. Water supply lines are copper. Photo by author.

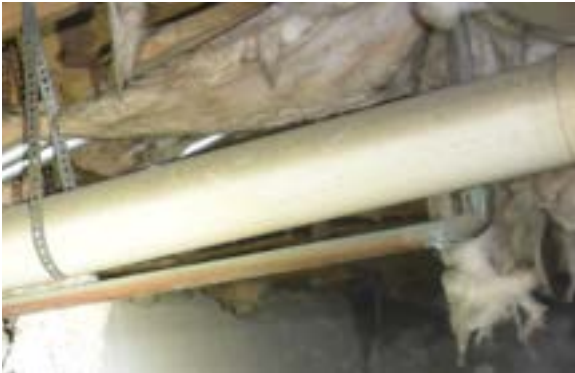
Figure 2.308. PVC waste and copper supply lines observed in modern addition crawlspace. Photo by author.

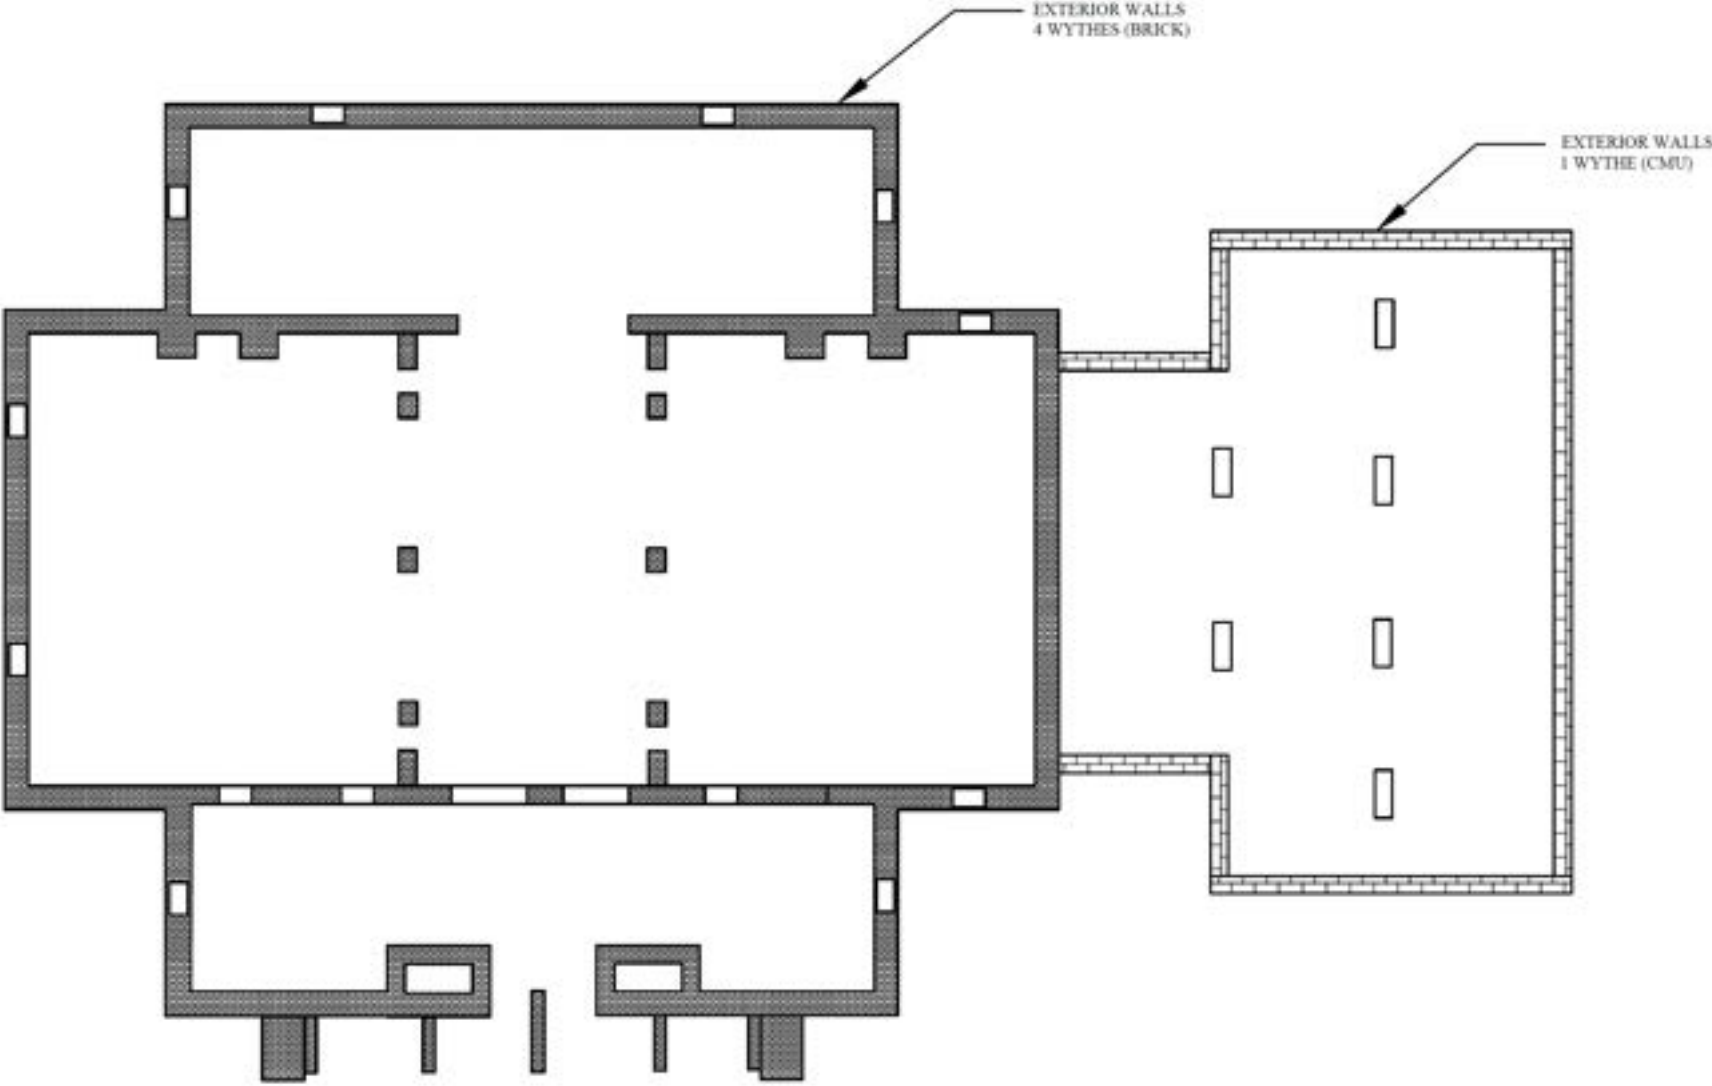
PELHAM CARNEGIE LIBRARY
FOUNDATION PLAN

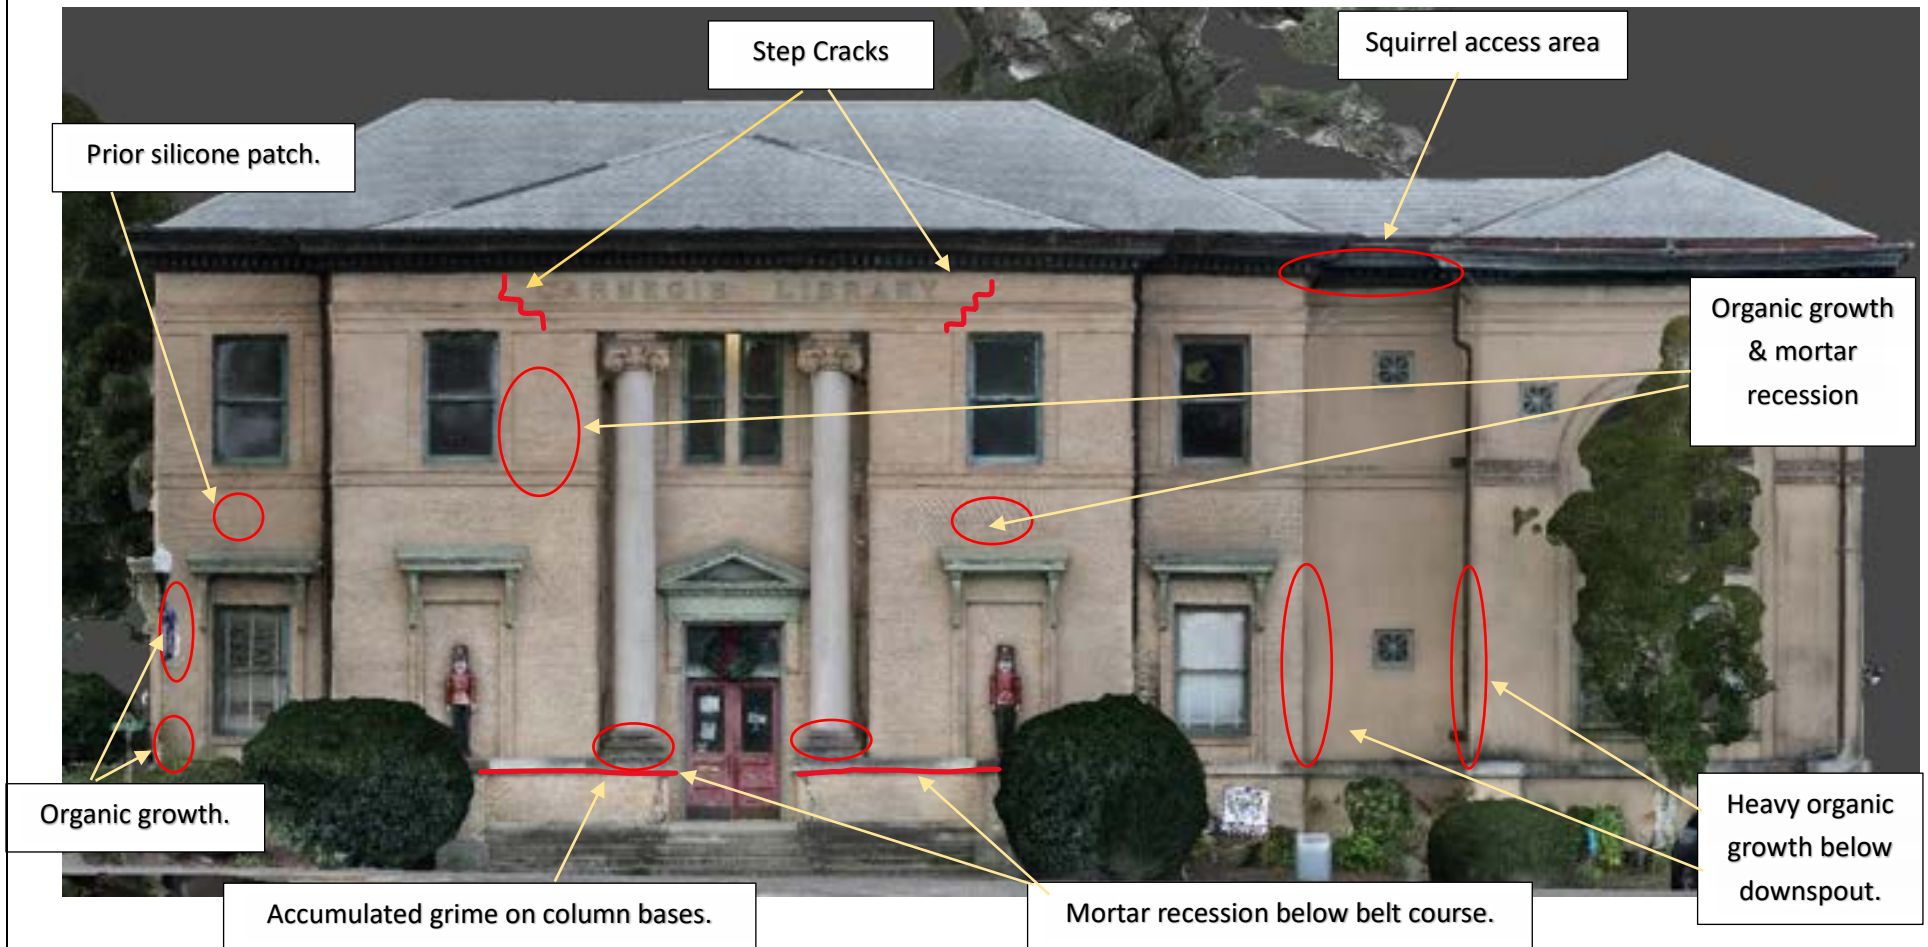
Image of exterior elevation is from a 3D model of the building. Some dimensional and surface finish distortion is present.

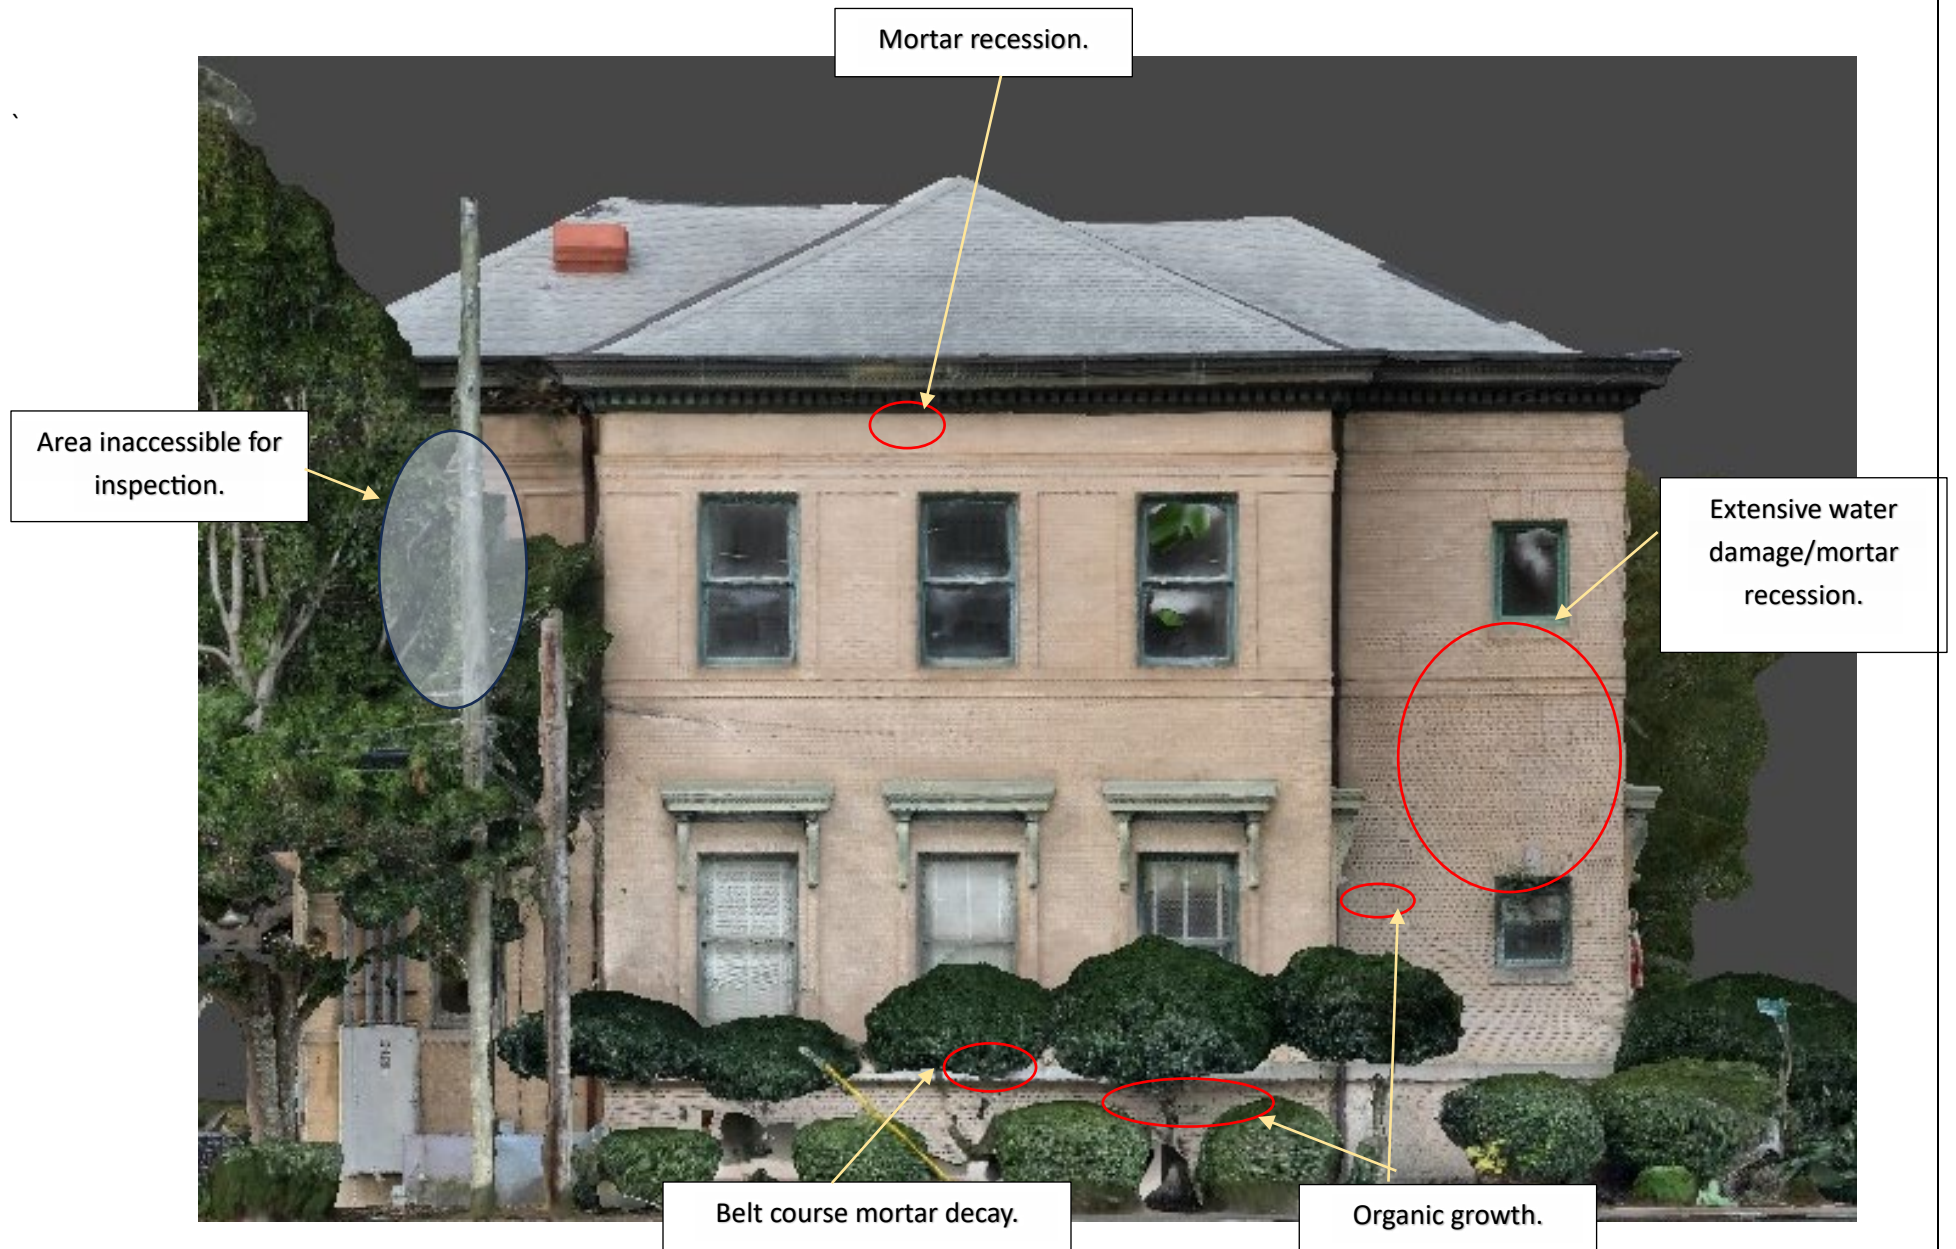
Image of exterior elevation is from a 3D model of the building. Some dimensional and surface finish distortion is present.
