Spring 2024

Historic Structure Report

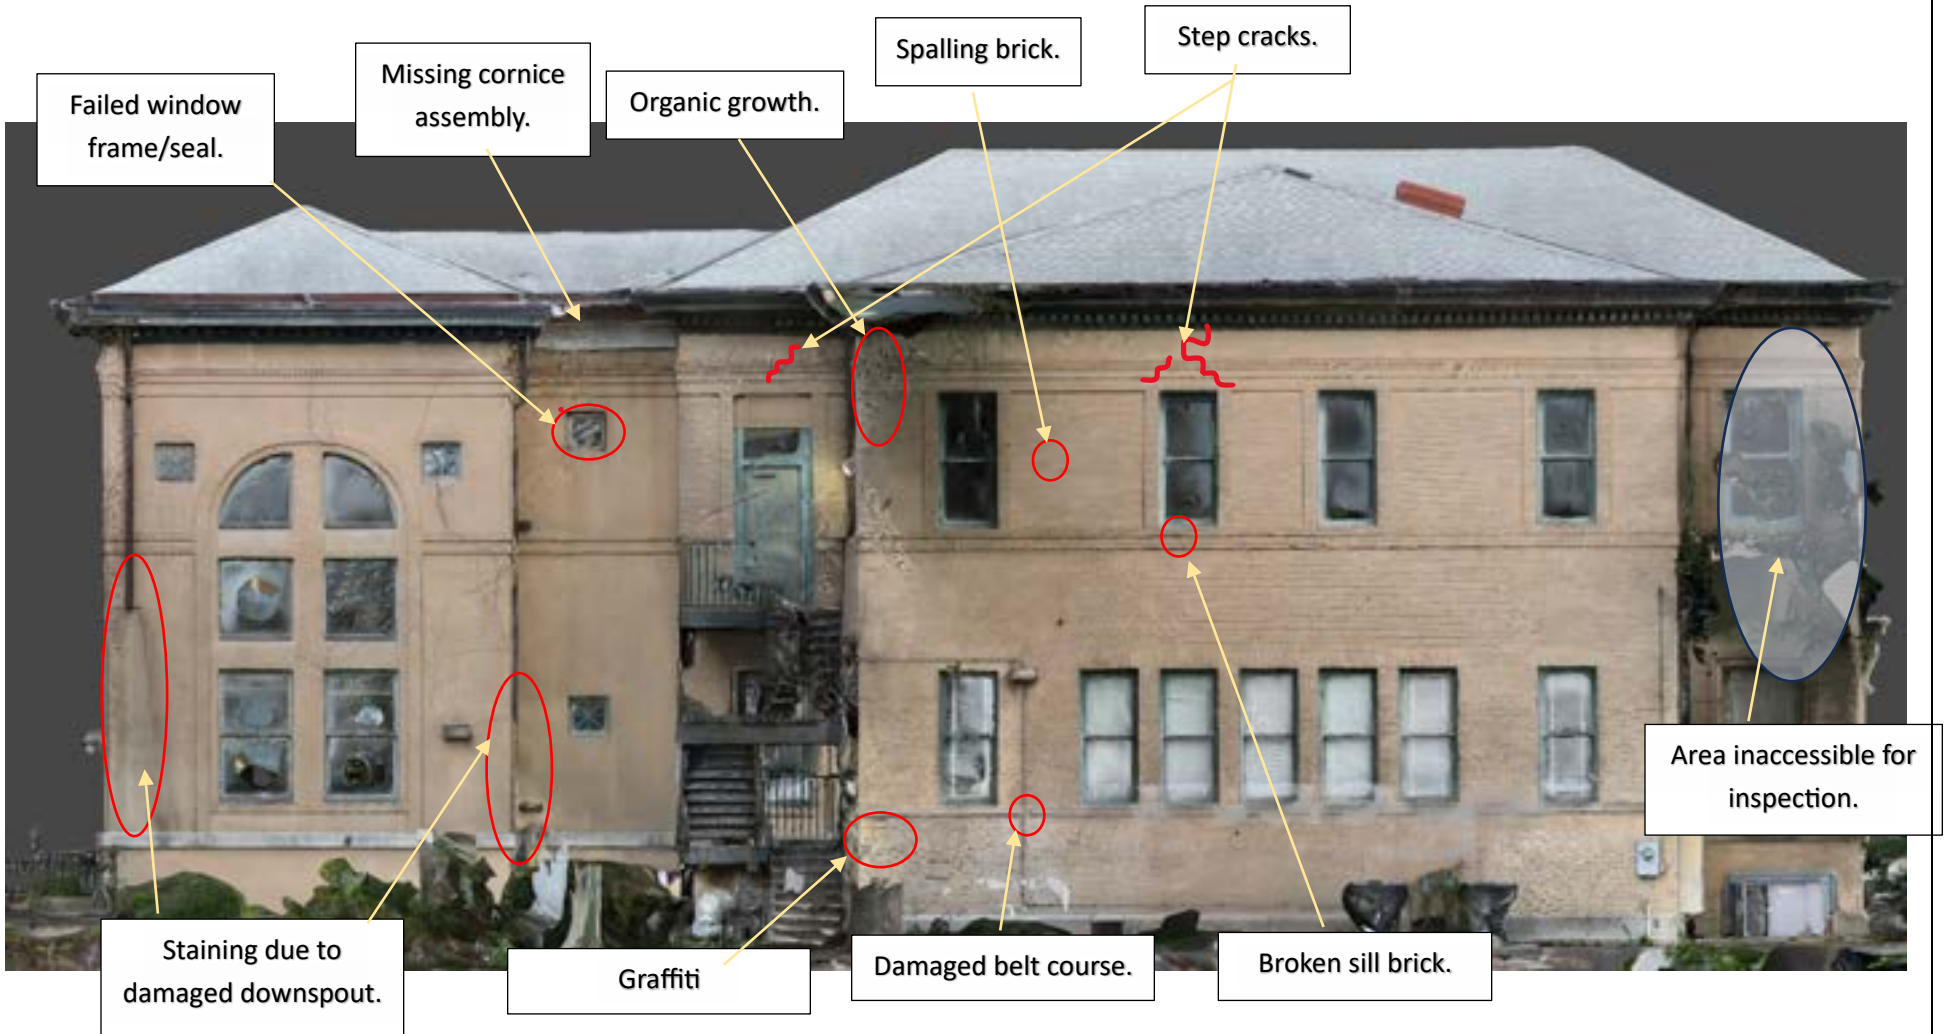
Image of exterior elevation is from a 3D model of the building. Some dimensional and surface finish distortion is present.

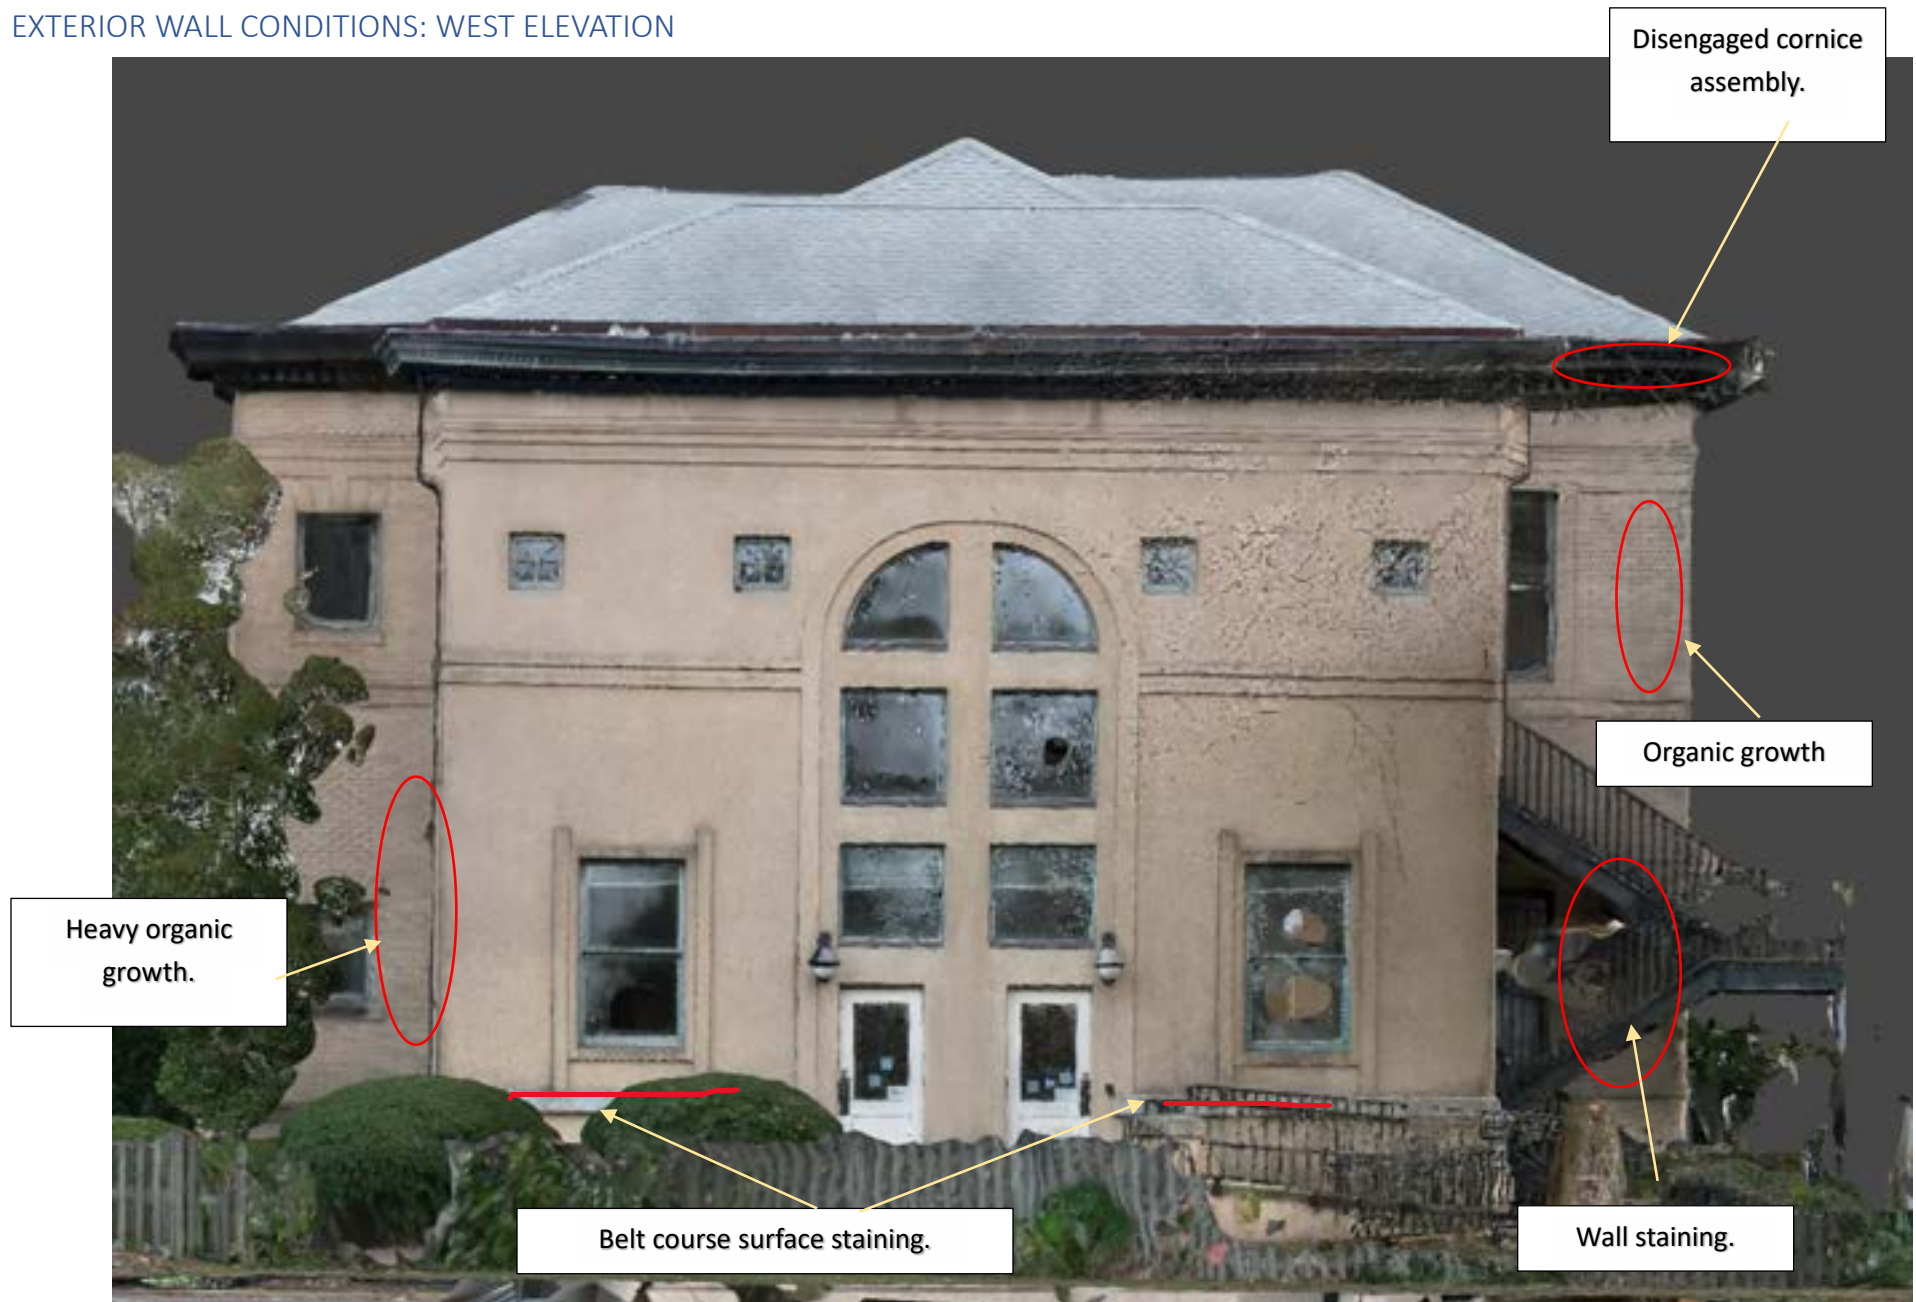
Image of exterior elevation is from a 3D model of the building. Some dimensional and surface finish distortion is present.

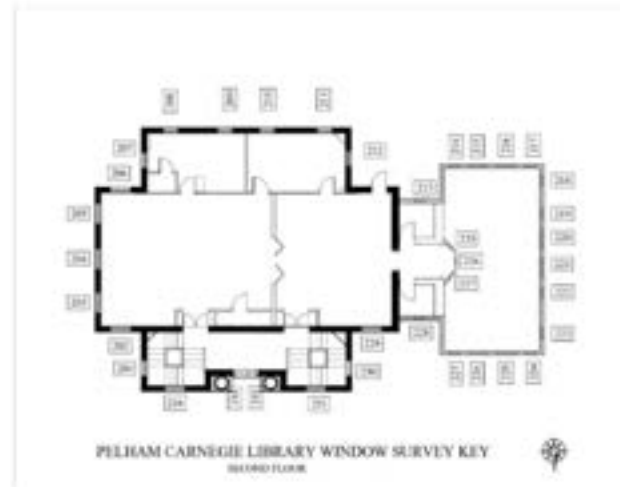
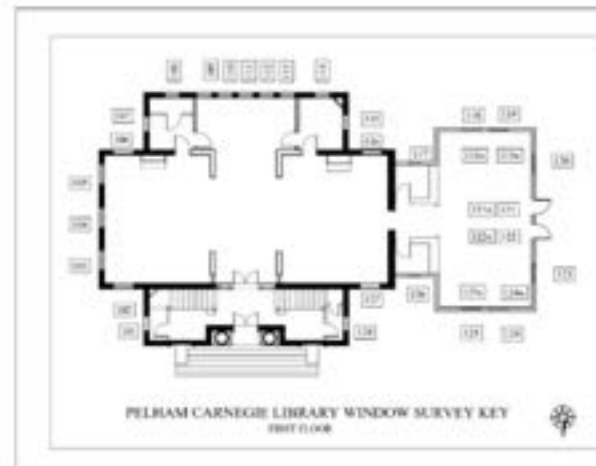
Window Condition Summary	# of Units	%	
Score between 1 - 1.5 (structurally sound)	21	29.6%	Units require only standard restorative maintenance (scraping, glazing, painting)
Score between 1.5 - 2 (material decay or damage noted)	21	29.6%	Units require standard restorative maintenance PLUS some material consolidation (i.e. epoxy) for some elements
Score between 2 - 3 (significant material decay/damage noted)	22	31.0%	Units require maintenance, epoxy AND new millwork
Scoring between 3 - 4 (multiple window elements failing)	7	9.9%	Units require significant reconstruction/replacement

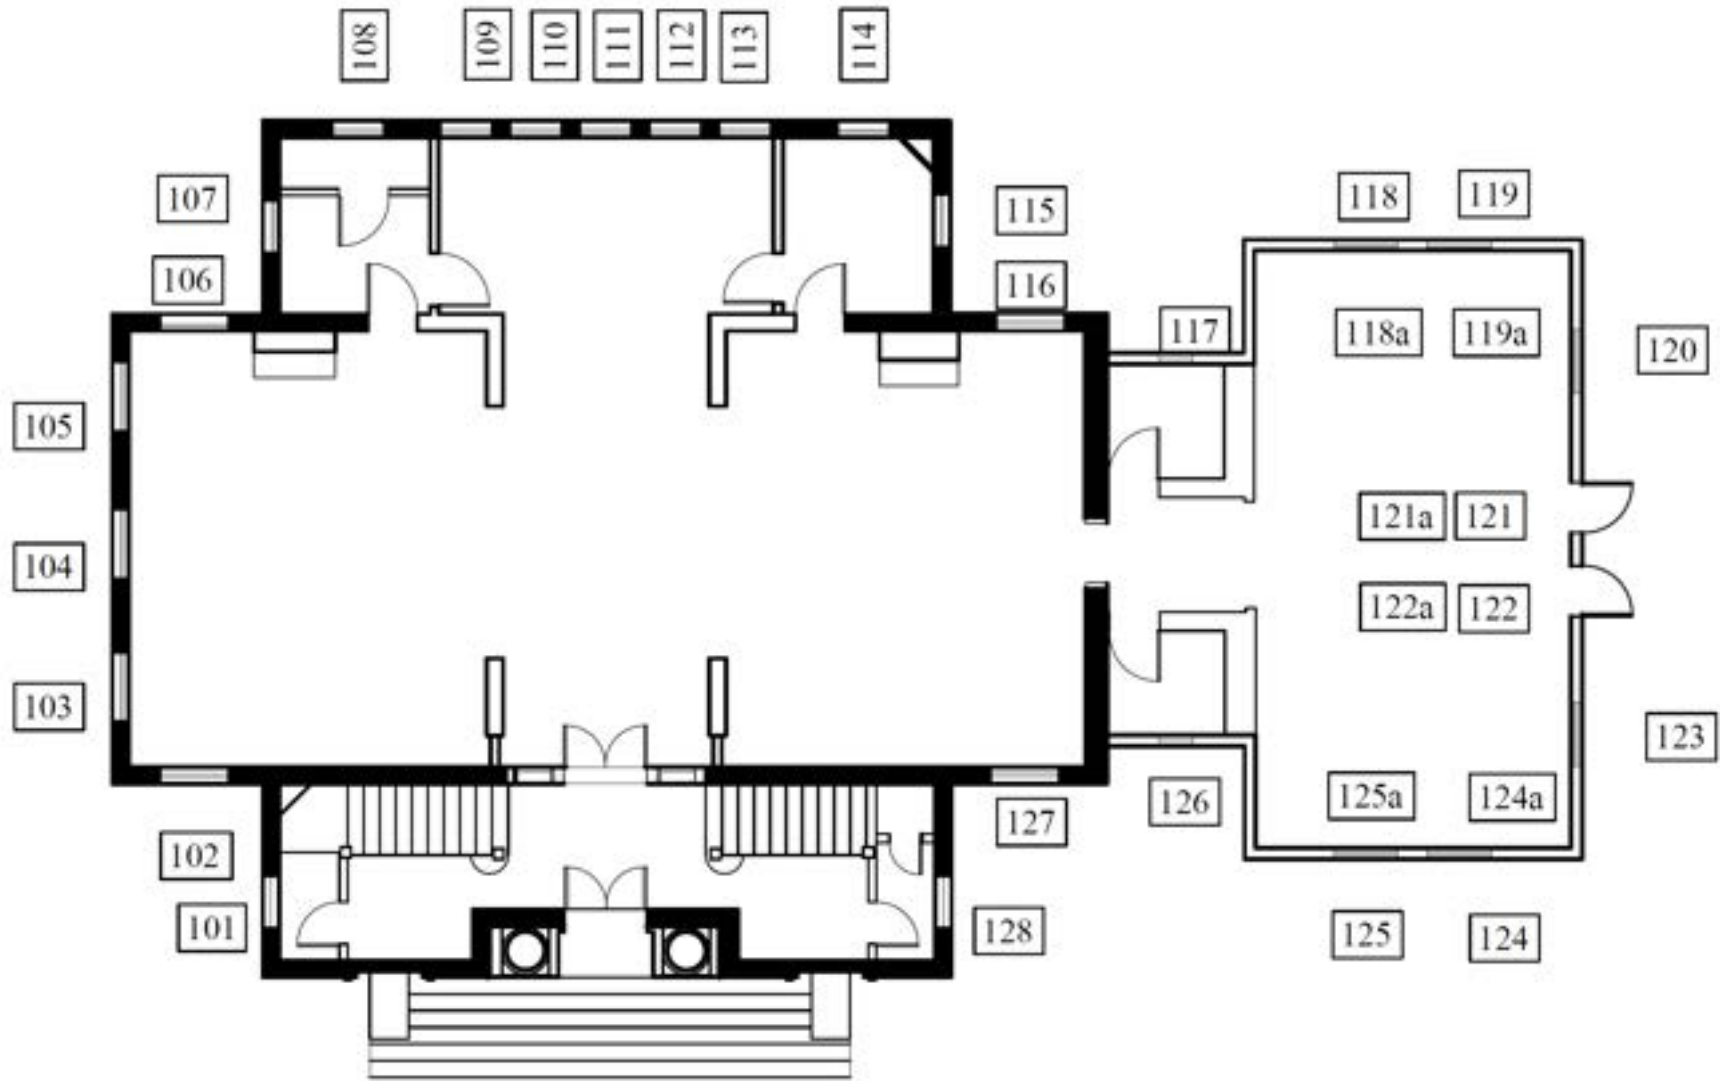
PELHAM CARNEGIE LIBRARY WINDOW SURVEY KEY
FIRST FLOOR

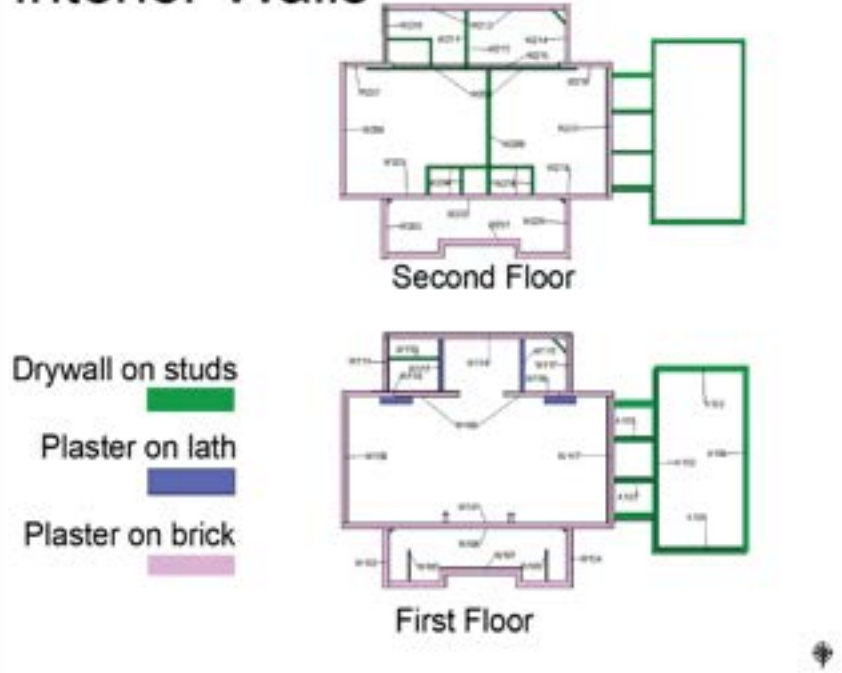
Larger Wall key provided at end of survey
